Engineering Services

10th January 2023

**Re; Chinamans Bridge, at Nagambie
on Nagambie Heathcote Road over Goulburn River
- POST OCTOBER 2022 FLOOD STRUCTURAL ASSESSMENT**

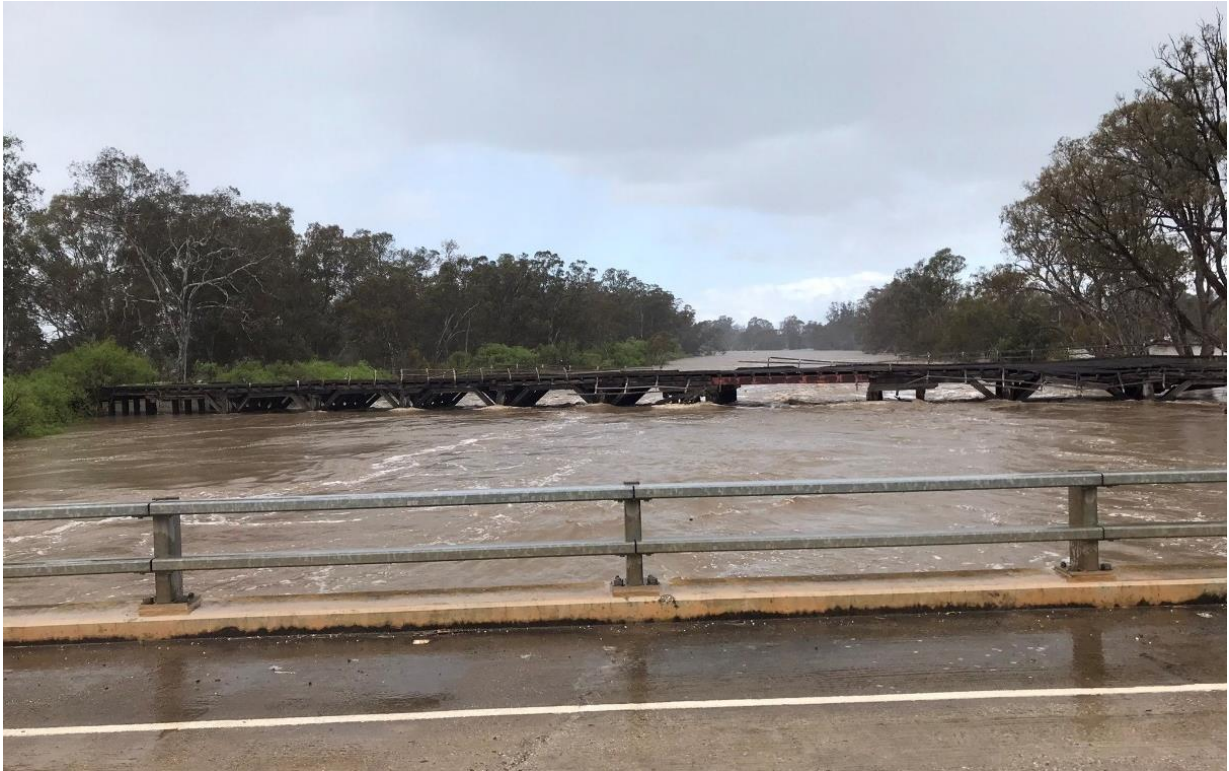
We also acknowledge the below flood image supplied by ¹Lee Roland. He advises that he recorded this image at 4.03pm on Friday 14/10/22. Also that this water level increased by about "12 to 18 inches" when the river peaked on Sunday 16/10/22.
