Structural Engineering Advice

Chinamans Bridge

Nagambie

27th May 2024

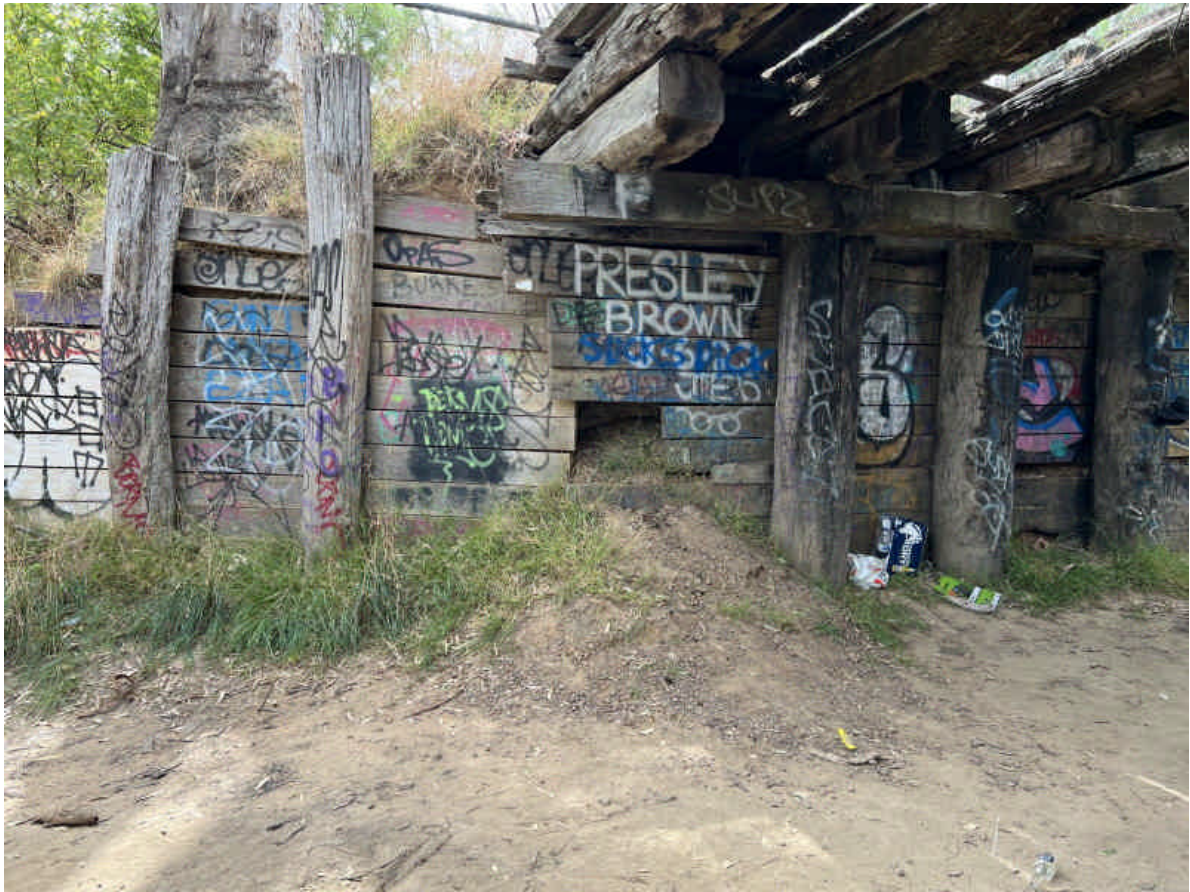
In general the central section of the northern abutment appears to be in serviceable condition, albeit the piles are in variable condition and two piles are missing from the western section, and the eastern section has partially collapsed.

A view of the northern abutment.

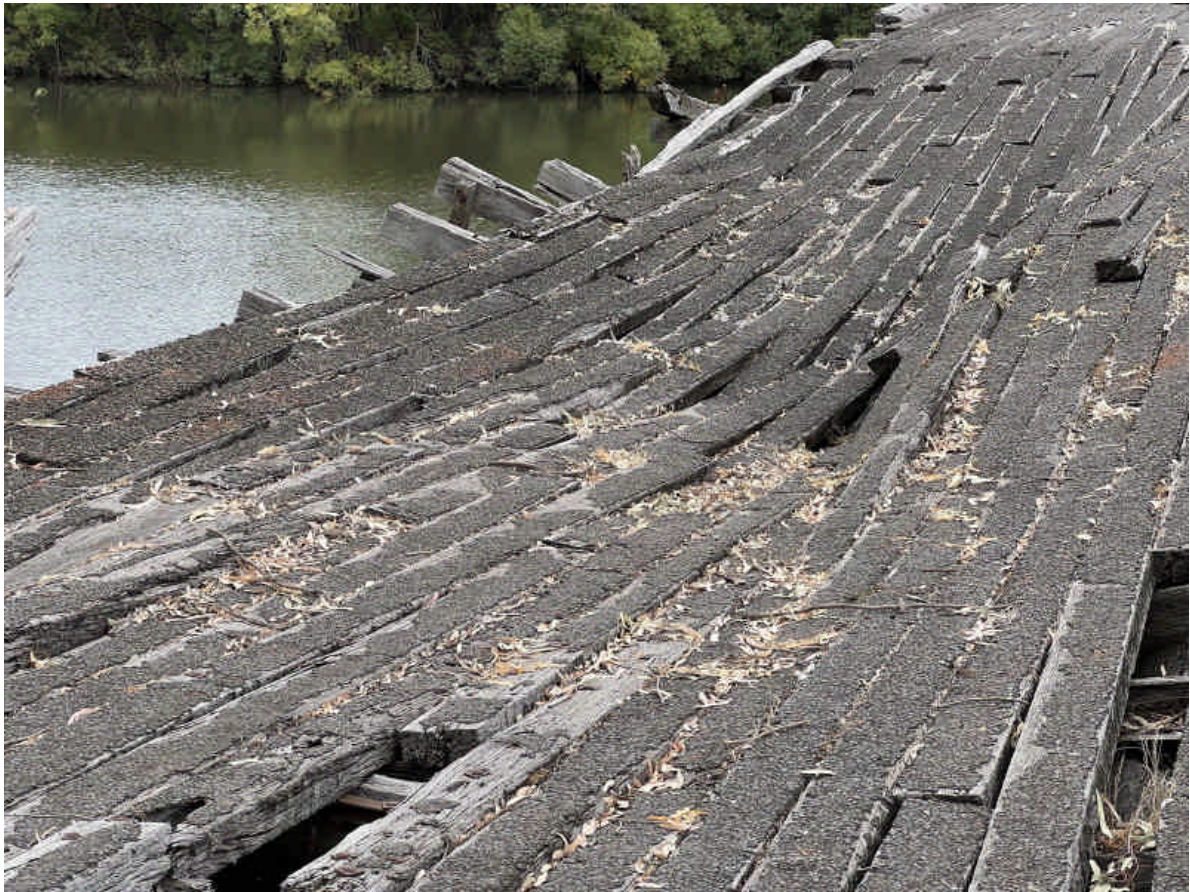
A view of a collapsed section of the deck.

A discussion of the remedial and strengthening works that would be required to achieve a live load capacity of 4.0 KPa or 4.5 kN follows. It should be noted that where the collapses have occurred the super-structure will need to be dismantled and then reconstructed.

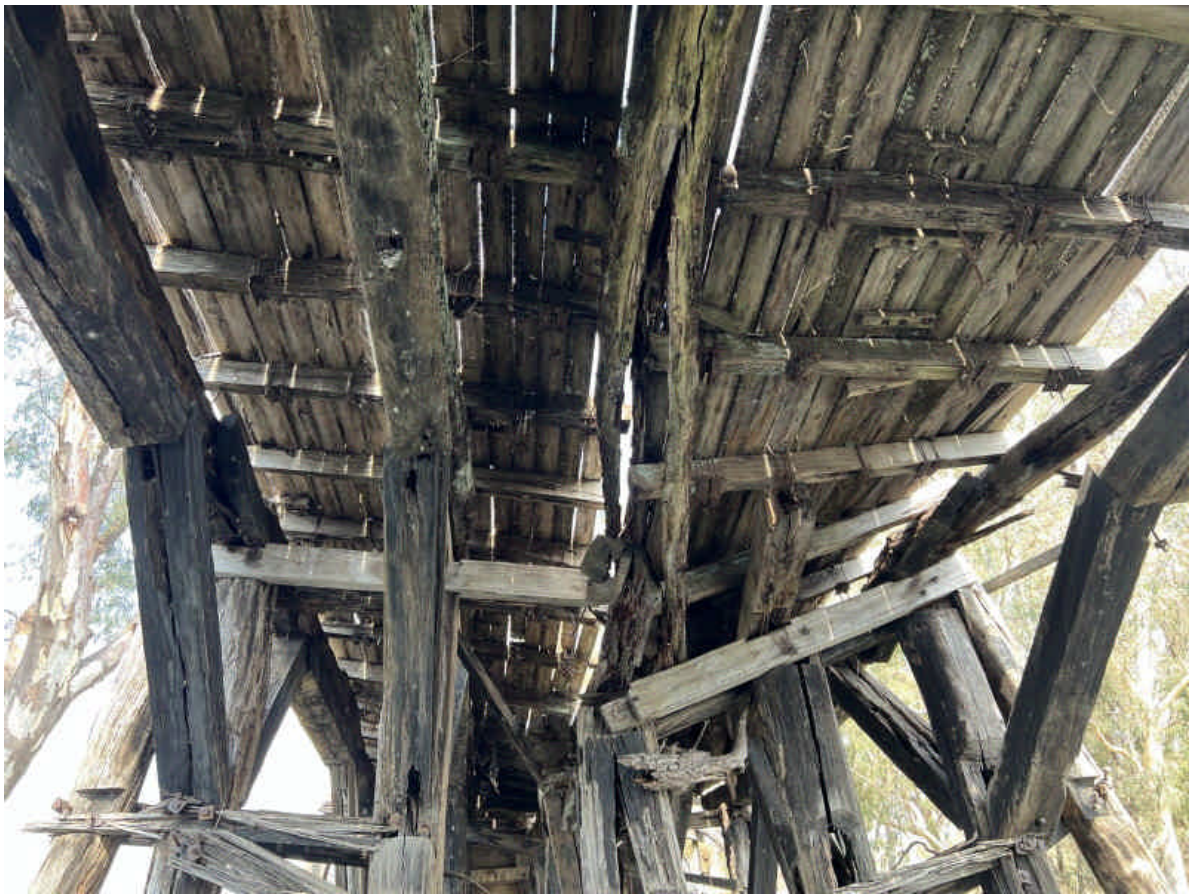
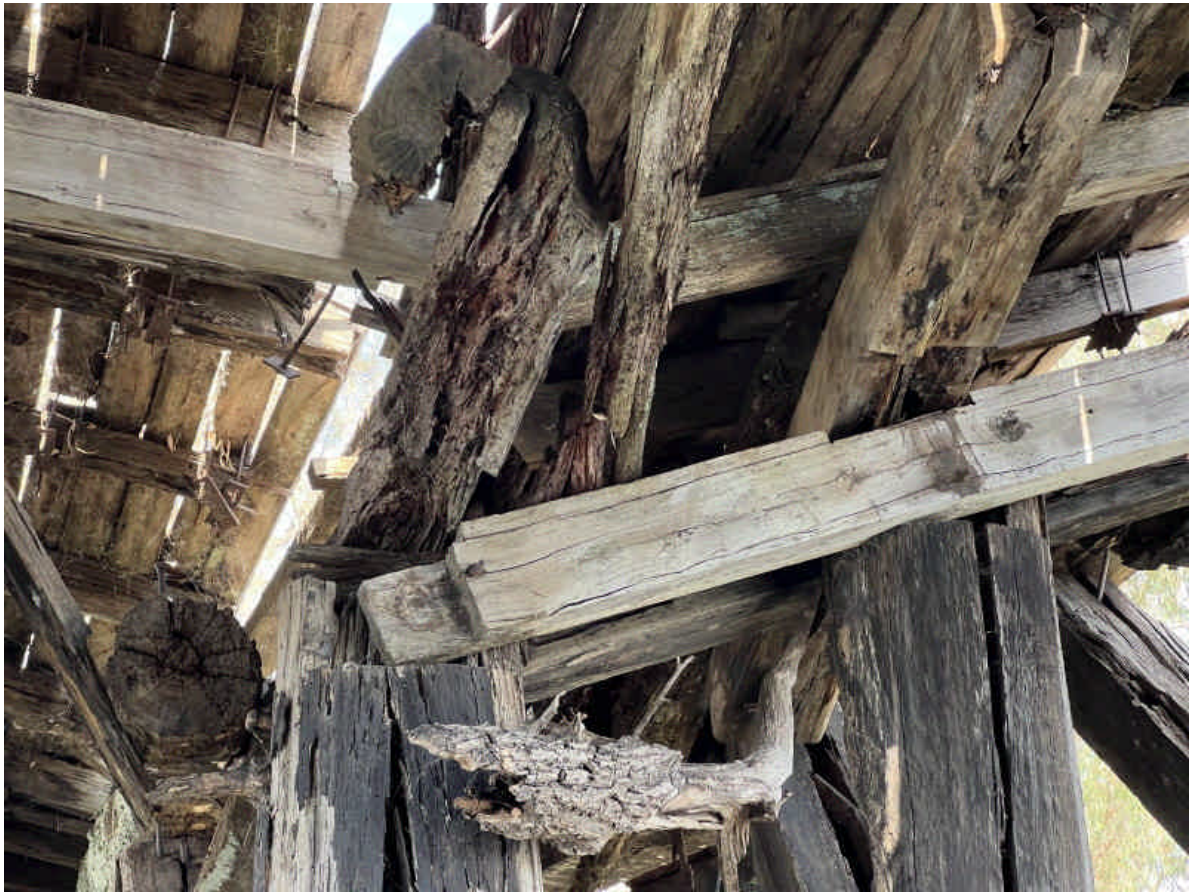
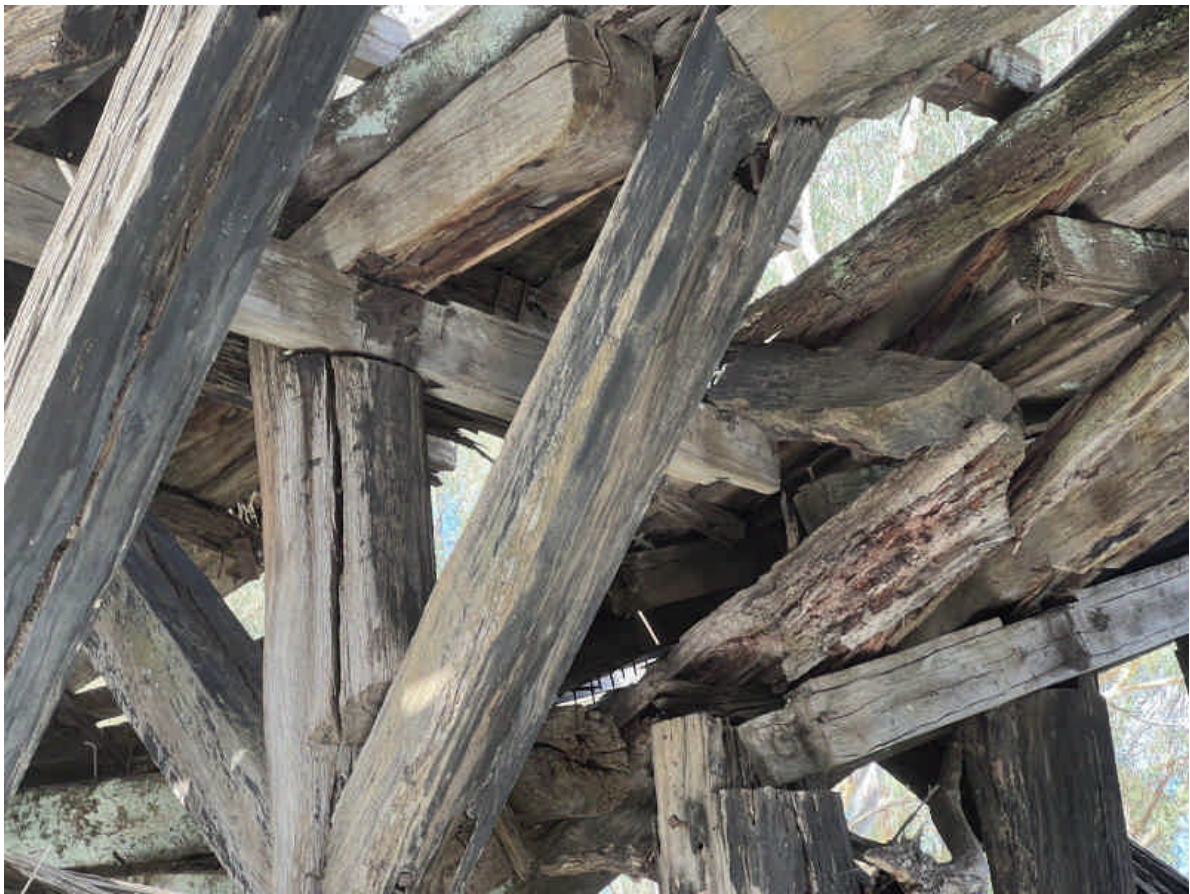
A view of the collapse at the southern end.

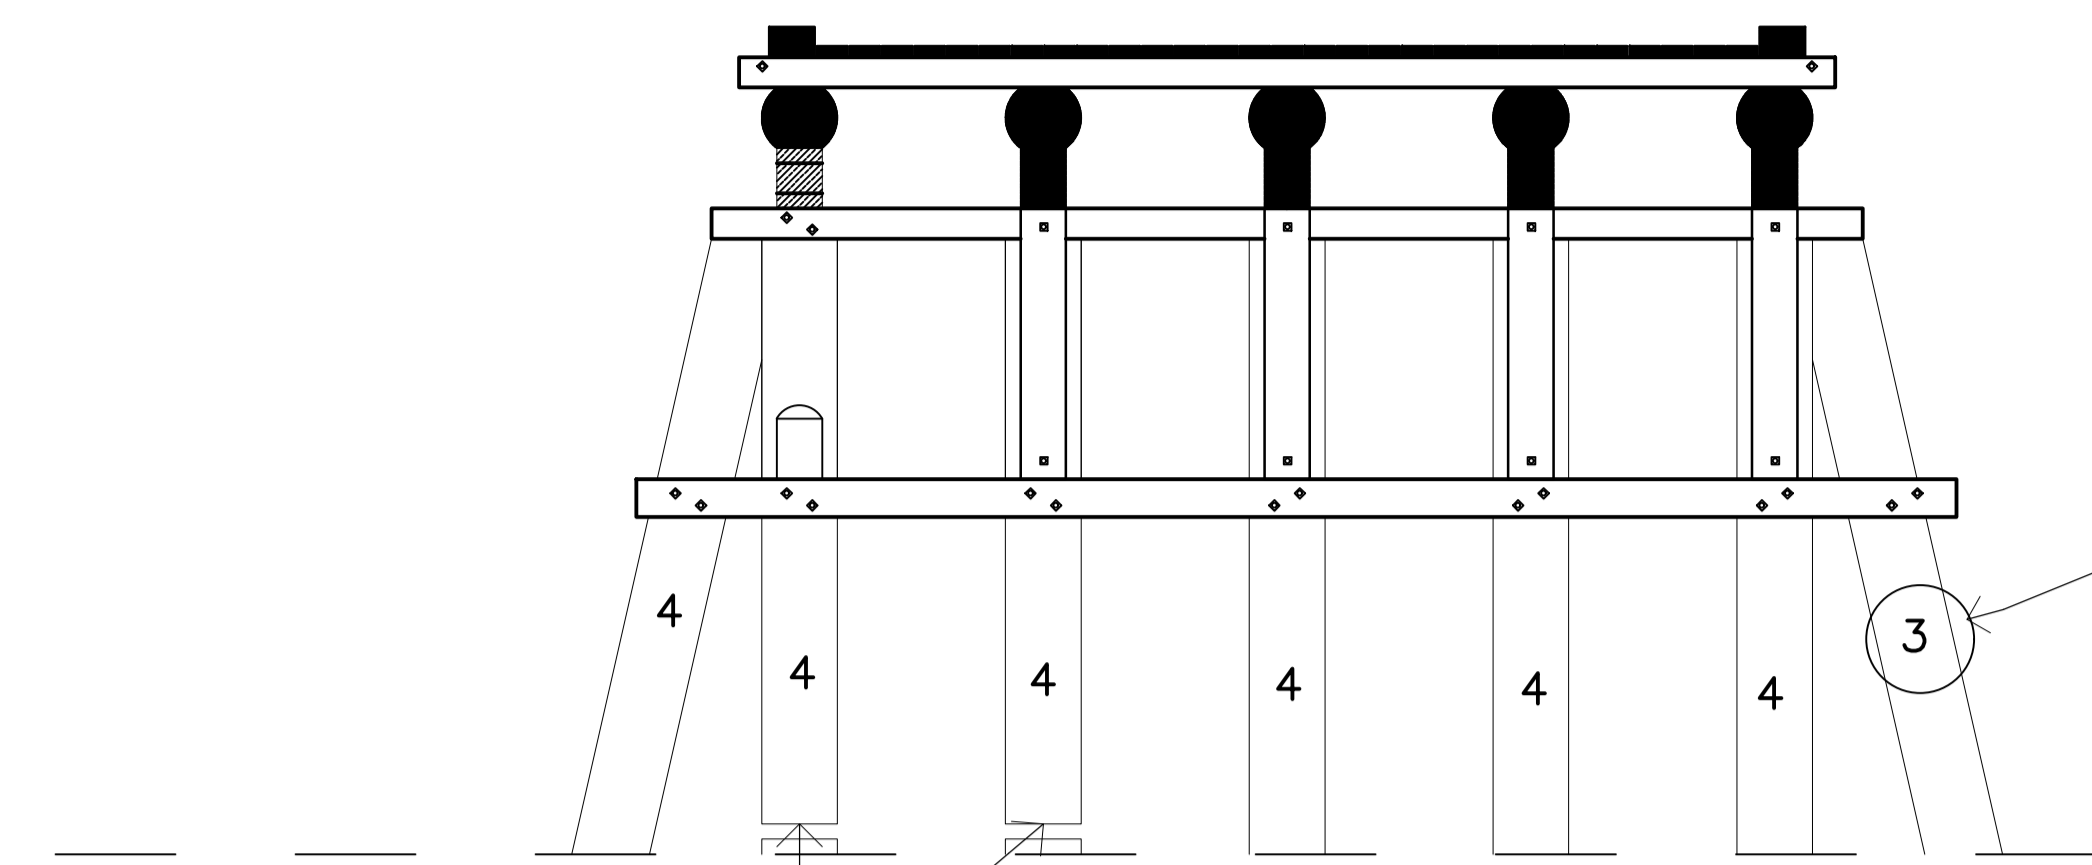
SECTION $\frac{3N}{S1}$ TRESTLE No. 3 NORTH VIEW
1:50

PILES ROTTEN AT BASE

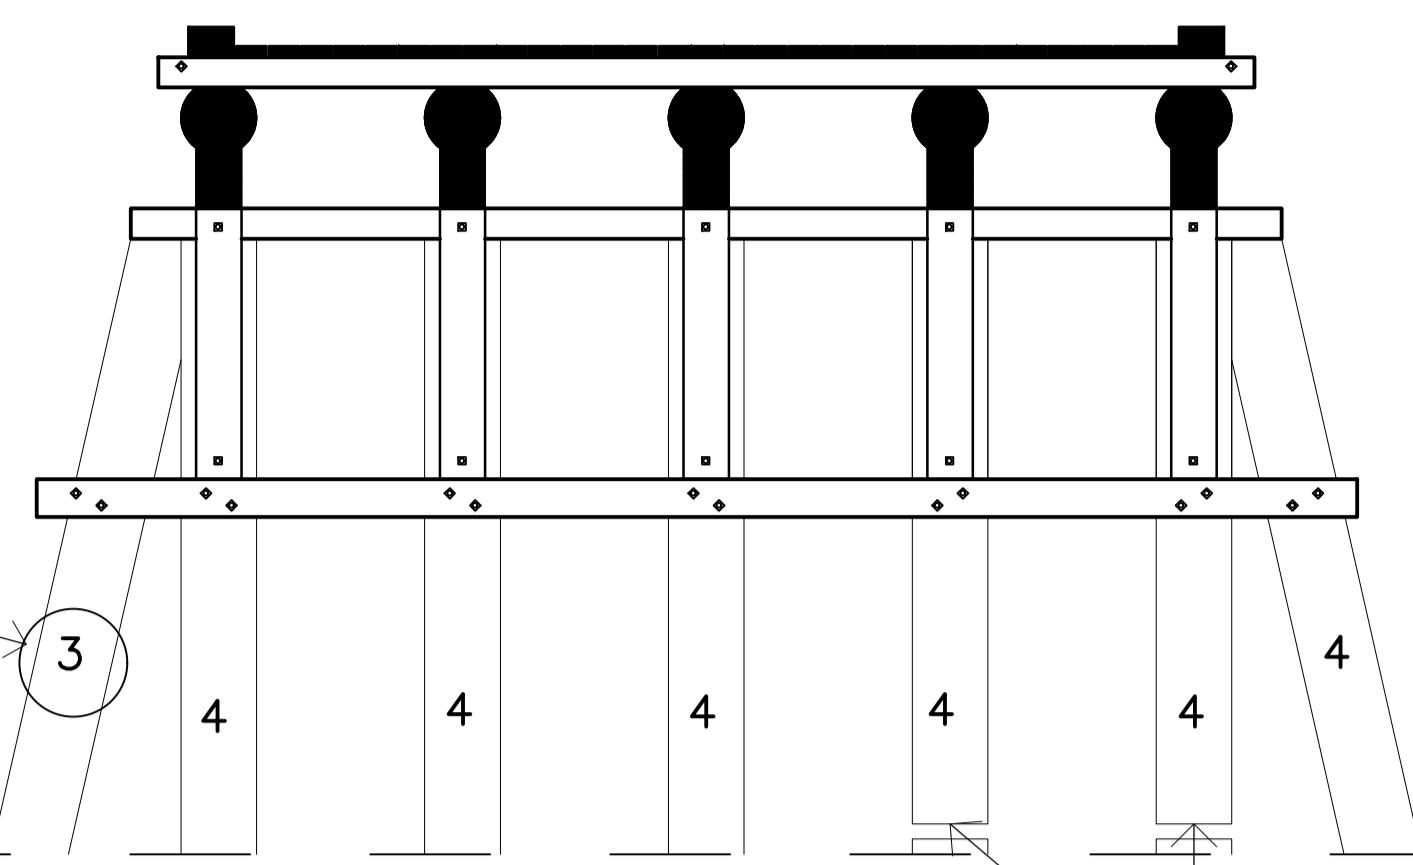
SECTION $\frac{3S}{S1}$ TRESTLE No. 3 SOUTH VIEW
1:50

PILES ROTTEN AT BASE

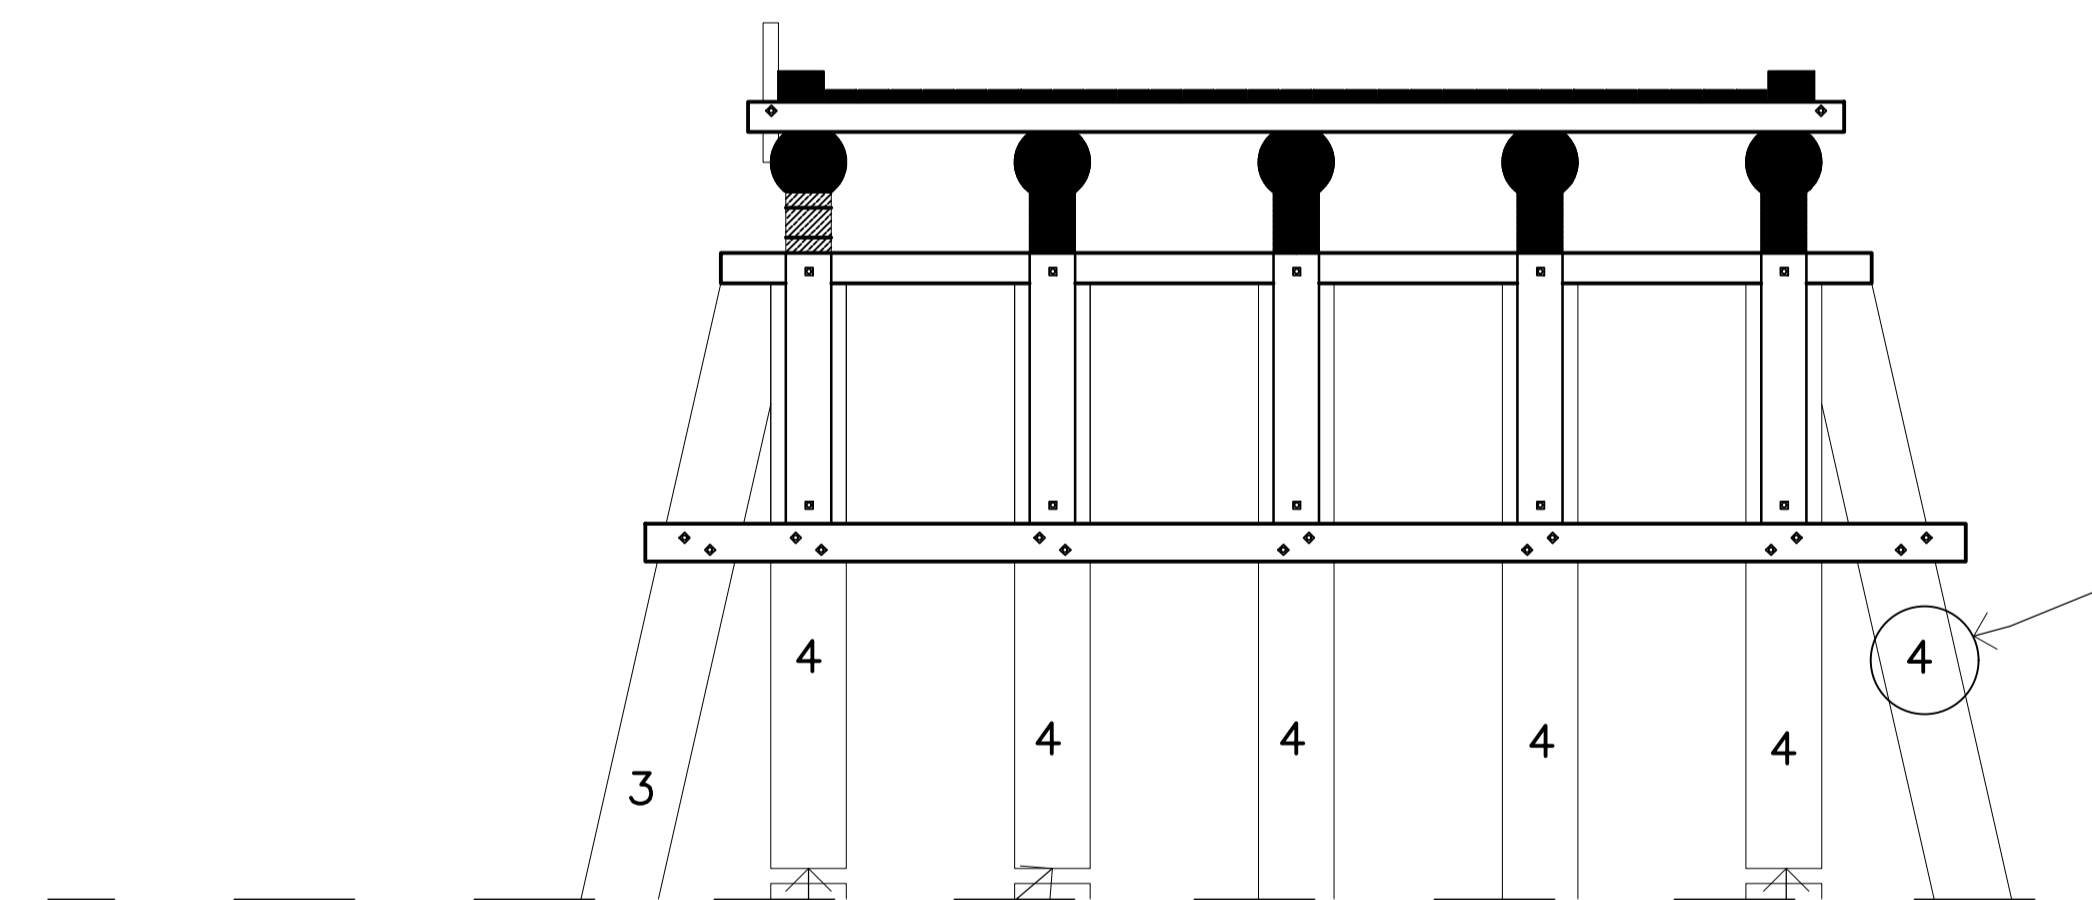
SECTION $\frac{4N}{S1}$ TRESTLE No. 4 NORTH VIEW
1:50

PILES ROTTEN AT BASE

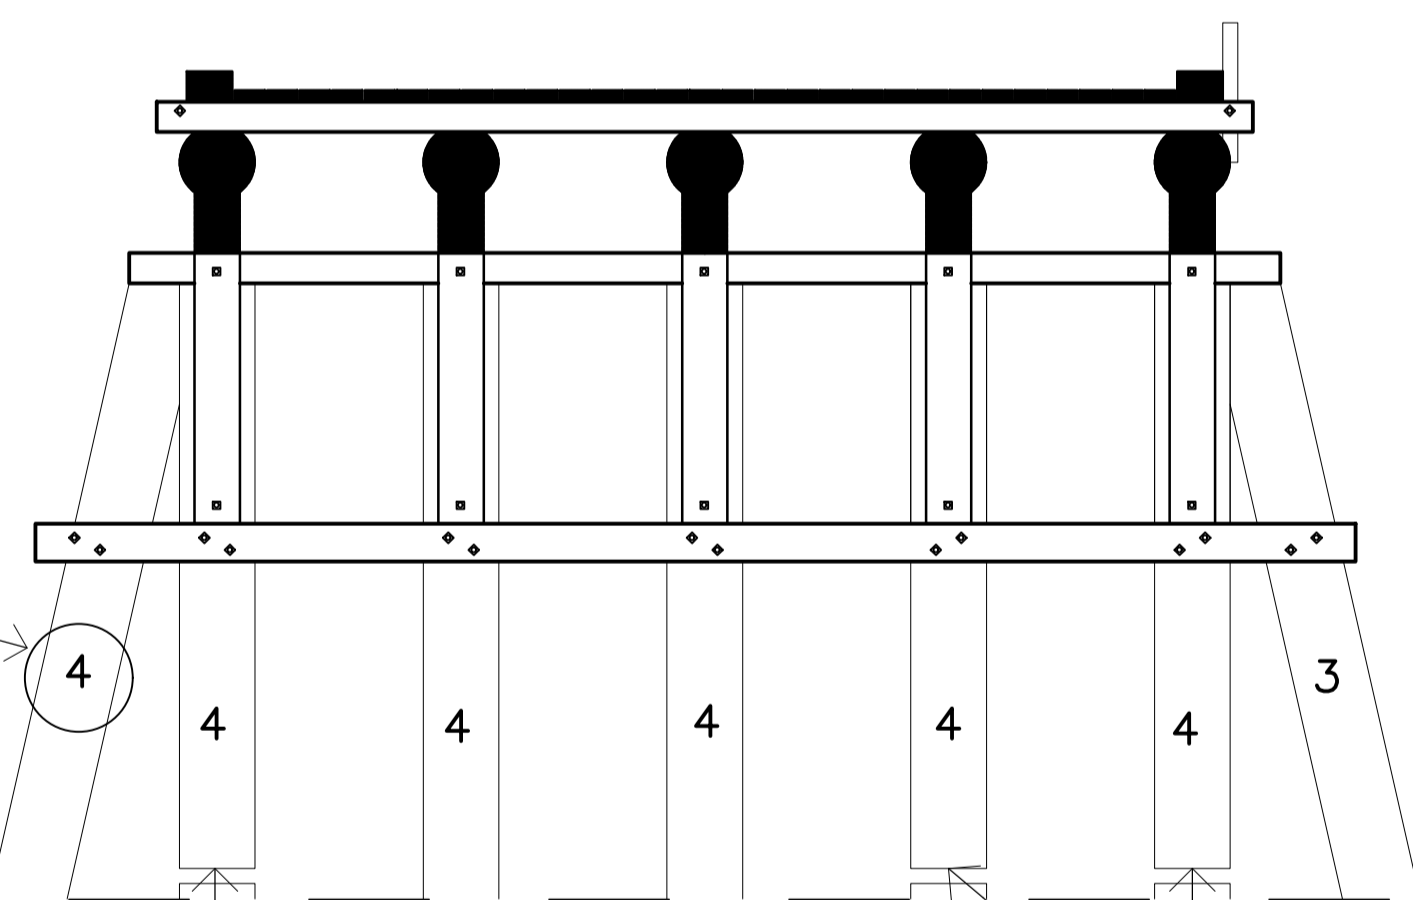
SECTION $\frac{4S}{S1}$ TRESTLE No. 4 SOUTH VIEW
1:50

PILES ROTTEN AT BASE

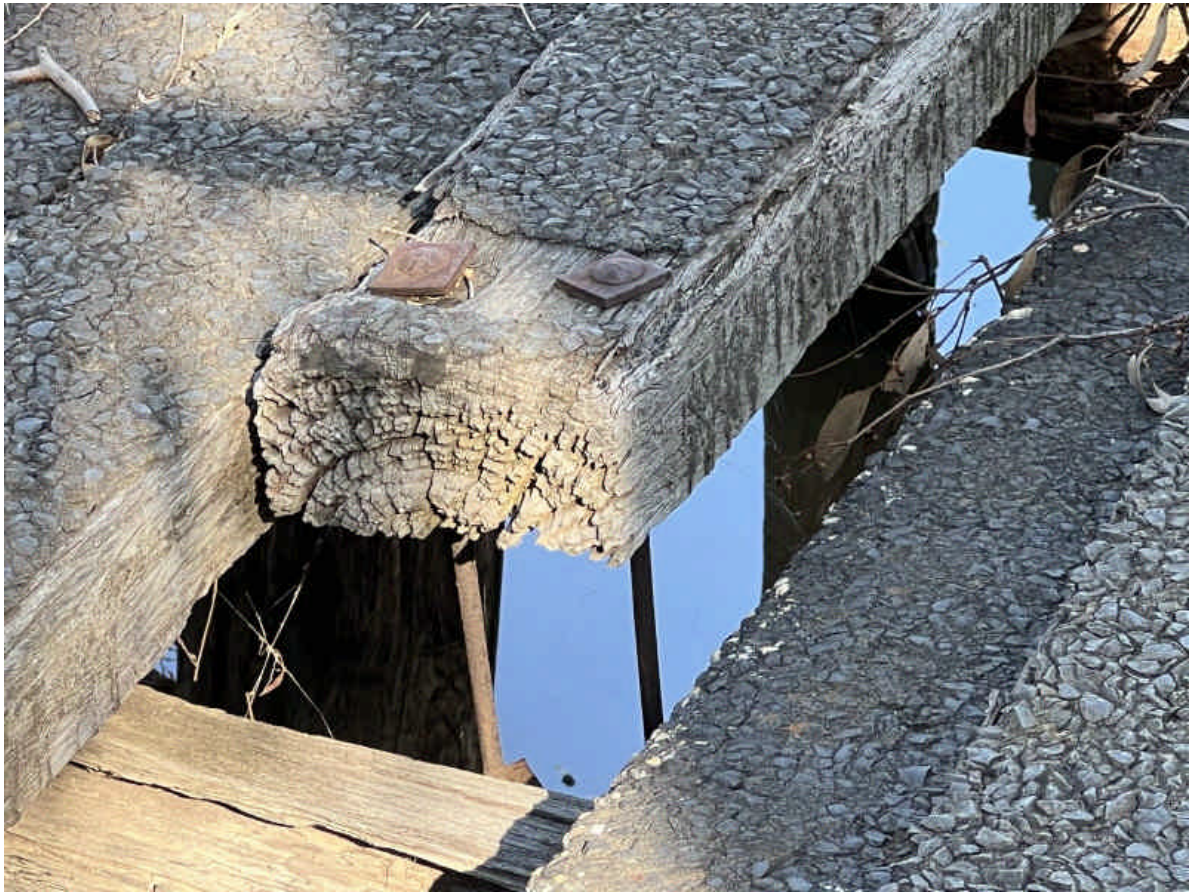
In general the HW decking appears to be in reasonable condition albeit the ends of the planks have dry-rot, and the asphalt coating may have been applied to 'patch' and even the tops of the planking. Refer to photographs 1 to 4, Appendix C.

A view of the end of a plank showing the dry-rot.

As the decking has been laid in very long lengths it should be possible to dock the ends of the planks to remove the dry-rot, before relaying them. It should be noted that a 25% reduction of structural depth will still achieve the required live load capacity.

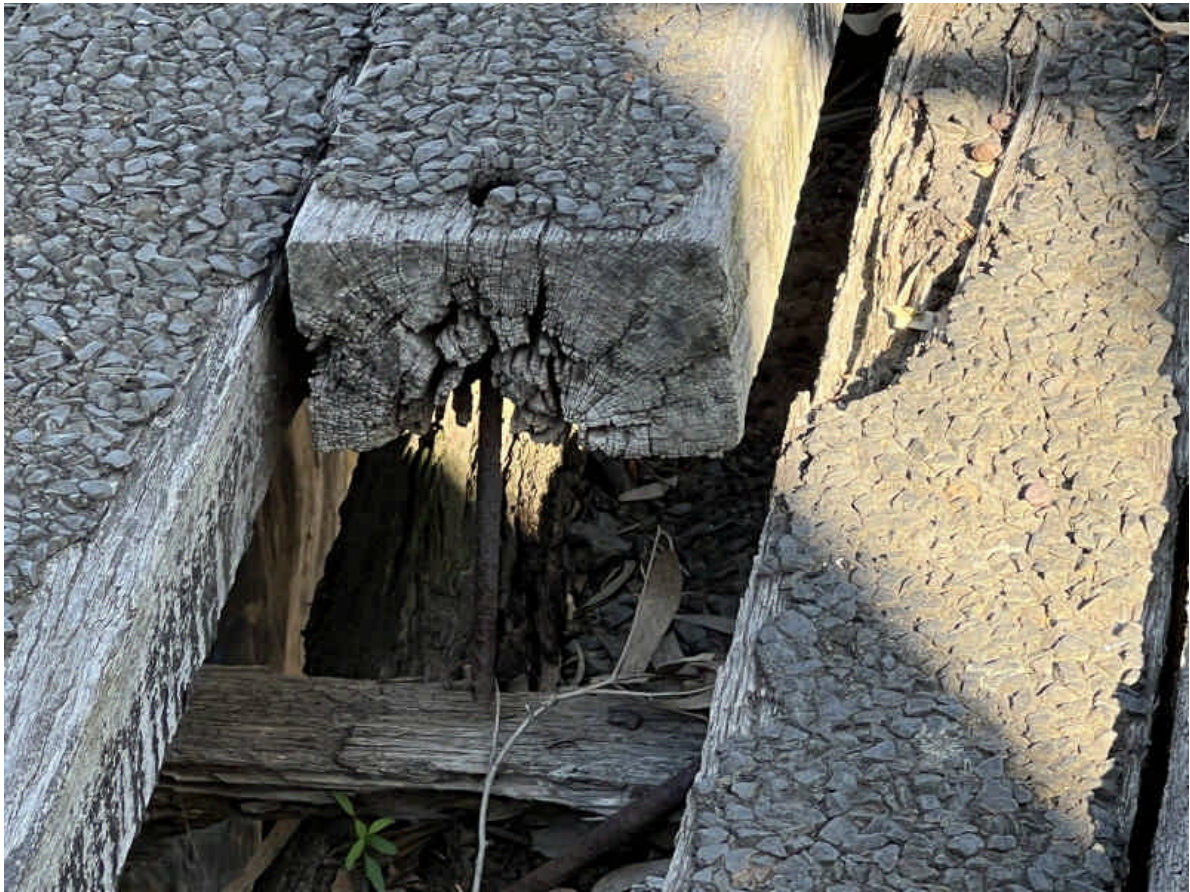
A view of the end of a plank showing the dry-rot.

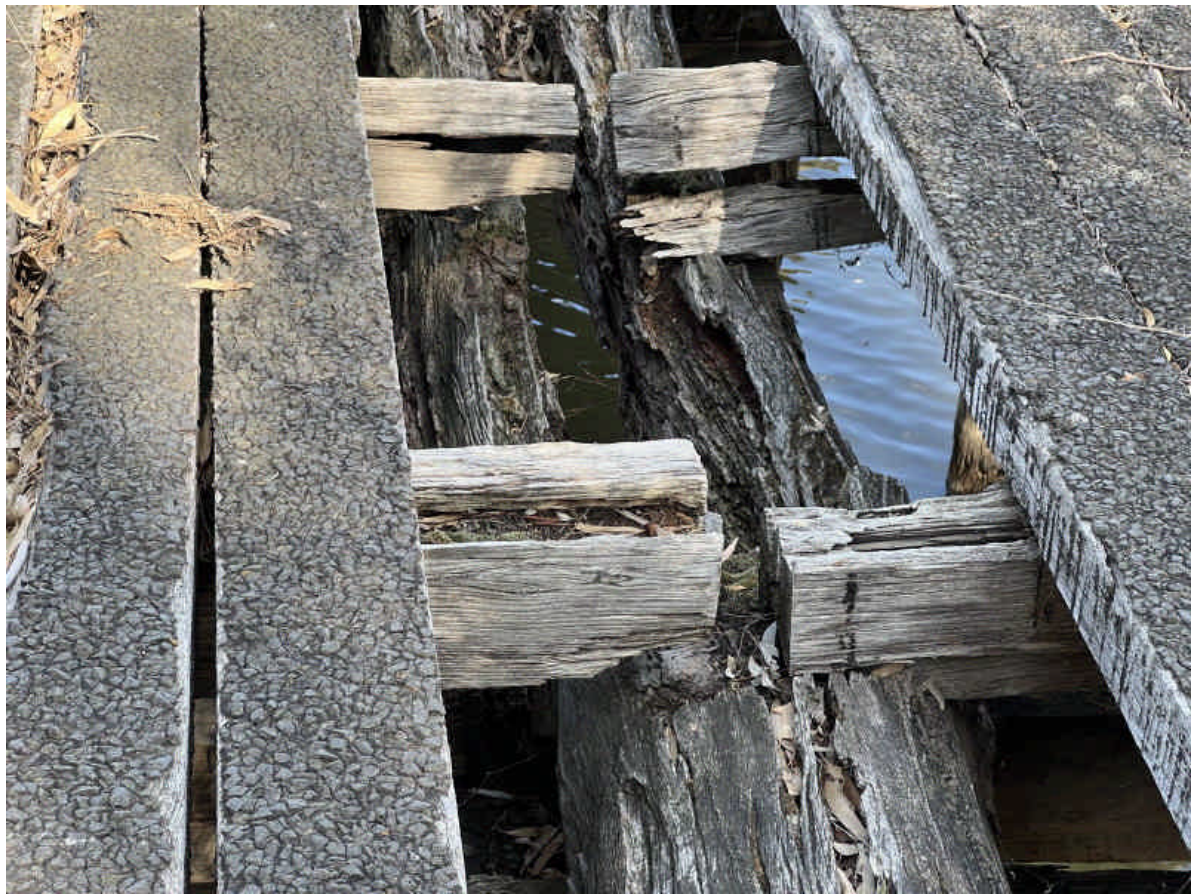
The HW cross-beams are in generally poor condition and many of them have failed. Further, the numerous bolts and plates that have been retrofitted along the sides and below the cross-beams to secure the planks in position, indicates that the tops of the cross-beams have deteriorated and no longer hold the dog spikes that were originally used to fix the planks. Refer to photographs 5 to 7, Appendix C.

A view of the ends of the cross-beams showing the extensive damage.

Although the exact condition of the cross-beams will not be obvious until the decking has been removed it is probable that the great majority of the cross-beams will need to be replaced with durable seasoned timbers. If there are any cross-beams that are in a serviceable condition they will achieve the required live load capacity.

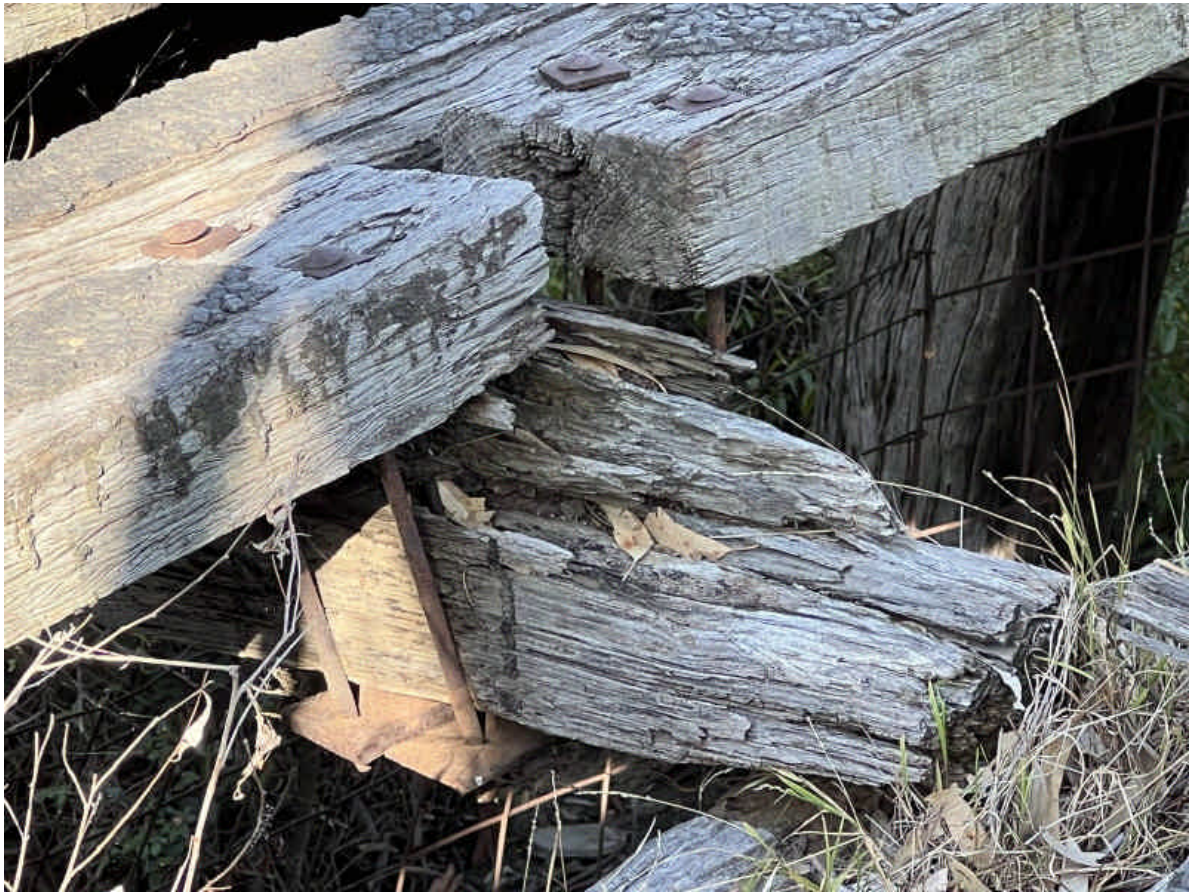
A view of the end of a cross-beam showing the extensive damage.

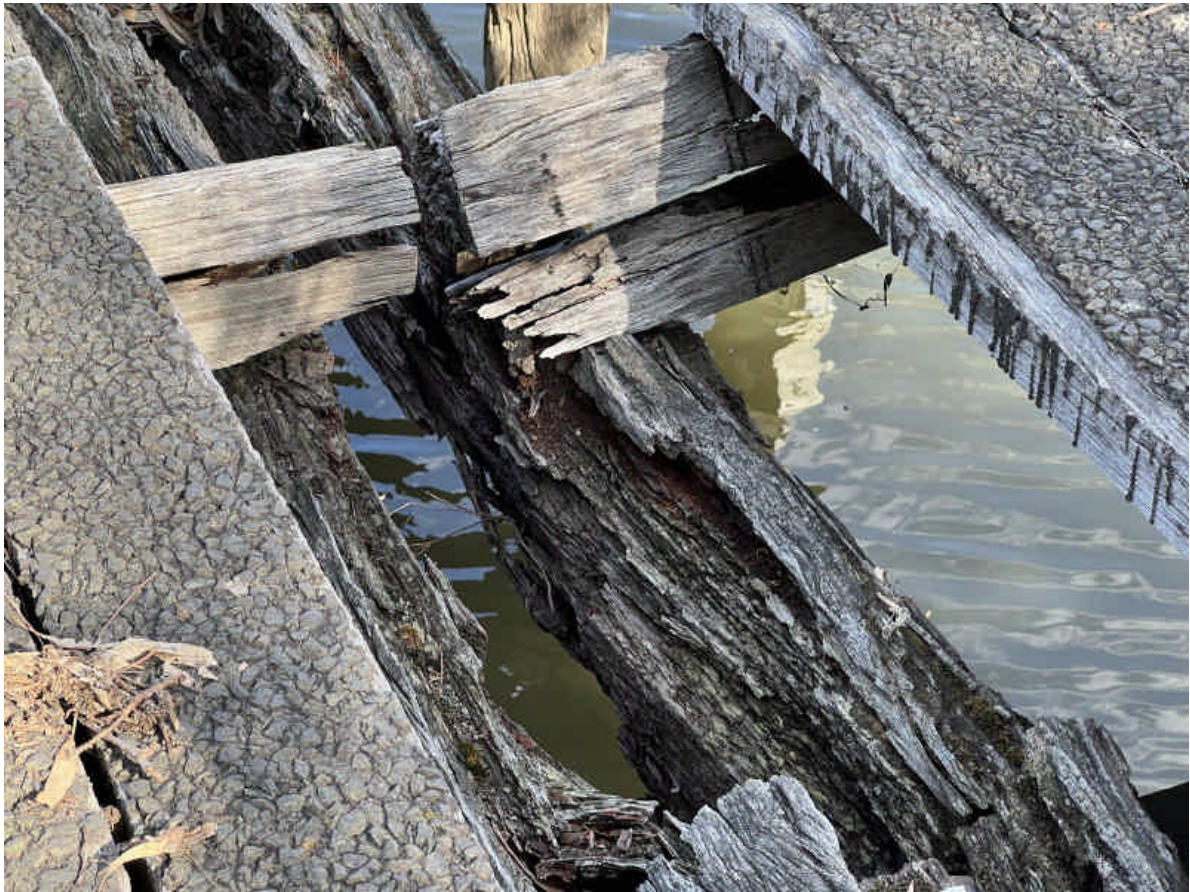
Where new beams have not been installed below the stringers (spans 1 to 3) some of the stringers have full depth splits and others have collapsed. Where the decking is missing, a number of the stringers have extensive channel-dry-rot in their tops (rot

in the middle of the section). Where the decking is intact and the tops of the stringers are not visible, the test drilling between the gaps in the planks found that there was extensive dry-rot in the tops of the stringers. Hence it is probable that the majority of the stringers have either channel-dry-rot in their tops or extensive pipe-rot. Refer also to photographs 8 to 11, Appendix C.

A view of the extensive damage in a stringer below the cross-beams.

Where new beams have not been installed below the stringers (spans 1 to 3) the stringers that have split apart and collapsed will need to be replaced. Where the stringers have channel-dry-rot and there is sufficient timber left at the sides of the stringers, the channel-dry-rot can be removed and sections of seasoned durable timber epoxy grouted into the remaining channels. Where there is insufficient timber left then either the channel-dry-rot can be removed, sections of seasoned durable timber epoxy grouted into the channel and steel beams fixed either side to augment the strength of the stringer, or otherwise new steel beams are installed adjacent to the stringer.

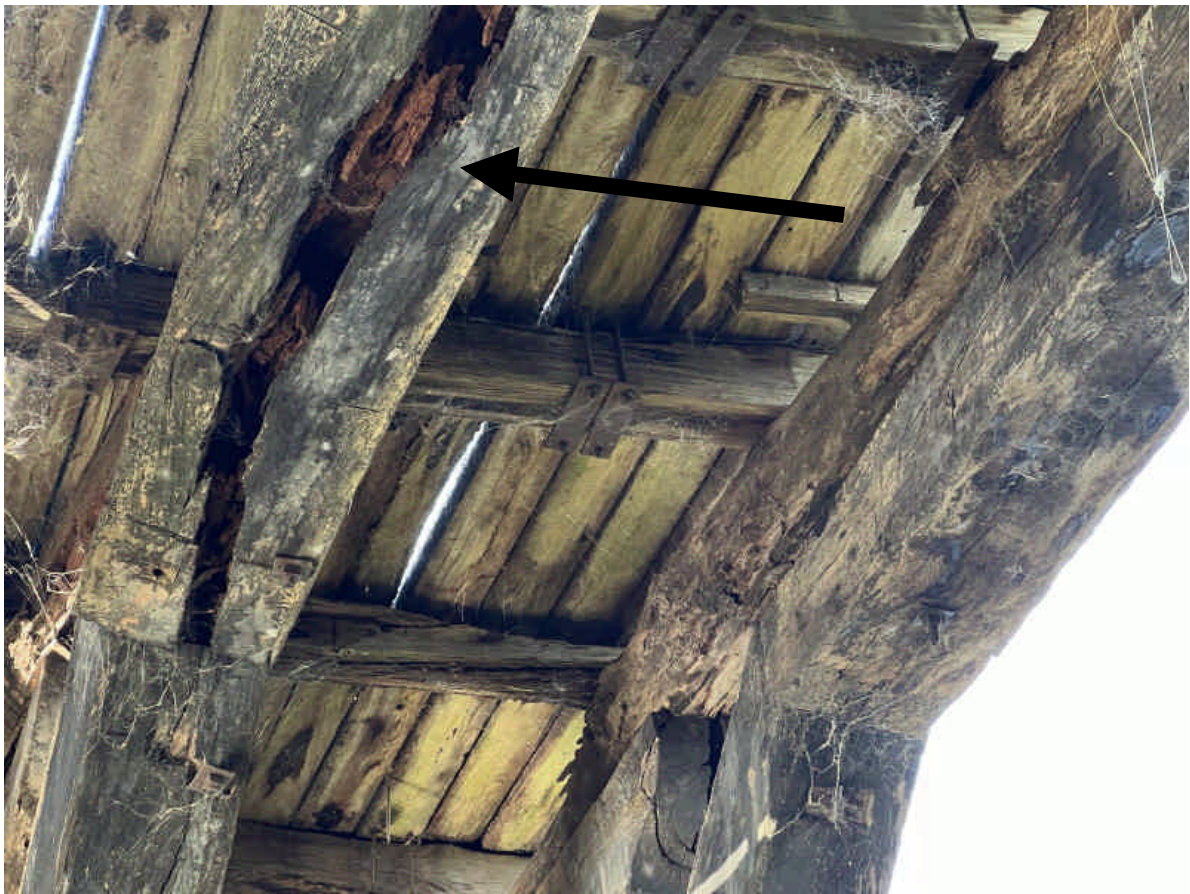
A view of the extensive damage in a stringer – see arrow.

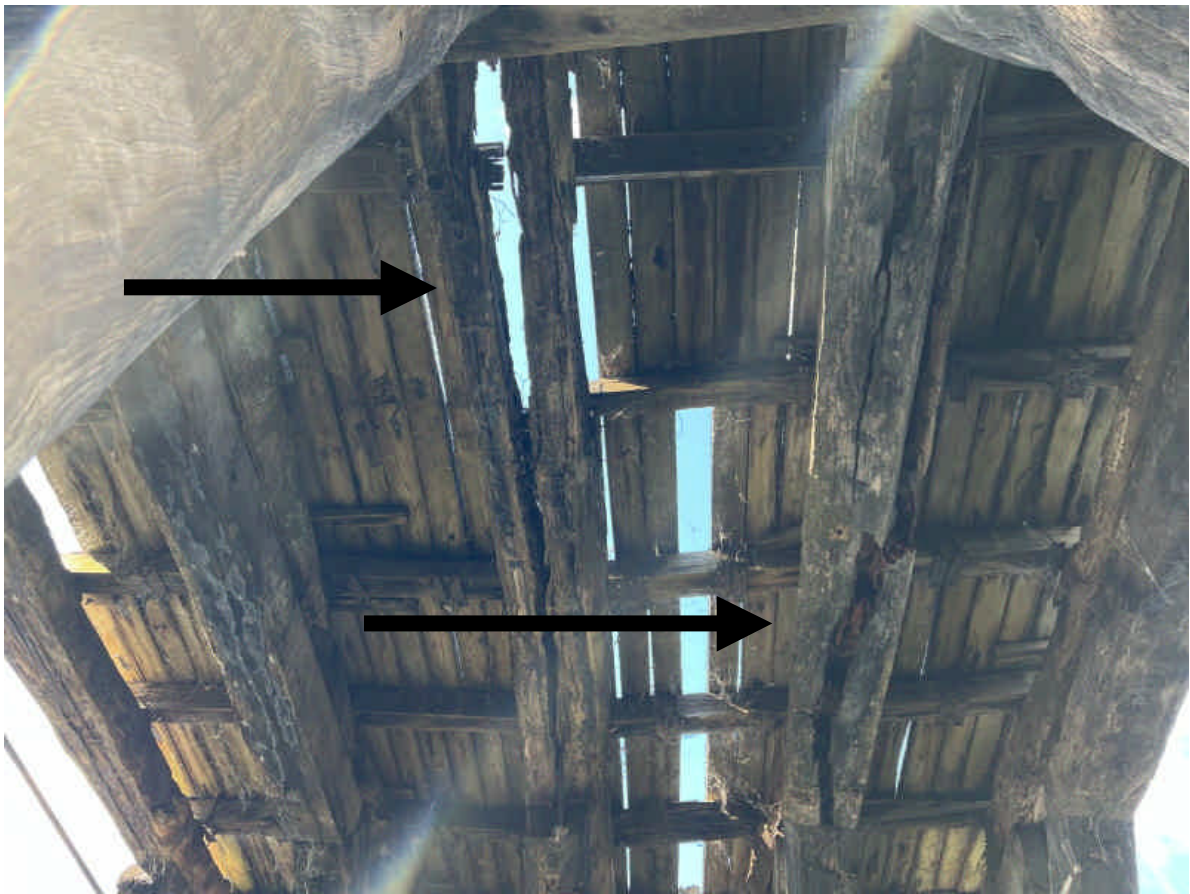
A view of the extensive damage in two stringers – see arrow.

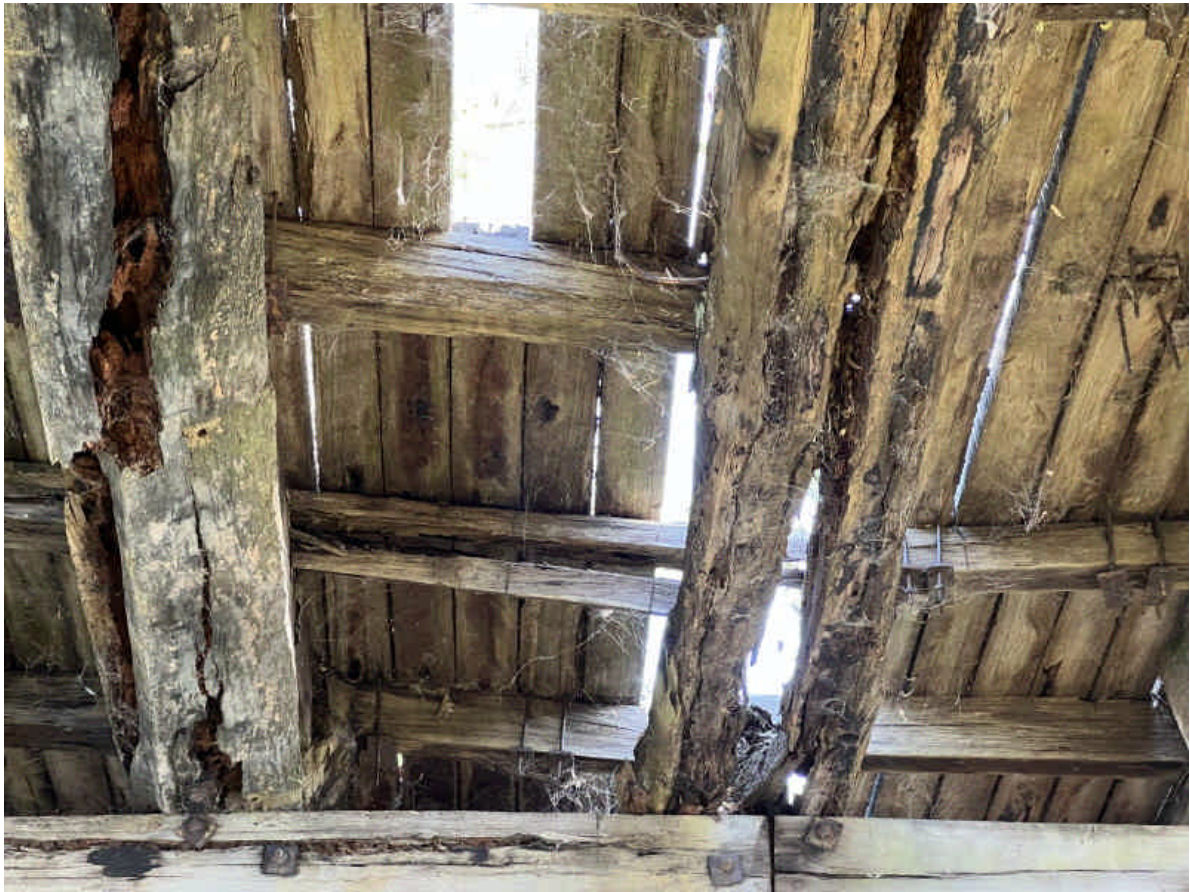
A view of the extensive damage in two stringers.
