Structural Engineering Advice

Chinamans Bridge

Nagambie

27th May 2024

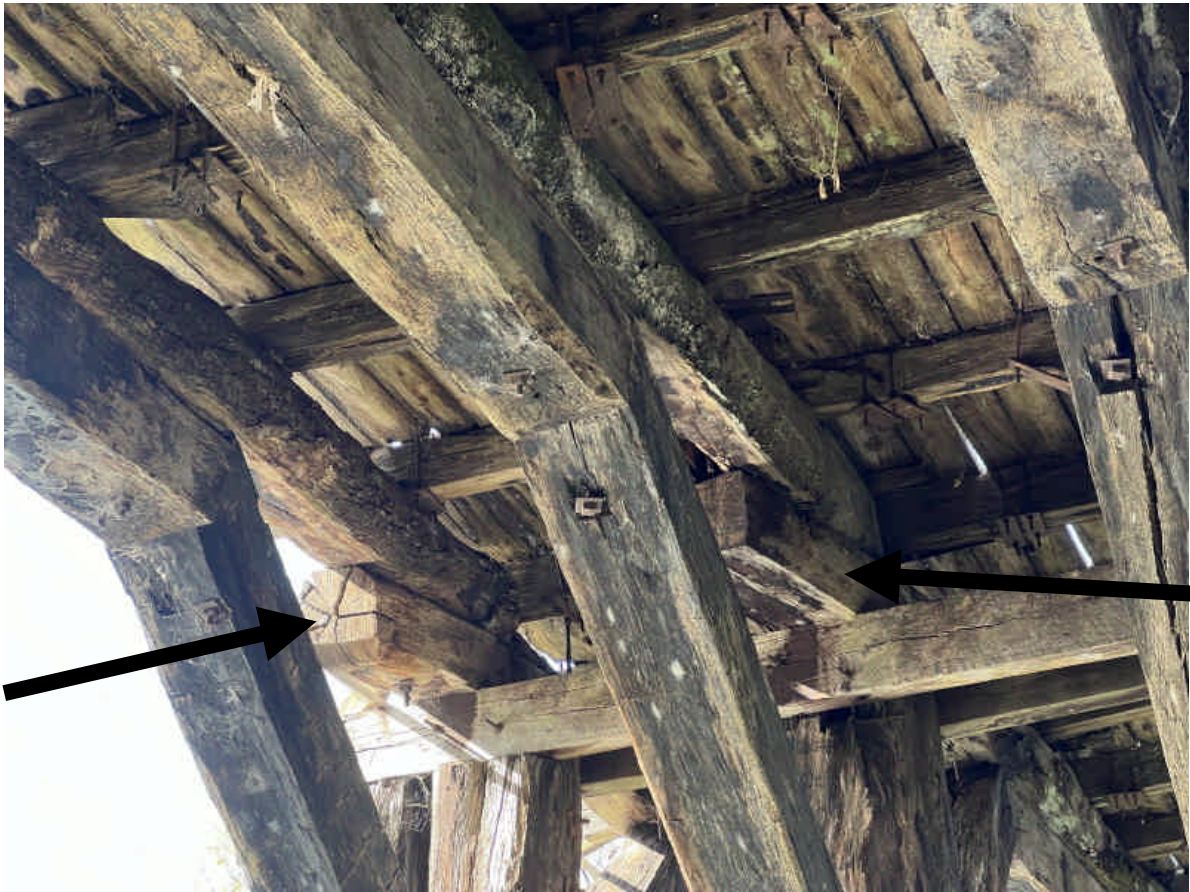
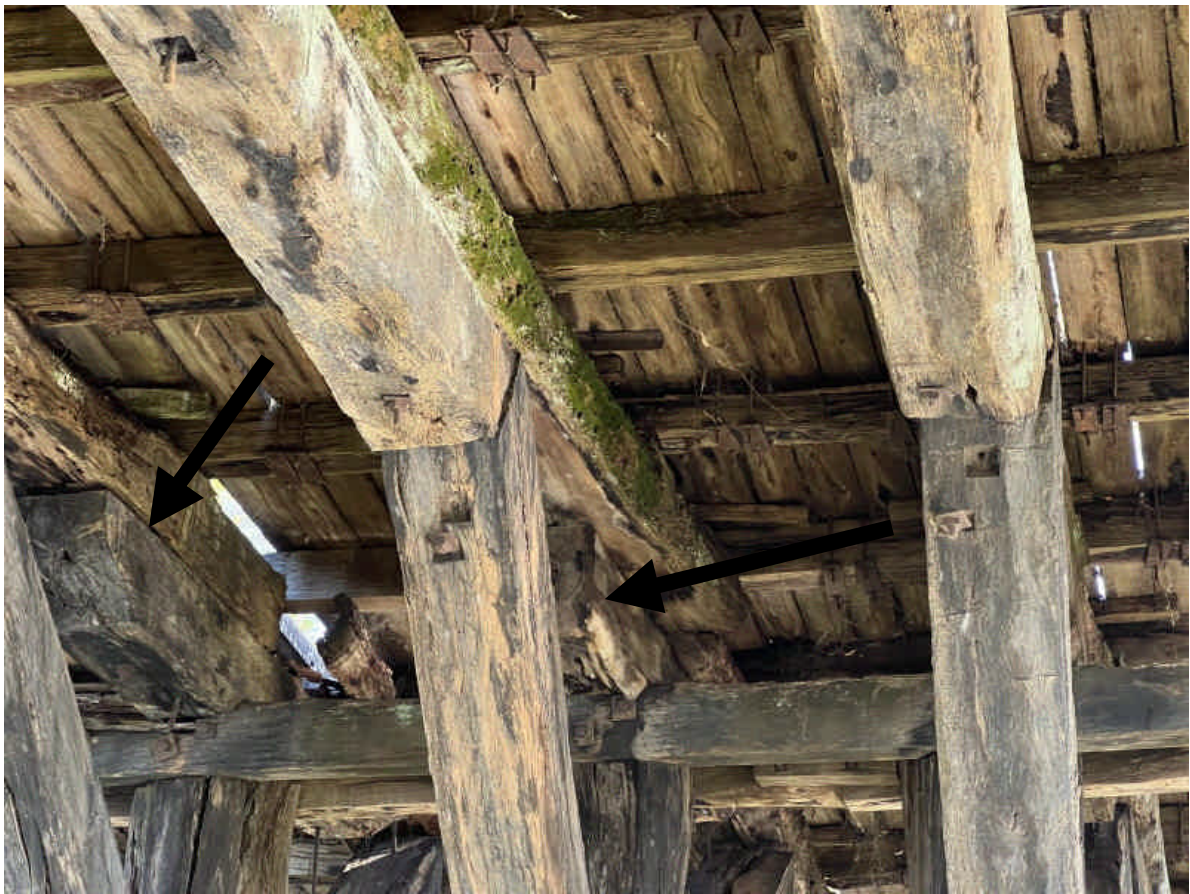
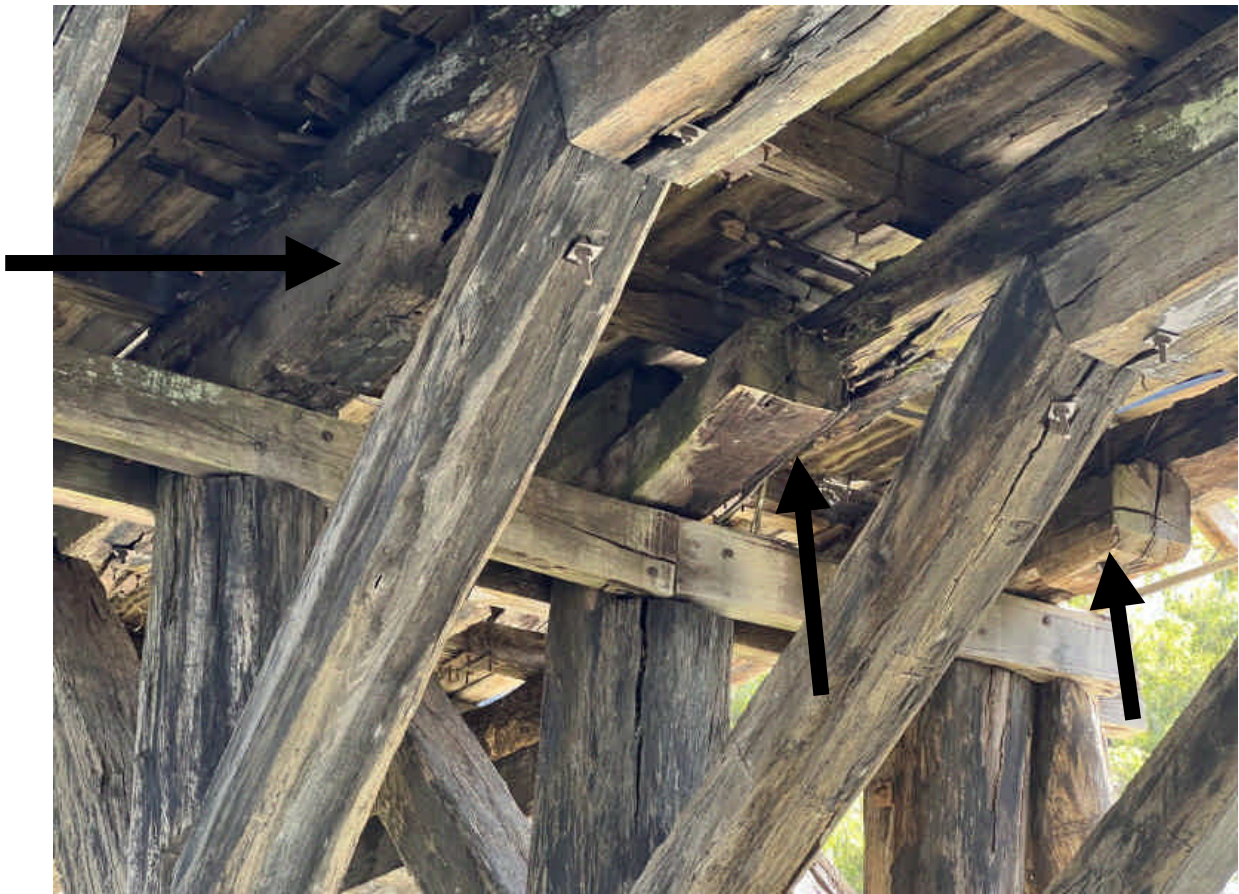
In general where the ends of the corbels are visible they appear to be in serviceable condition, albeit some have splits and pipe rot. Refer to photographs 12 to 14, Appendix C.

A view of the corbels – see arrows.

Where the corbels are in a serviceable condition they will achieve the required live load capacity, noting that their condition will need to be assessed following the removal of the decking and cross-beams.

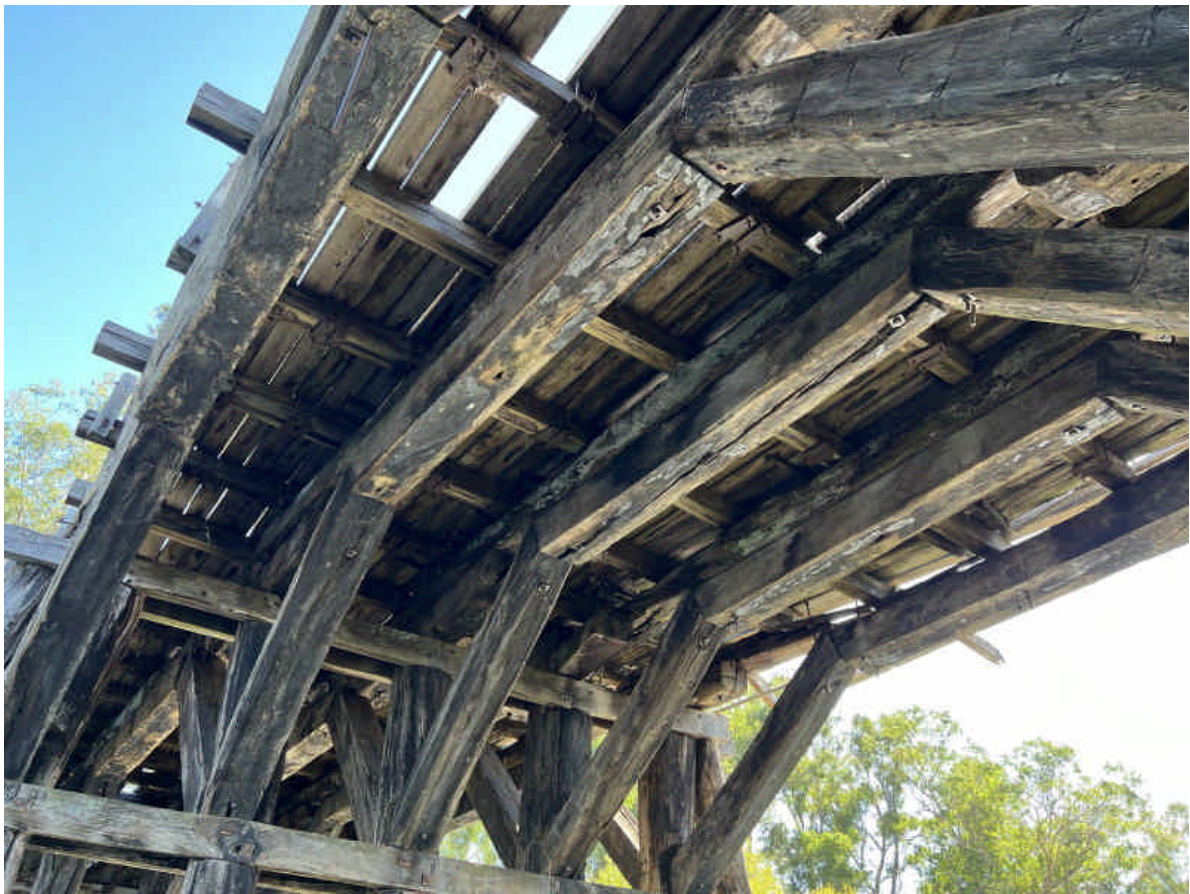
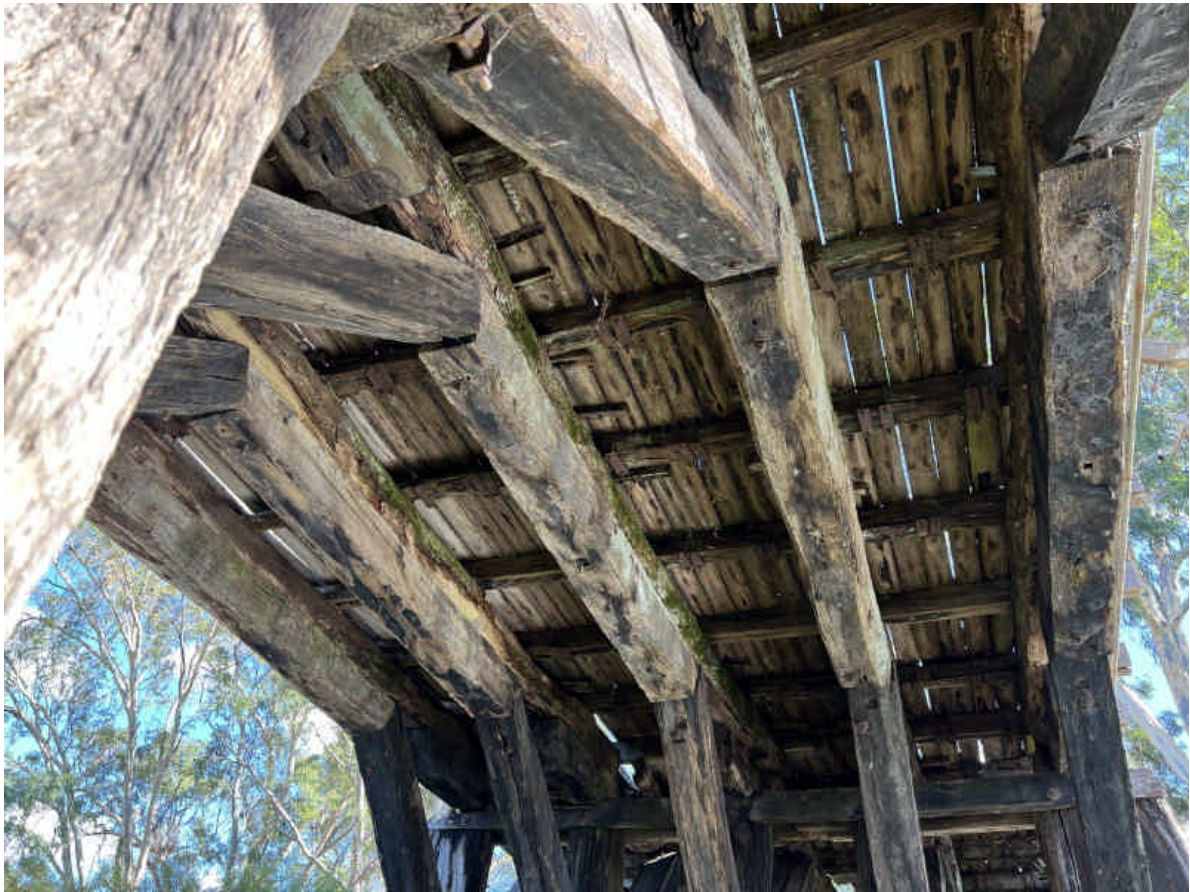
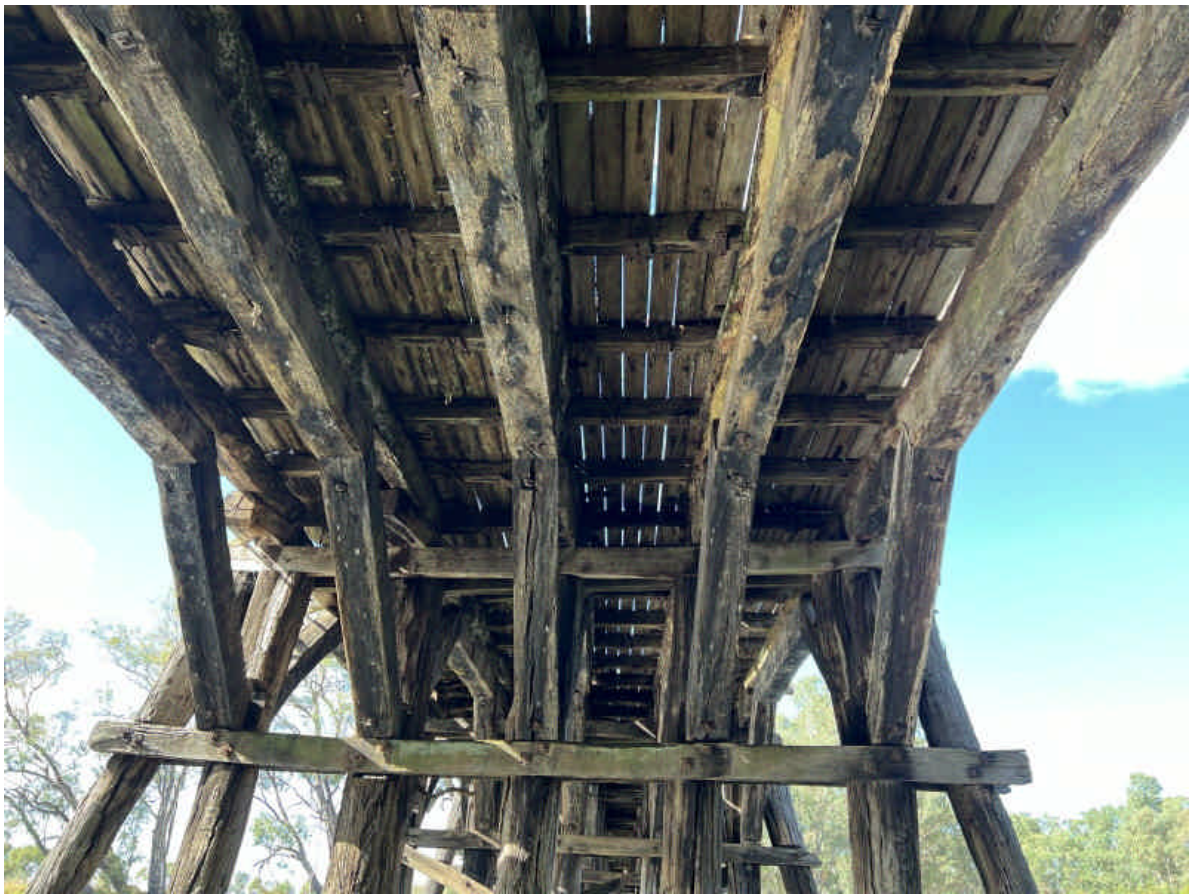
In general the new beams appear to be in serviceable condition. Refer to photographs 15 to 17, Appendix C.

A view of the new beams below the stringers.

Where the new beams have been installed below the stringers (spans 4 to 15) it is probable that the new beams are in serviceable condition as their tops have been somewhat protected by the original stringers, and as such it may only be necessary to reset the beams where they have moved. Where the beams have split, and do not contain dry rot, then they can be stitched together with bolts and plates.

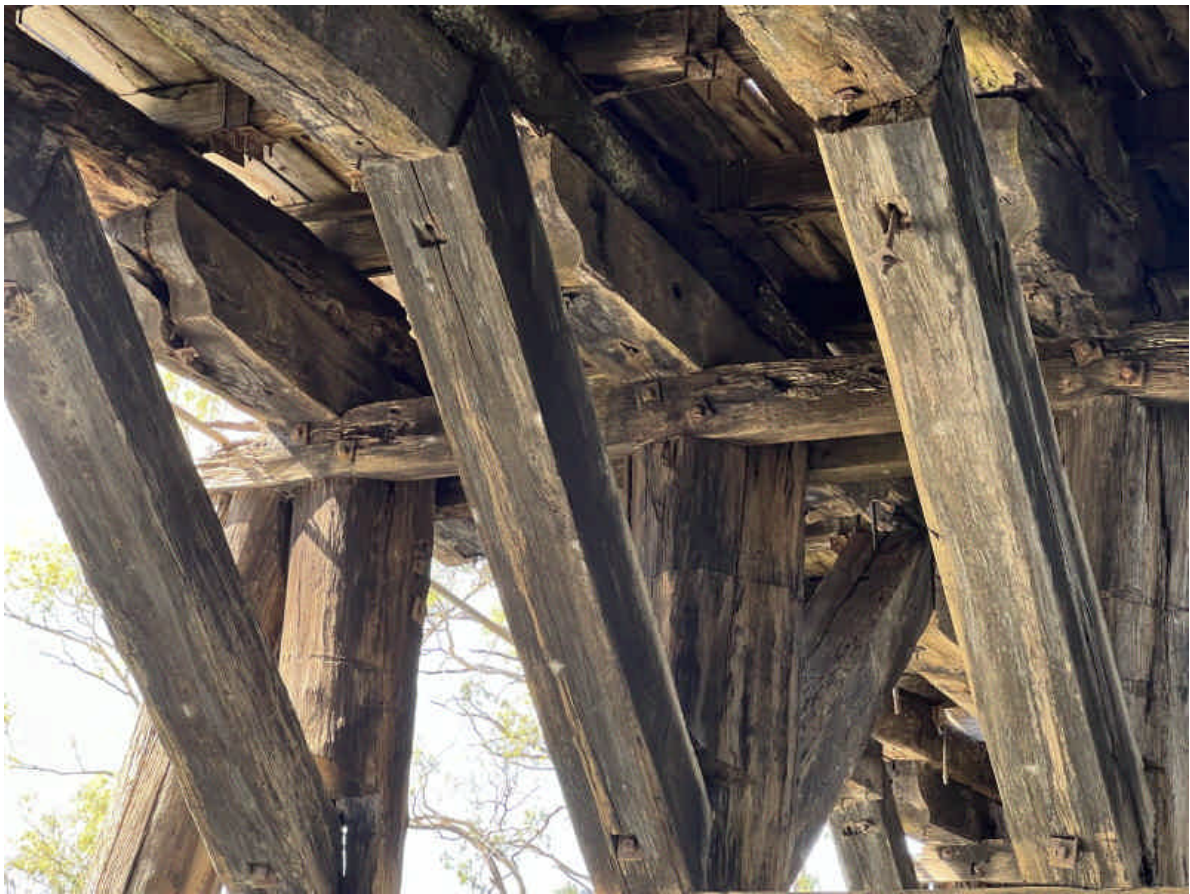
In general the knee braces appear to be in serviceable condition. Refer to photographs 18 to 20, Appendix C.

A view of the knee braces.

Where the knee braces have dislodged they will need to be reset and the bolted connections at either ends of the braces checked and replaced if necessary. Where the knee braces are in a serviceable condition they will achieve the required live load capacity, noting that their condition will need to be assessed.

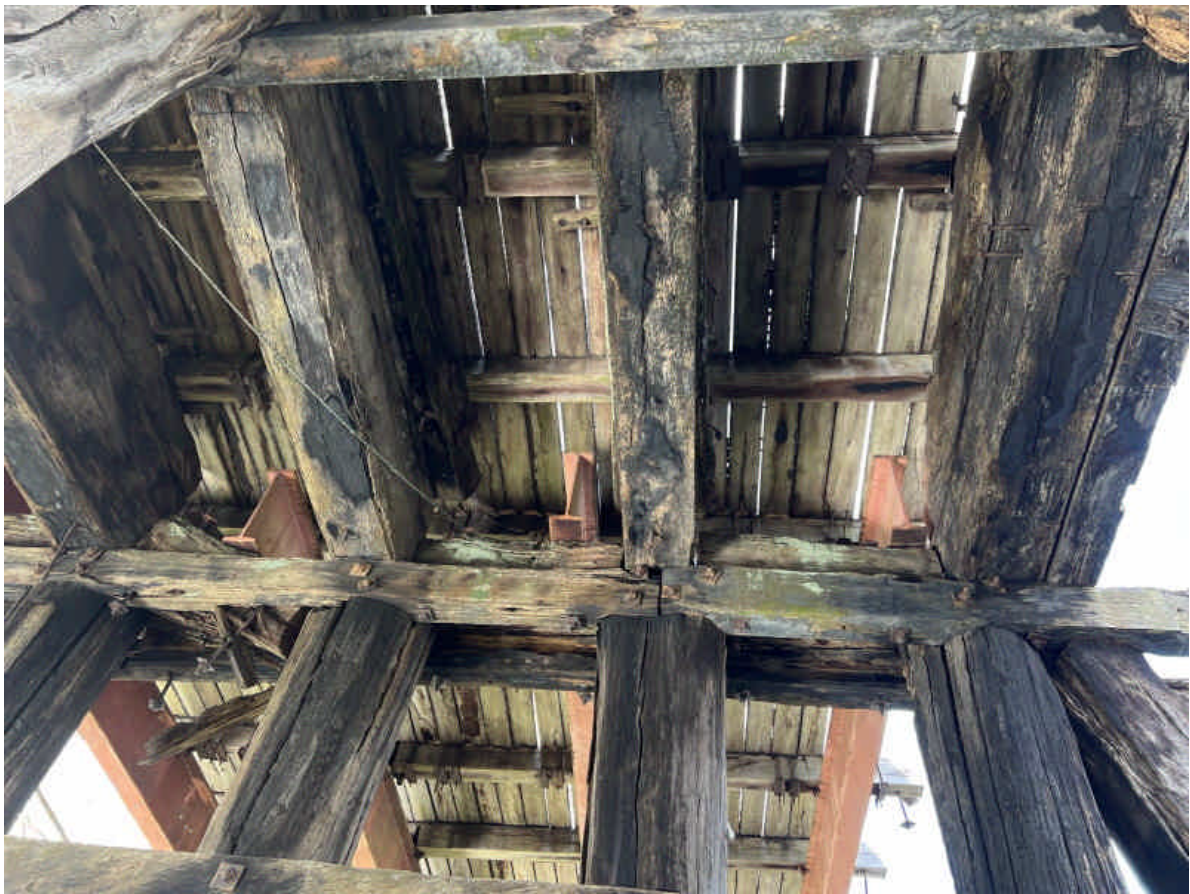
In general the cross-head beams appear to be in serviceable condition, with the exception of the beams that support the steel beams at Trestle 10, ie the trestle that support the southern end of the steel beams. Refer to photographs 21 and 22, Appendix C.

A view of the cross head beams that support the steel beams.

Notwithstanding that the cross-head beams appear to be in a serviceable condition, the tops of the beams will need to be inspected following the removal of the decking and cross-beams. If there is tunnel-dry-rot in the tops of the beams then they will need to be remediated as per the stringers – see Section 7.3. Where the HW blocking has crushed under the steel beam then the blocking will need to be replaced. Where the beams are in a serviceable condition they will achieve the required live load capacity.

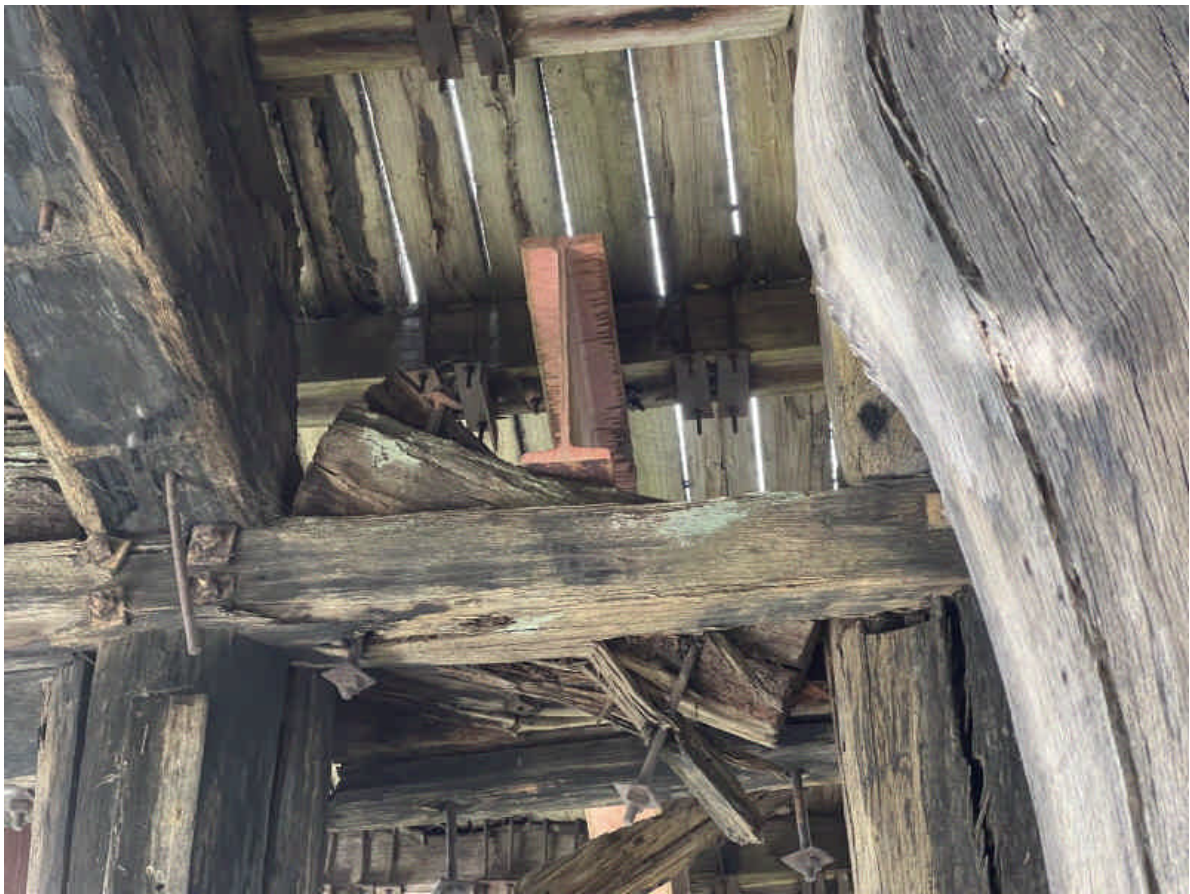
A view of the cross-head beam partial collapse.

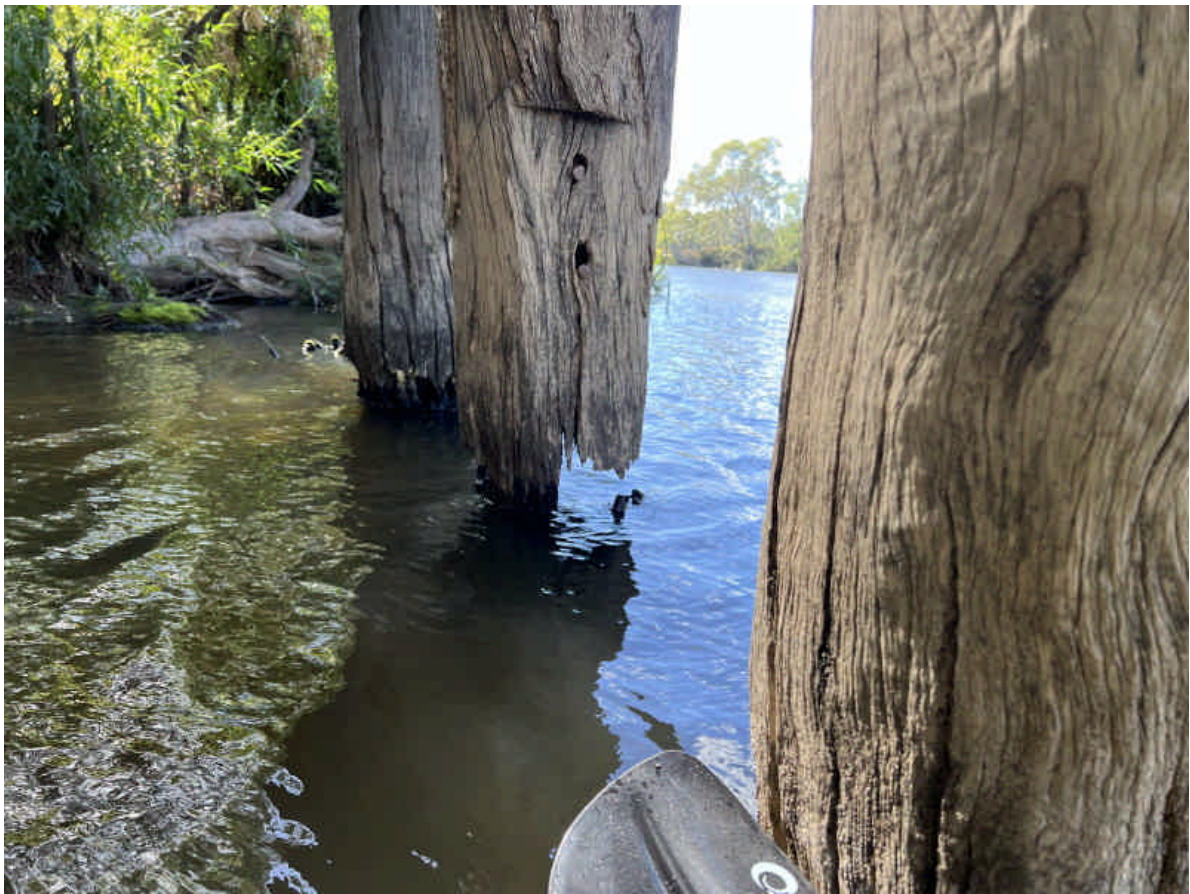
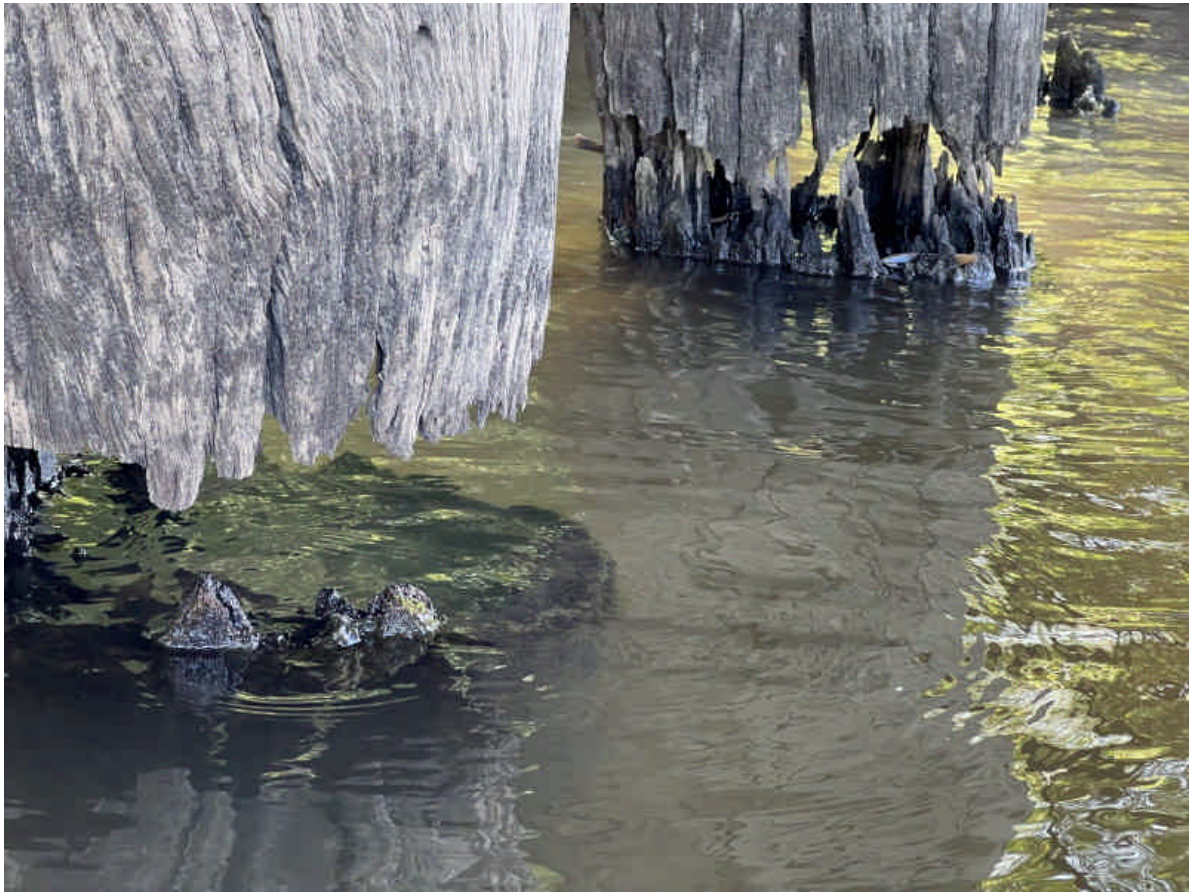
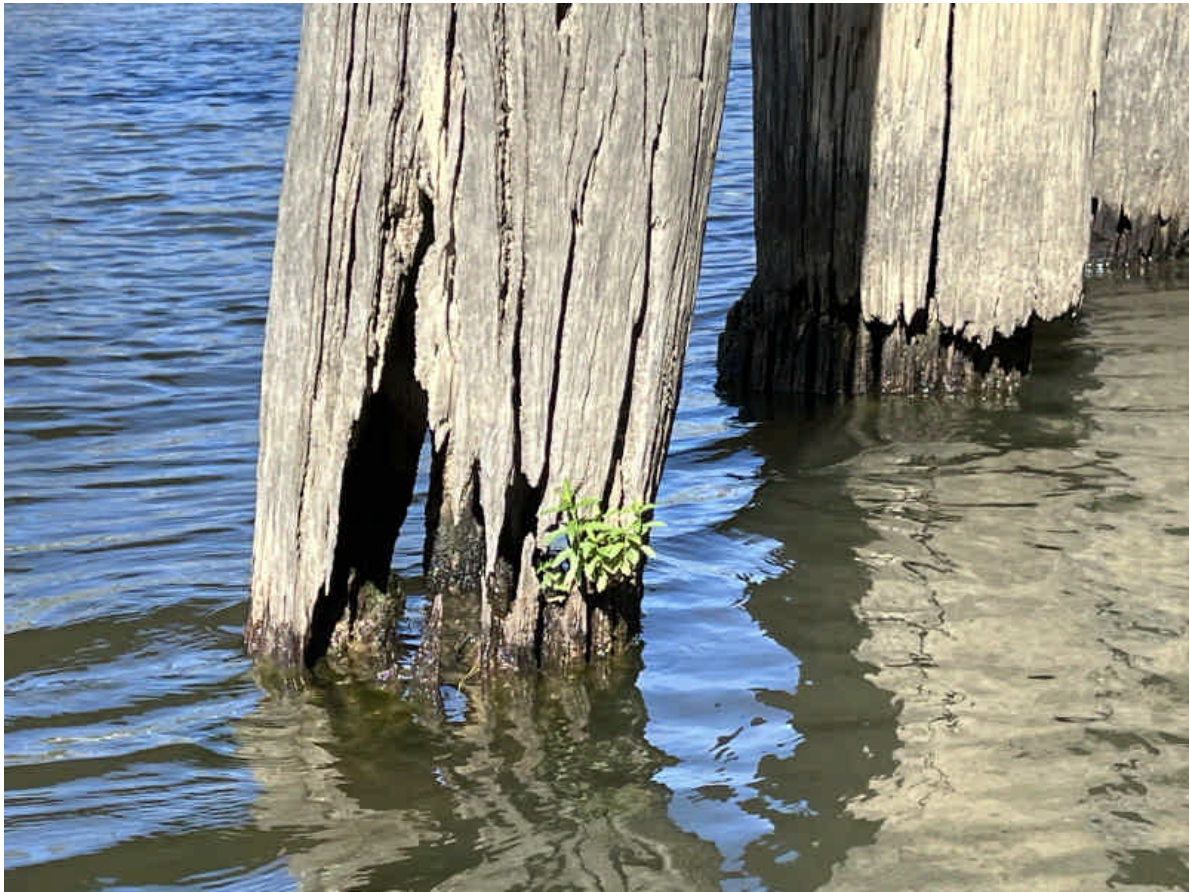
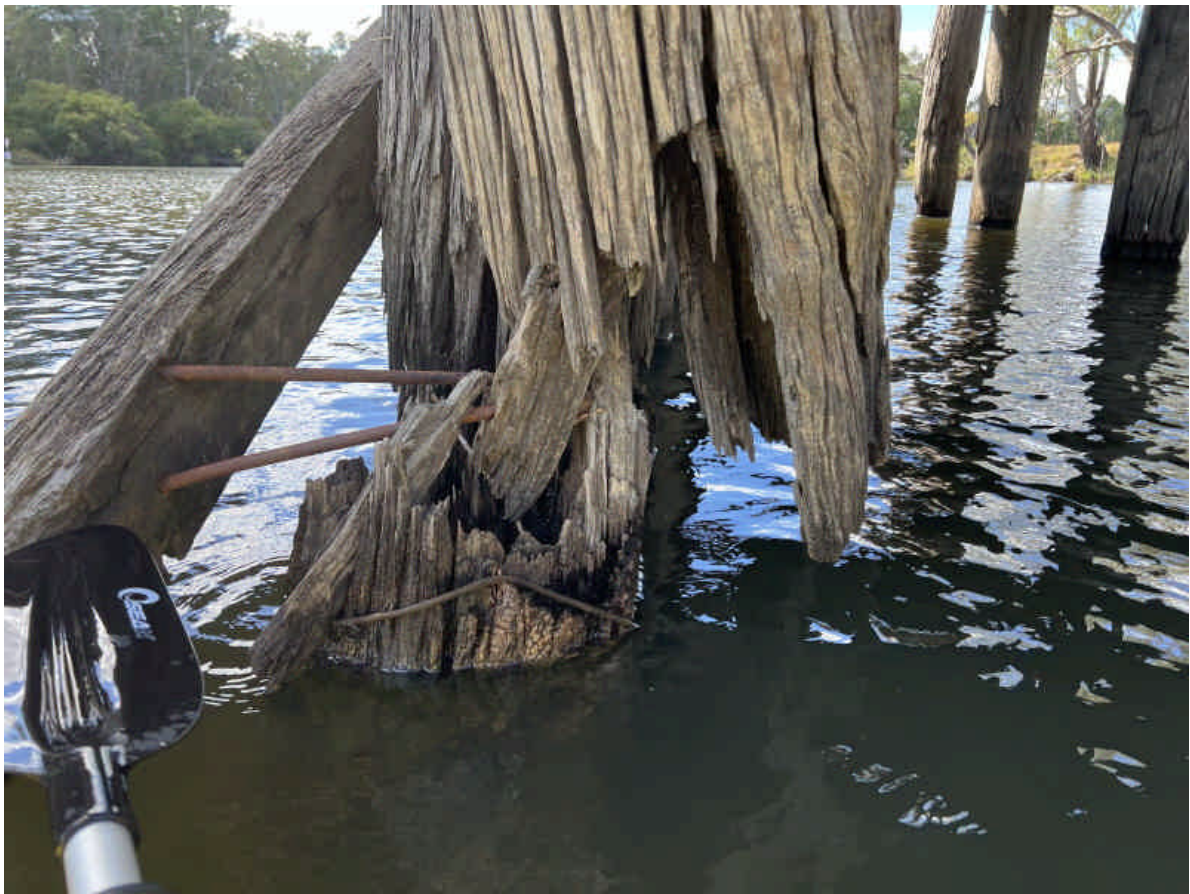
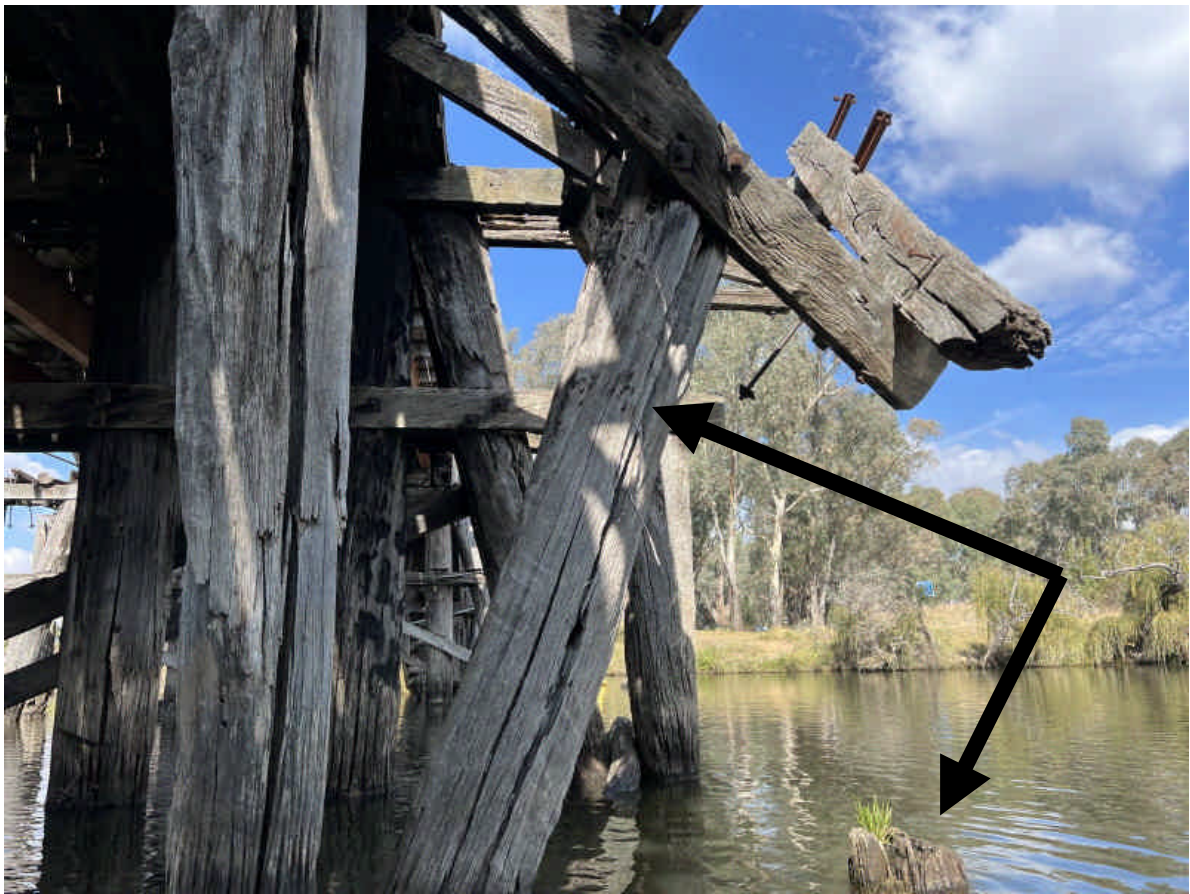
In general the piles of Trestles 2 to 14 (the trestles within the river) are in poor condition at the river level, and of the 92 piles of those trestles, 57 piles (62%) are in Condition State 4, 17 piles (18 %) are in Condition State 3, and the remaining 18 piles (20%) are in Condition State 2, in accordance with the RTA Bridge Inspection Manual (June 2007)).

Condition State 4 is defined as "*Advanced deterioration, heavy decay, insect infestation, splits, cracks or crushing has produced loss of strength that affects serviceability of the bridge*". Condition State 3 is defined as "*Medium decay, insect infestation, splitting, cracking or crushing has produced loss of strength of the element but not of a sufficient magnitude to affect the serviceability of the bridge.*" Condition State 2 is defined as "*Minor decay, insect infestation, splitting, cracking, checking or crushing may exist but none is sufficiently advance to affect serviceability.*" We have adopted the RTA Manual in lieu of the VicRoads Bridge Maintenance and Repair Manual as the RTA Manual is more explanatory, noting that both Manuals use a similar 1, 2, 3 and 4 rating system. Refer to photographs 23

A view of Condition State 4 piles.

Where the Condition State of the piles is 4 then the piles will either need to be remediated or replaced with F27 seasoned durable HW with a natural durability class of 1 in accordance with Australian Standard AS1720.2 – *Timber Structures Part 2 : Timber Properties* (ie yellow box, ironbark, tallowwood, spotted gum or turpentine). Where a pile requires remediation at the river level then the DENSO Seashield system can be used to strengthen the piles and also fill the pipe-rot in the length of the pile. Where the piles have split steel clamps can be installed around

the clamps or PFC scabs can be installed to strengthen the pile. Otherwise the deficient sections of piles can be removed and new lengths of F27 seasoned durable HW with a natural durability class of 1 spliced in.

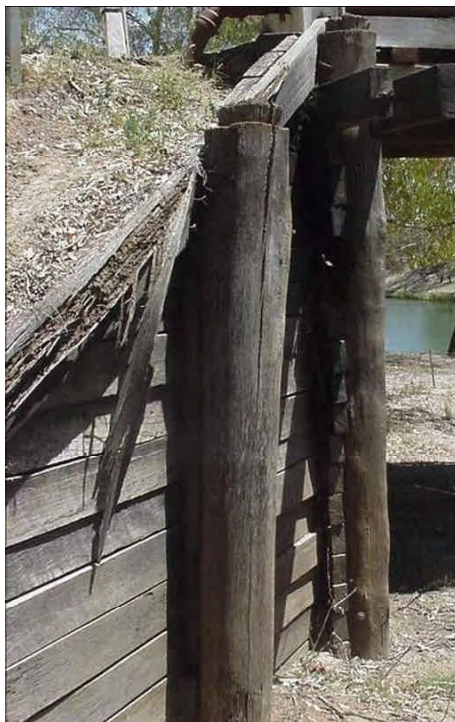
Minor decay, insect infestation, splitting, cracking, checking or crushing may exist but none is sufficiently advanced to affect serviceability.

Minor split in the pile.

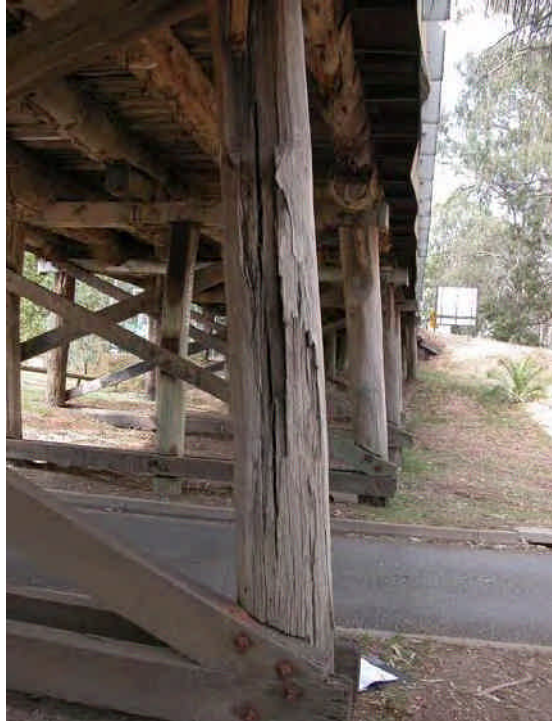
Medium decay, insect infestation, splitting, cracking or crushing has produced loss of strength of the element but not of a sufficient magnitude to affect the serviceability of the bridge.

Timber pile split and with indications of damage below ground.

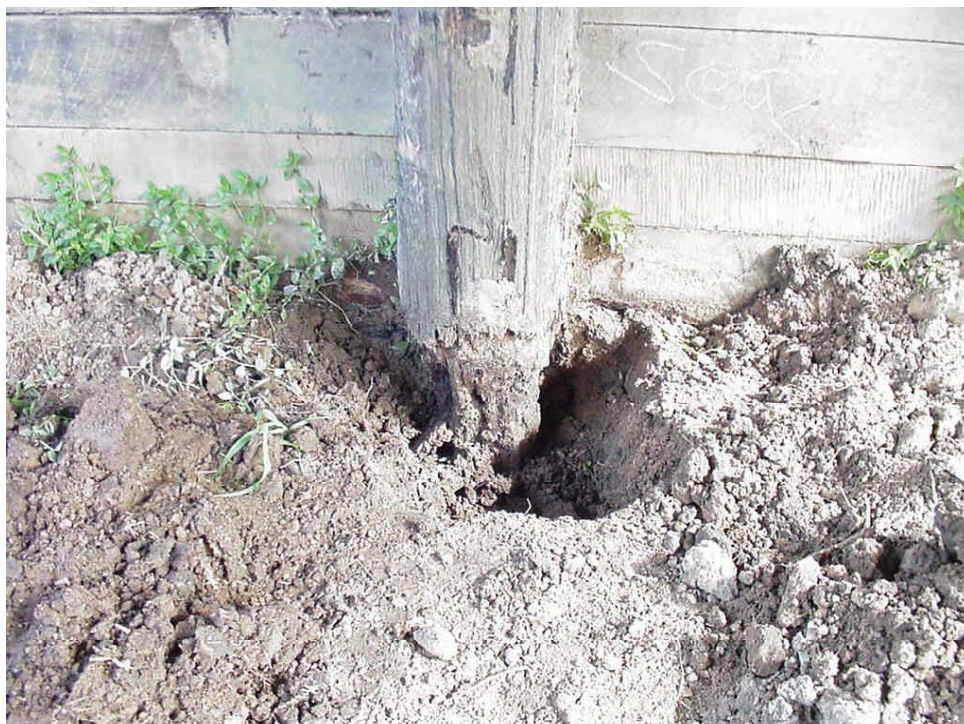
Advanced deterioration. Heavy decay, insect infestation, splits, cracks or crushing has produced loss of strength that affects the serviceability of the bridge.

Significant rot and major loss of section just below the ground surface.

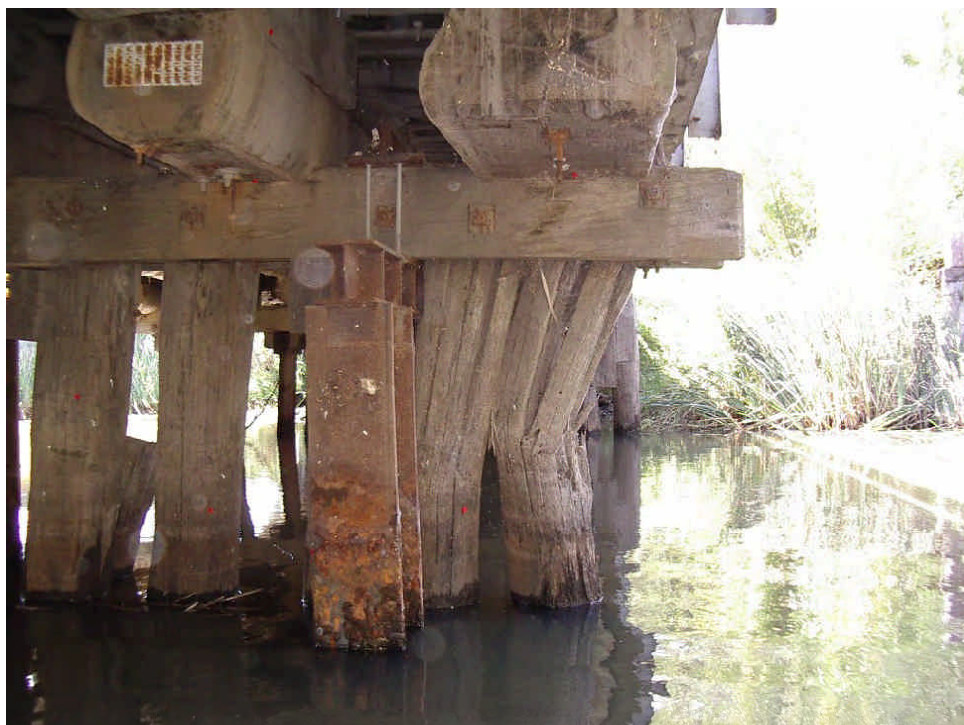
Failed timber piles.

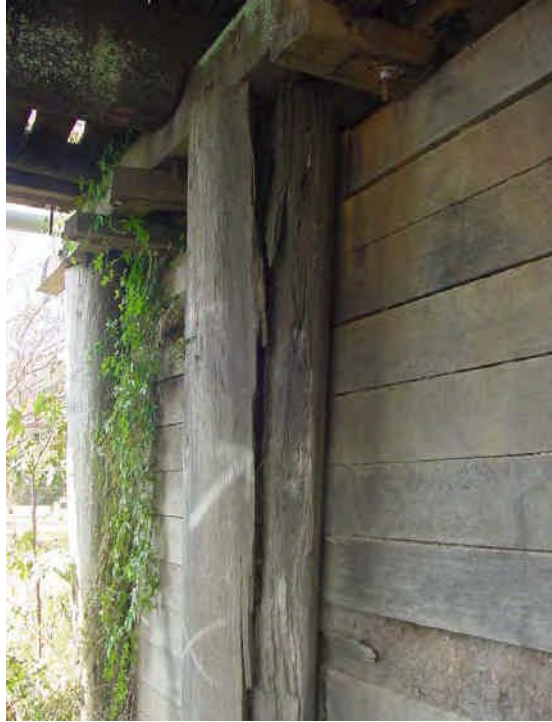
Advanced deterioration. Heavy decay, insect infestation, splits, cracks or crushing has produced loss of strength that affects the serviceability of the bridge.

Major split on the pile.
