# Nagambie & Violet Town

## Flash Flood Investigations

Strathbogie Shire Council

May 2017

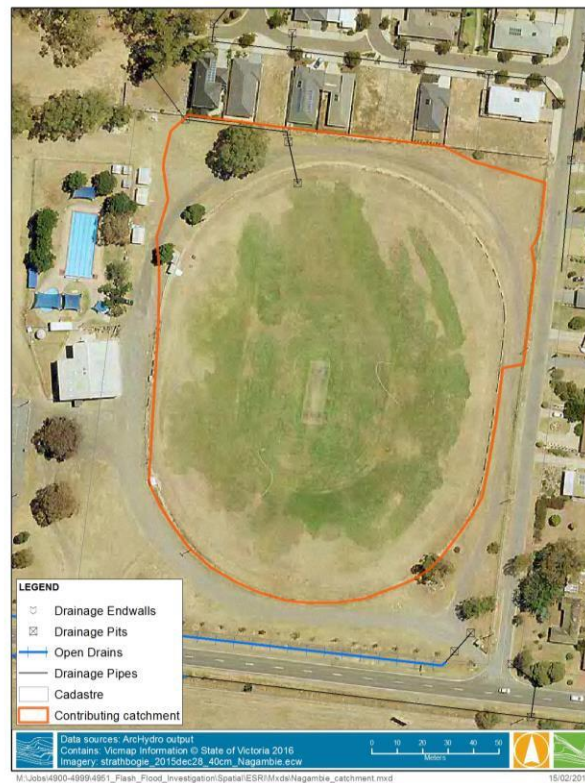
**Figure 2-2 Catchment for impacted houses - Nagambie**

The local catchment to those properties impacted on Ludovic-Marie Court consists of 2.2 ha of public land to the south, predominately comprised of the Nagambie Recreation Reserve, as seen in Figure 2-2. The total rain falling on this catchment would have equated to a volume of 1.4 ML (of which a small fraction would be lost to infiltration). This small local catchment drains to the pit located on the boundary of the football oval and the pit adjacent to the back fence of the impacted properties on Ludovic-Marie Court.

Without detailed modelling, the peak flow from the catchment cannot be accurately determined, however, given the size of the catchment, a short duration is likely to be critical (calculations suggest a 10 minute critical duration). Based on the rainfall record, peak runoff would have occurred at the maximum intensity rainfall, which saw 29.4 mm fall over a 15 minute period. The peak flow from the 29<sup>th</sup> December 2016 event was likely very close to the peak flow estimated using the Rational Method technique for a 1% AEP event. The Rational Method 1% AEP peak flow was estimated as 0.26 m<sup>3</sup>/s with a time of concentration just over 10 minutes.

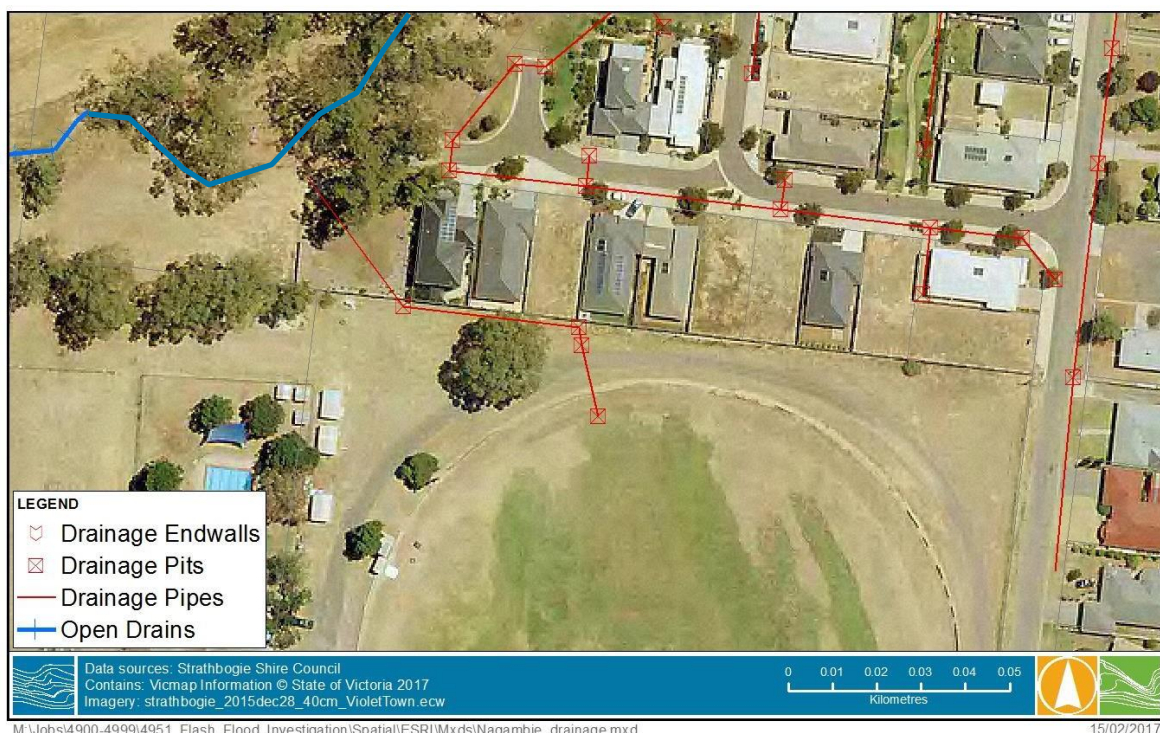
**Figure 2-3 Drainage network at the Nagambie site**

The residents at 7, 9 and 11 Ludovic-Marie Court all experienced flooding as a result of overland flow from the south of their properties. The properties adjoin the recreation reserve. Figure 2-3 shows a number of empty blocks, some of which have now been developed. Floodwaters encroached on the houses, but no property experienced above floor flooding other than in garages. The rate of flow caused local erosion of garden landscaping.

A drainage network, consisting of 225 mm diameter reinforced concrete pipes divert water from the oval and along the northern boundary of the recreation reserve, discharging into the nearby waterway, as seen in Figure 2-3.

The capacity of the pipe network was determined using various hydraulic pipe flow capacity estimation techniques, which all provided a consistent estimate of 0.02 m<sup>3</sup>/s. The flow capacity is limited by the grade of the pipe parallel to the northern boundary of the reserve. It is likely that with the surface entrance to the pit behind 17 Ludovic-Marie Court being higher than the surrounding ground level that the pipe may not have been flowing to its full capacity during the recent flash flooding event.

1. It is recommended that Council consider upgrading the drainage system behind those impacted properties on Ludovic-Marie Court in Nagambie.

2. If a swale is not constructed, as per recommendation (1), Council should consider investigating the capacity of the existing drainage system, and consider upgrading to an 18% AEP capacity if required, ensuring all pits are slightly below the surface level.

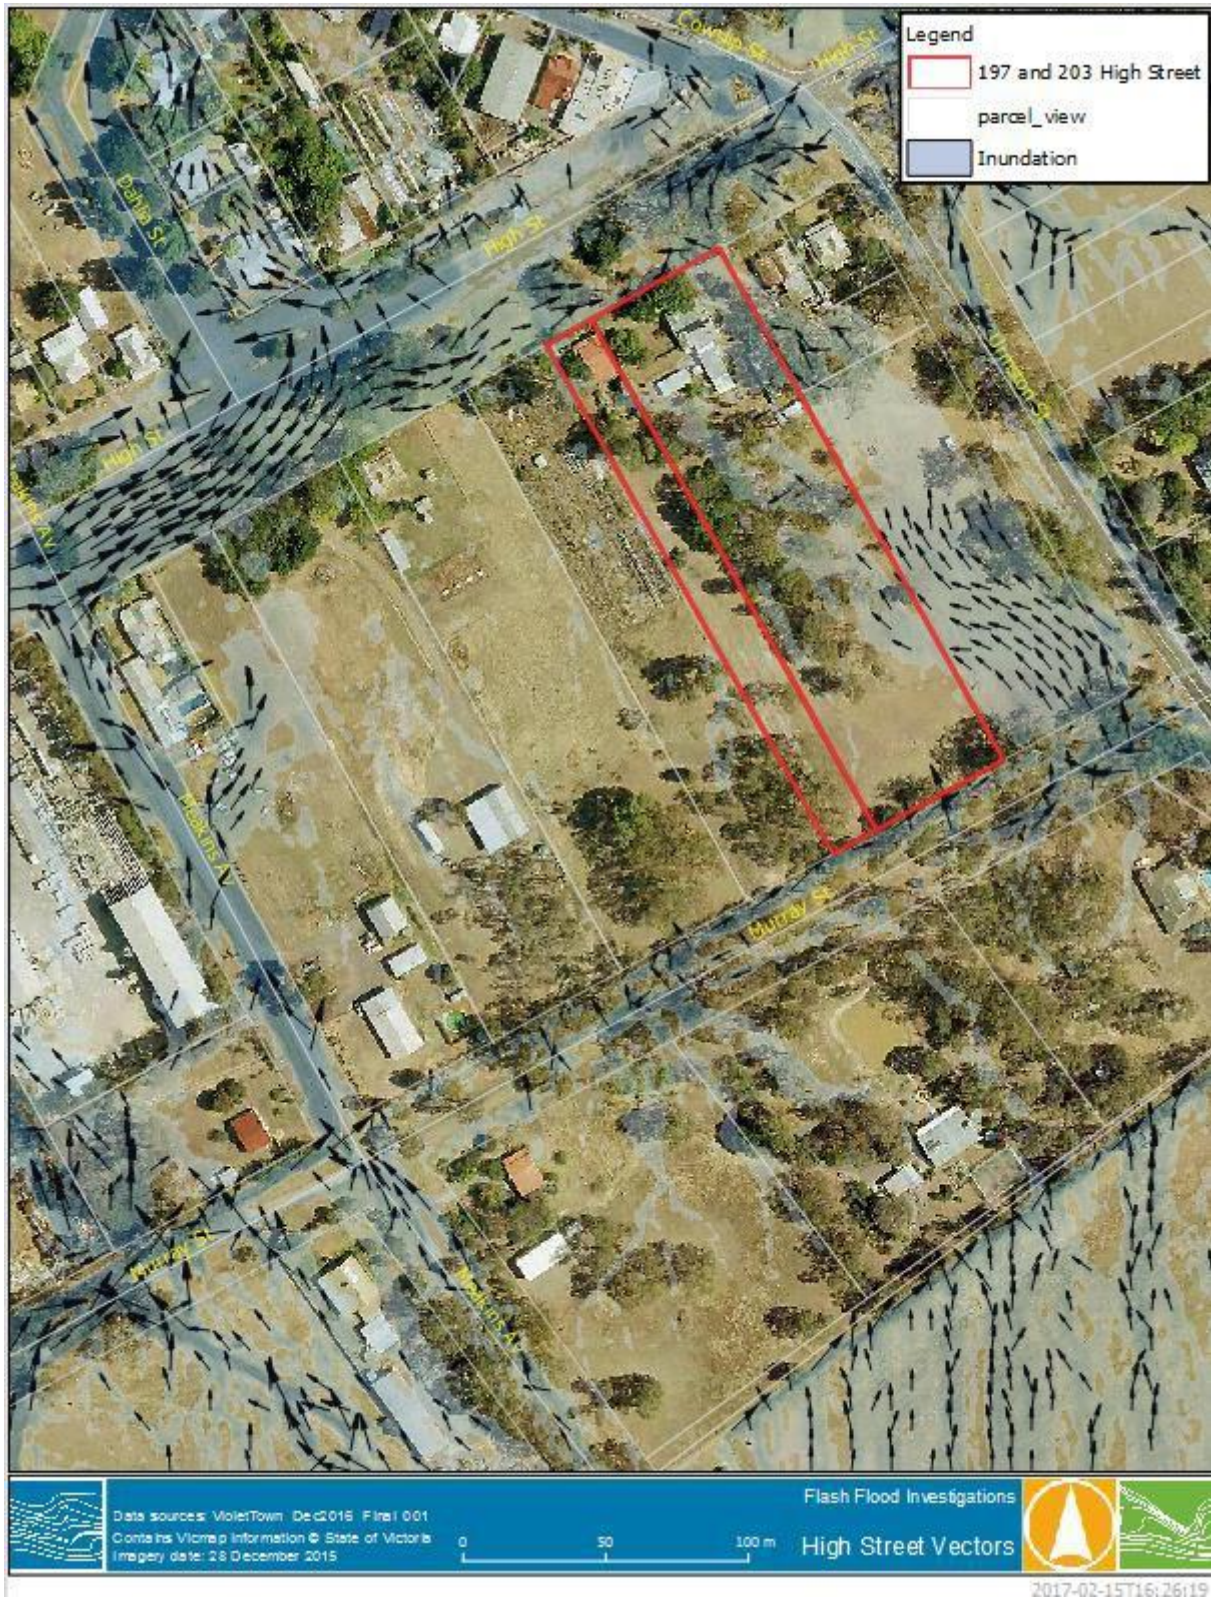
**Figure 3-2** Overland flow paths impacting properties on High Street, Violet Town

1. That runoff from the catchment south of High Street flowed along Meakins Avenue and flowed north-west through 221, 215 and 209 High Street, and along the southern easement on High Street towards Cowslip Street. This water encroached on properties 197 and 203 High Street from the front (Figure 3-2). This is consistent with anecdotal evidence.

Properties at 197 and 203 High Street experienced above floor flooding on the evening of the 29<sup>th</sup> December 2016. Anecdotal evidence, consistent with the hydraulic modelling, indicate that water predominately entered the properties from the front. Water marks suggested inundation up to 30 cm above ground level. Sandbags were deployed at both properties and at the headwall of the open drain at the Murray Street – Urmston Street intersection. Council also deployed pumps to alleviate water levels in the early morning of the 30<sup>th</sup> December.

An open drain alongside Murray Street diverts water from the upstream catchment (south of High Murray Street) toward the north-east, discharging into Honeysuckle Creek. The open drain is of significant size (although residents have said that it has silted up considerably over the years), with an estimated capacity of 2.4 m<sup>3</sup>/s. This is well in excess of the 18% AEP design standard and is potentially in excess of a 1% AEP. The channel showed signs of isolated overtopping during the December 2016 event, as noted by flattened vegetation on the northern bank at the Murray St – Urmston St intersection. The overtopping was not extensive, and is consistent with those locations demonstrated in the modelling (i.e. notably at one location behind 193 High Street, as seen in Figure 3-2).

3. It is recommended that Council consider **improvements to the Murray Street** drain to ensure that flows south of the drain are intercepted, that they do not spill out of the drain, and all flow continues through to the Honeysuckle Creek. This would require works around the Meakins Avenue intersection and upstream of the culvert at Urmston Street where the December event overtopped the drain bank. Consideration will need to be given to how this aligns with the Water Act, and as per the 'beneficiary pays' principle (Victorian Floodplain Management Strategy), **landholders as the beneficiaries may be requested to contribute funds** to the construction works.

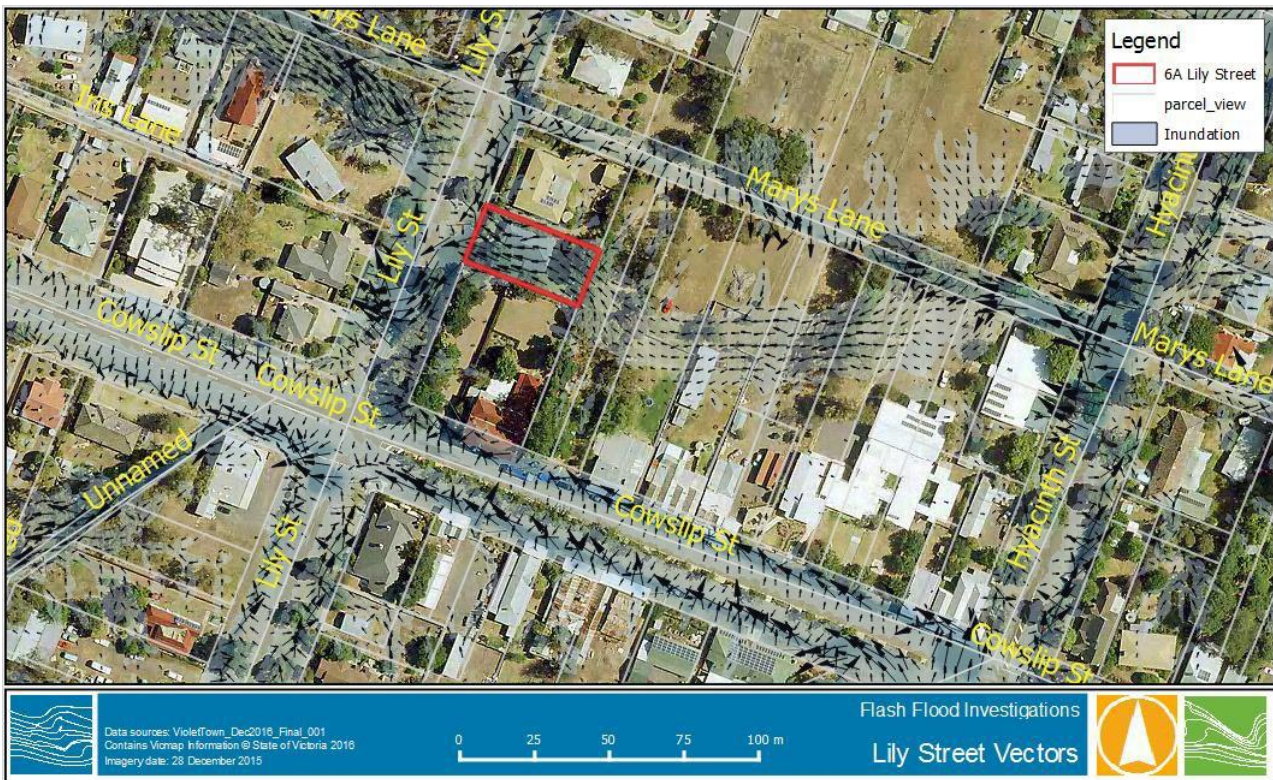
Figure 3-3 Overland flow paths impacting 6A Lily Street, Violet Town

3. A localised flow path exists through the property at 6A Lily Street (Figure 3-3), with water approaching from Hyacinth Street and Marys Lane, flowing south-west through the back of properties on Cowslip Street, and then directly west towards Lily Street.

The property at 6A Lily Street was inundated from floodwaters entering through the back of the property. While the property did not experience above floor flooding, the shed at the back of the property was inundated to a depth of approximately 20 cm.

5. A solution for the Lily Street flooding requires further information regarding the existing drainage network. However, it is likely that the drainage network may not cater for all the overland flow and that some **additional surface water drainage may be required along Marys Lane** and Lilly Street to reduce the impact of overland flows on the property at 6A Lily Street. It is recommended that Council consider further survey and investigation into the stormwater network (as per recommendation 2 above). Consideration will need to be given to how this aligns with the Water Act, and as per the 'beneficiary pays' principle (Victorian Floodplain Management Strategy), **landholders as the beneficiaries may be requested to contribute funds** to the construction works.

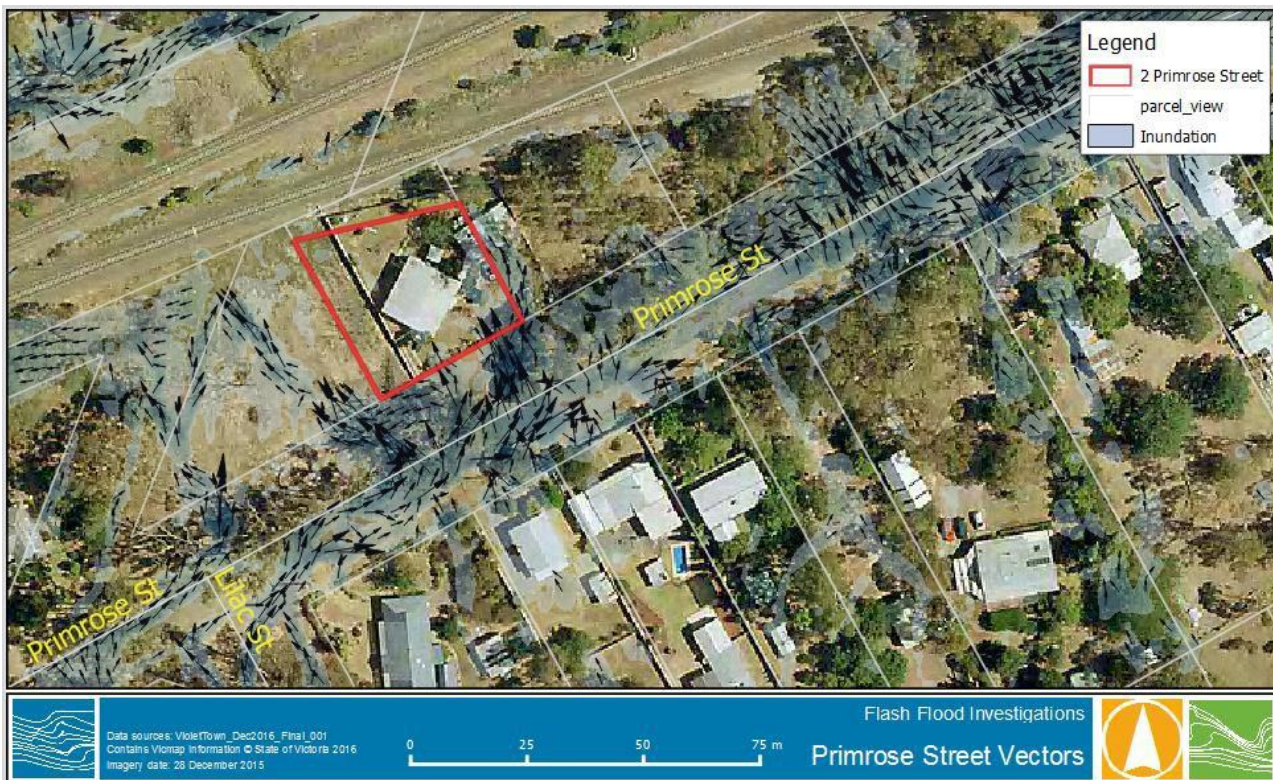
Figure 3-4 Overland flow paths impacting 2 Primrose Street, Violet Town

4. Floodwaters naturally accumulate at the low ground near 2 Primrose Street (Figure 3-4), and are prevented from dissipating to lower ground by the railway embankment.

The property at 2 Primrose Street was not subject to a site inspection, however information was provided by the residents to Council that the property experienced flooding on the 29<sup>th</sup> December 2016. While the flood levels remained below the floor level of the house, sheds at the back of the property were inundated.

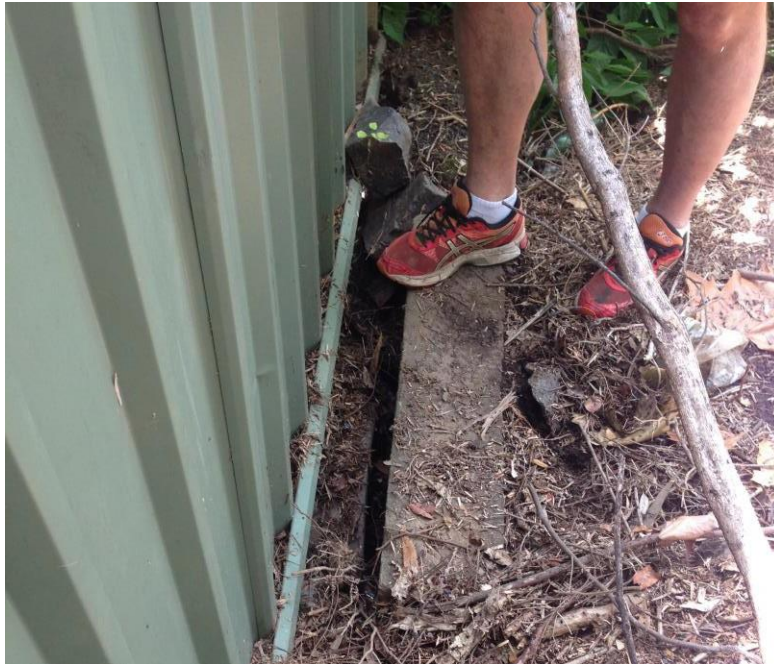
**Figure 3-6** Drainage network connection behind 6A Lily Street, Violet Town

A local drainage pipe extends underground from the Lions Park through the southern boundary of 6A Lily Street, connecting at a pit at the front of the property, seen in Figure 3-7. The connection immediately behind 6A Lily Street is not an open pit as such, but there is an open connection, as shown in Figure 3-6. It is understood that this connection was blocked by debris in December 2016 and was cleared by the property owner, upon which flood levels were observed to recede. It is understood that recent inspections found that the drainage network extends beyond what was known to exist through the Lions Park, however there are no pit entries to the network in this location.

Inspection indicated the pipe to be approximately 600 mm diameter. At the grade of the natural surface, the pipe has a capacity of 0.08 m<sup>3</sup>/s. Design flows were estimated using a Rational Method technique for a contributing catchment area of 7.5 ha. The estimated 18% AEP design flow was 0.47 m<sup>3</sup>/s. This is significantly higher than the estimated pipe capacity. Given the unknowns of the pipe system in this area and the lack of functioning pits, it is recommended that the details of the network be investigated further to allow a detailed investigation into the actual capacity of the system.
