CHINAMANS BRIDGE, NAGAMBIE

OPTIONS ASSESSMENT

Prepared for Strathbogie Shire Council

June 2024 — FINAL

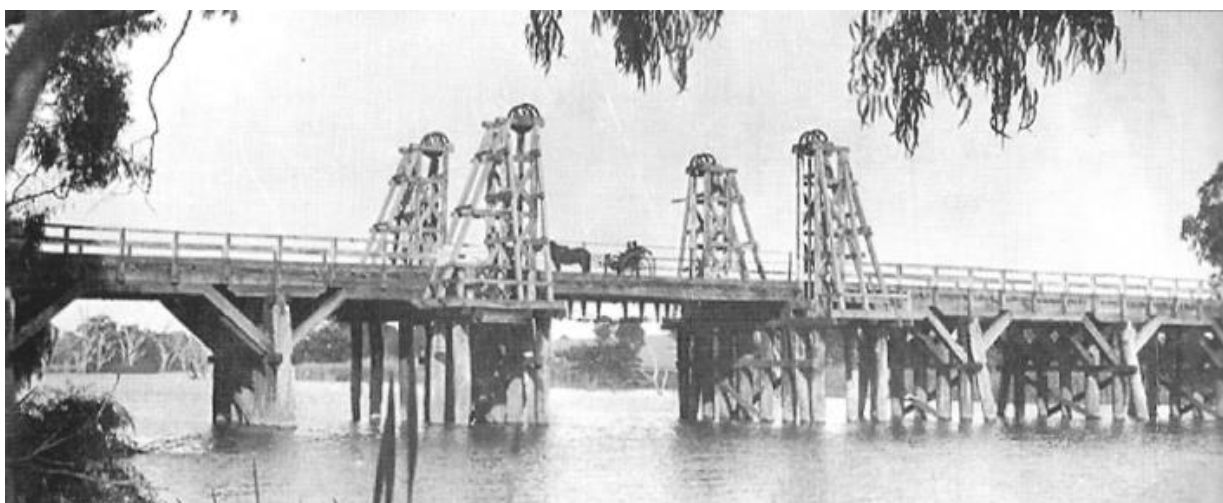
Figure 3. Chinamans Bridge (Kerris Bridge), John York, Harry McDonald, in Horse and Gig. *Source:* Nagambie Historical Society, pre-1940.

The following historical photographs have been supplied by the Nagambie Historical Society (undated). The photographs show the original lift bridge to allow river travel, which was likely removed in c1940s, as noted above.

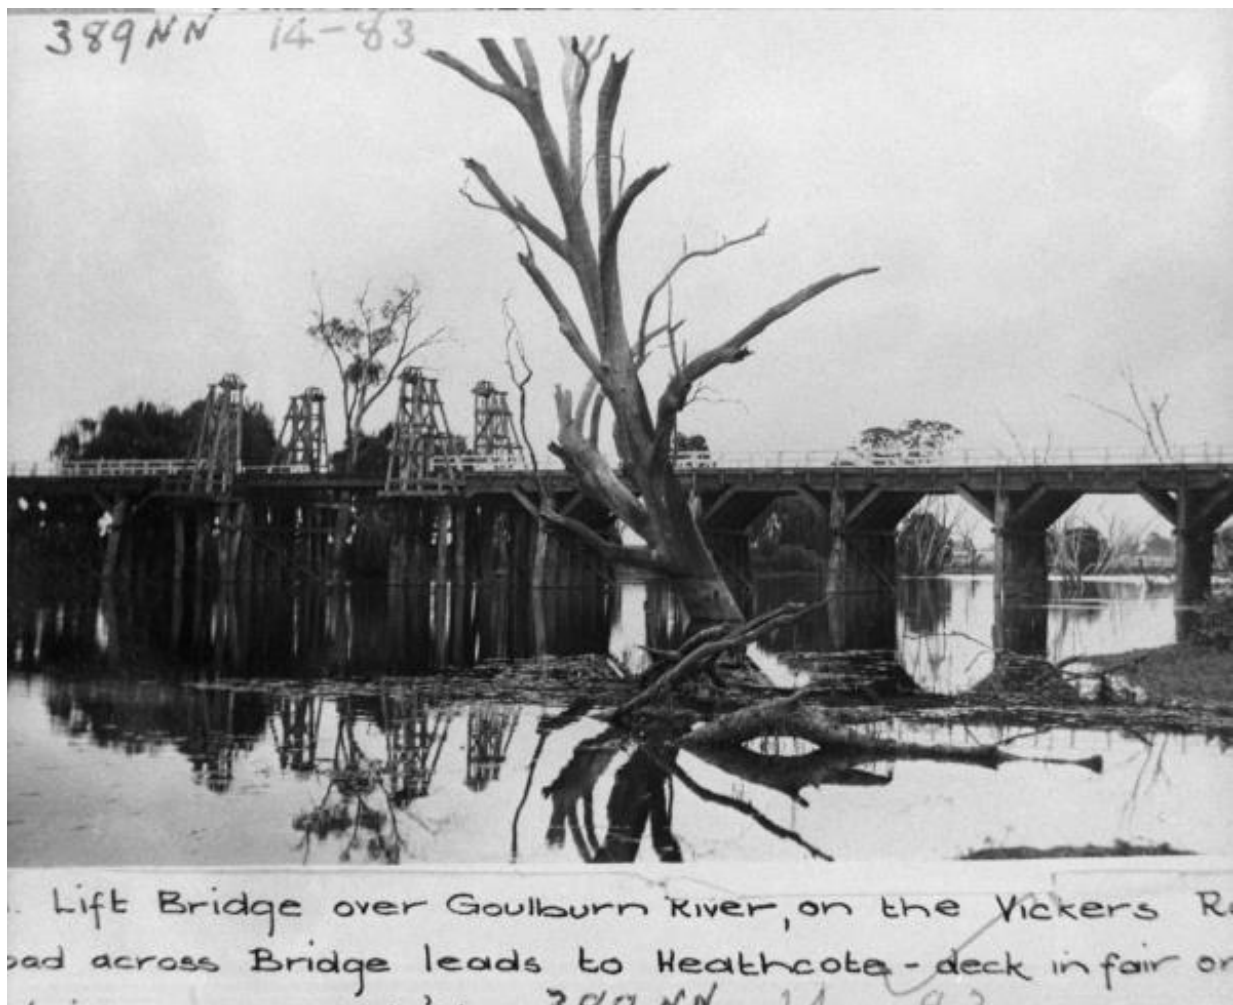
The following photograph housed at the Public Records Office dates to 1914 and specifically notes that the deck is in 'fair order'.

Figure 5. Lift Bridge over Goulburn River, Vickers Road. Caption reads "deck in fair order". *Source:* PROV, VPRS 17684/P0003/212, Negative number 14_00083, 1 April 1914.

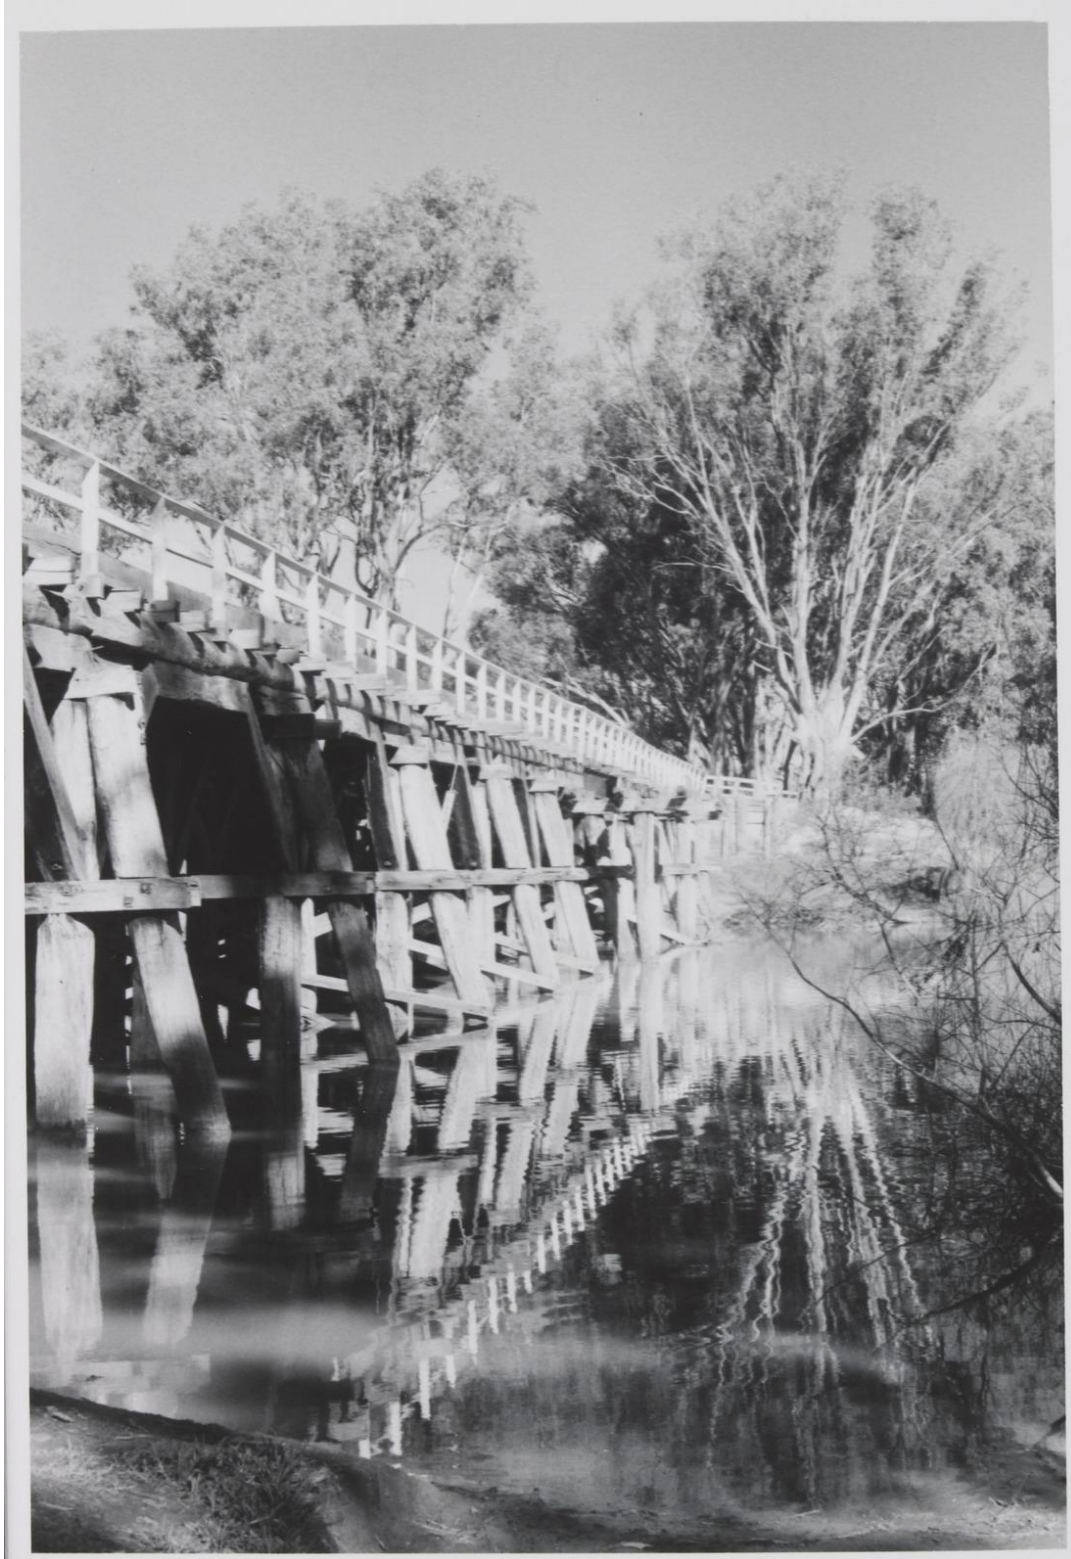
Figure 6. Nagambie. Trestle Bridge over Goulburn River and branch [picture]. John T Collins, August 14, 1979.
Source: JT. Collins Collection, La Trobe Picture Collection, State Library of Victoria Accession no. H98.250/1032.

The following photograph housed at the State Library of Victoria is dated to 1979. The bridge still appears to be in relatively fair condition at this time, with the balustrade still intact.

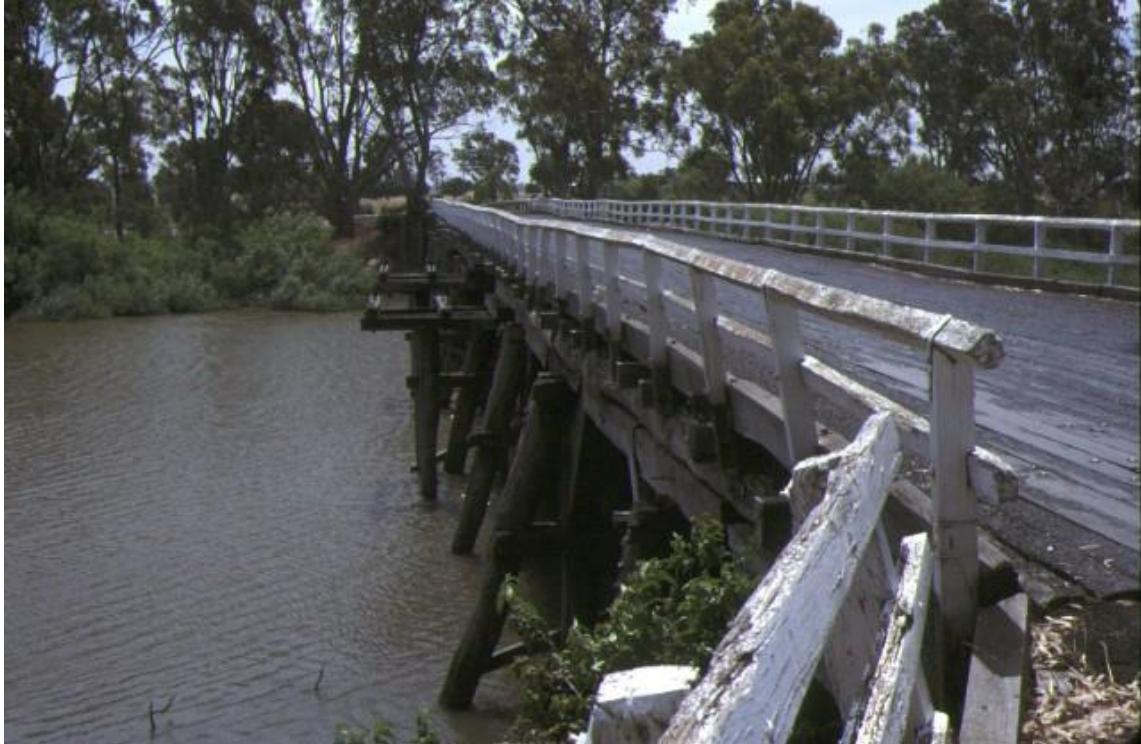
Figure 7. Chinamans Bridge. *Source:* National Trust of Australia (Victoria), 1987.

The following photographs taken by the National Trust of Australia (Victoria) in the 1980s and 1990s detail the level of decline at this time.

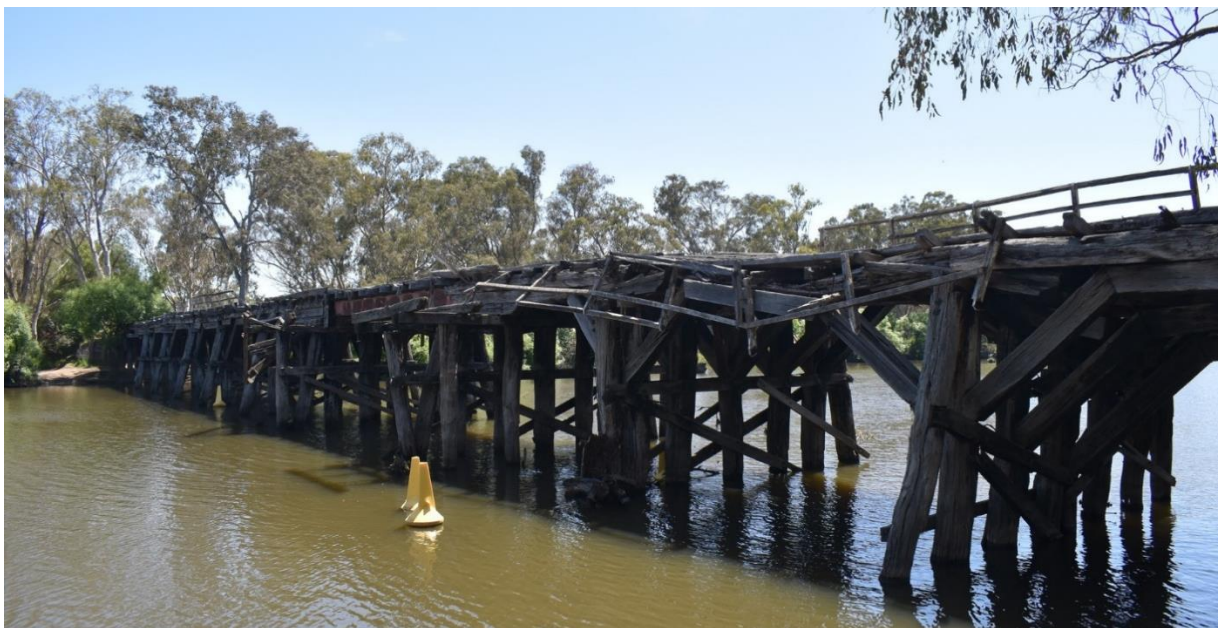
Figure 9. Chinamans Bridge, looking north. *Source:* Extent Heritage, November 2023.

The deck is constructed from long linear planks fixed to underlying cross beams. A later addition to the bridge is bitumen, which was used to resurface the deck. Evidence of the original balustrade rails are present in part, though much of the railing has collapsed into the water

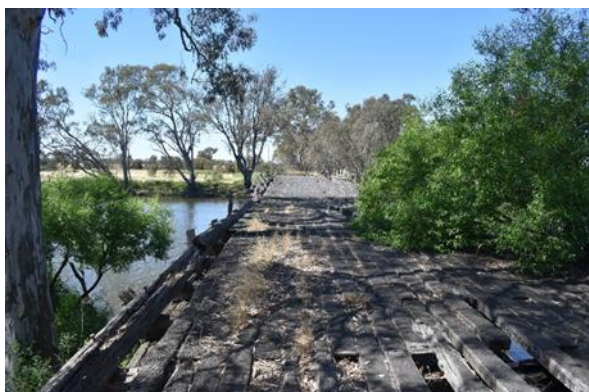
Figure 10. View of the bridge decking looking southeast. *Source: Extent Heritage, 2023.*

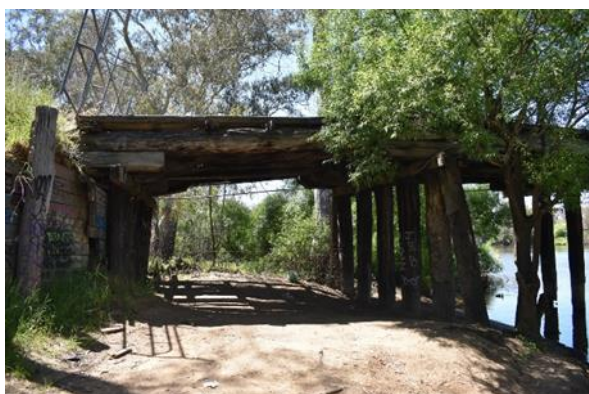
Figure 12. View of the southern abutment, looking north. *Source: Extent Heritage, 2023.*

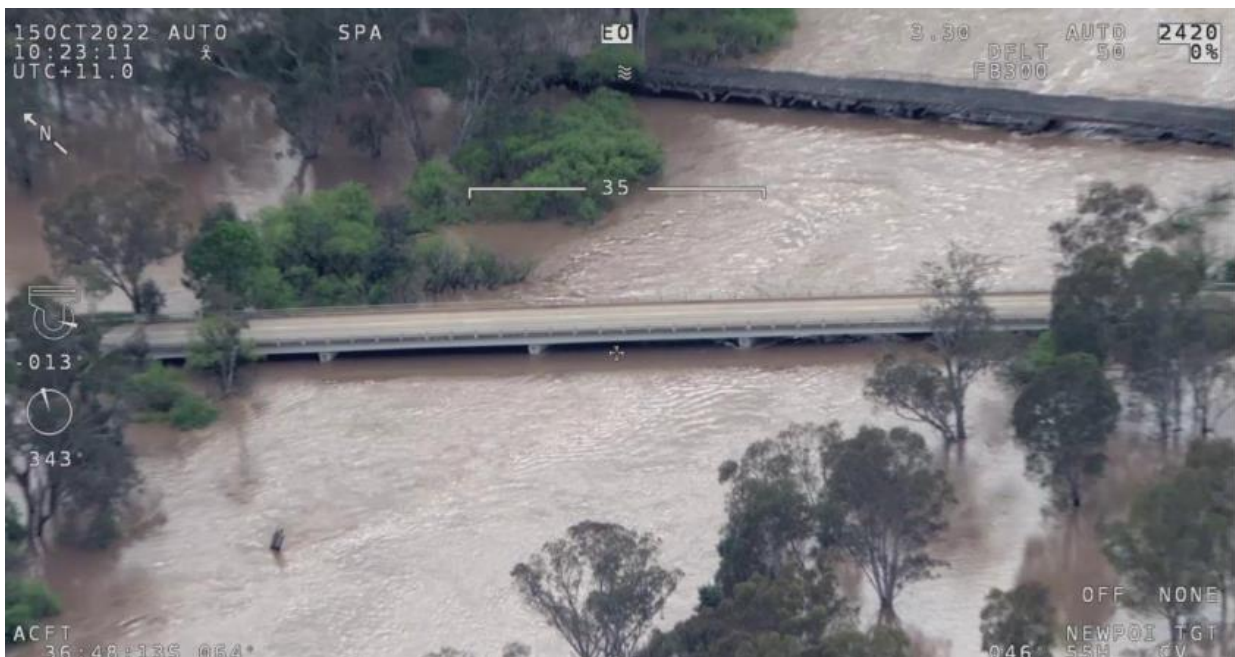
Figure 14. Chinamans Bridge, Nagambie, with current road bridge in middle-ground. *Source:* Heritage Victoria, October 2020.

- *Event information:* After heavy rain on 13 and 14 October, the Goulburn River was at a major flood level. It is unclear how high exactly the water reached at Chinamans Bridge, but an [aerial photograph] (see Figure 14) taken near the peak and shows the flood waters almost reaching the stringers at the top of the crossheads.
- *Impact to heritage:* The bridge withstood the effects of the flood remarkably well for its vulnerable state of preservation prior to the event. However, it is likely that the flood debris has inflicted some damage, and the timber platforms and handrails which have started to detach and are in poor condition, and flood waters may have contributed to their deterioration.

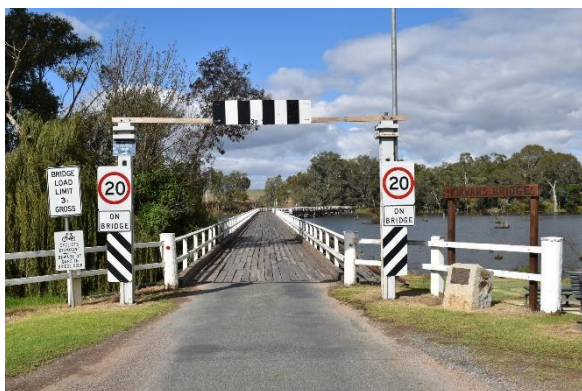
Figure 16. Direct overview of Kirwans Bridge looking south. *Source: Extent Heritage, 2022.*

This is considered a relevant example of a local timber bridge with similar conservation issues at play that has been conserved through the successive replacement of degraded materials with contemporary structural materials as opposed to a like-for-like replacement.

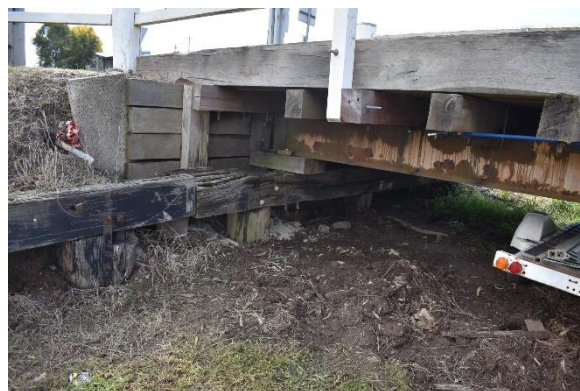
Figure 17. Detail view of new steel girders under Kirwans Bridge. *Source: Extent Heritage, 2022.*

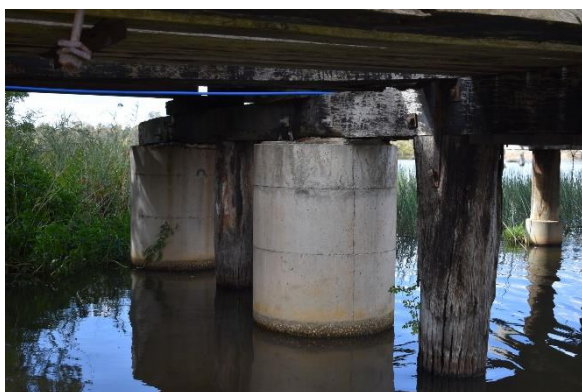
Figure 18. View of contemporary concrete piles on Kirwans Bridge. *Source: Extent Heritage, 2022.*

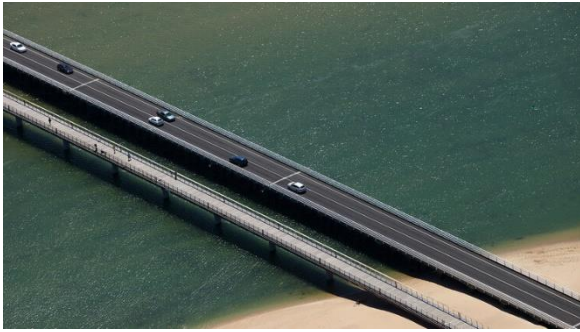
Figure 20. Aerial view of the reconstructed Barwon Heads Bridge and new adjacent William Buckley Bridge. *Source:* Peter Elliot Architecture.

The Barwon Heads Bridge was substantially refurbished during adaptation works in 2009 with much of its original fabric replaced. A new bridge was constructed to the south running parallel with the adapted bridge. During construction the new bridge was used for vehicle traffic while the original bridge was upgraded but was eventually converted to a pedestrian bridge.

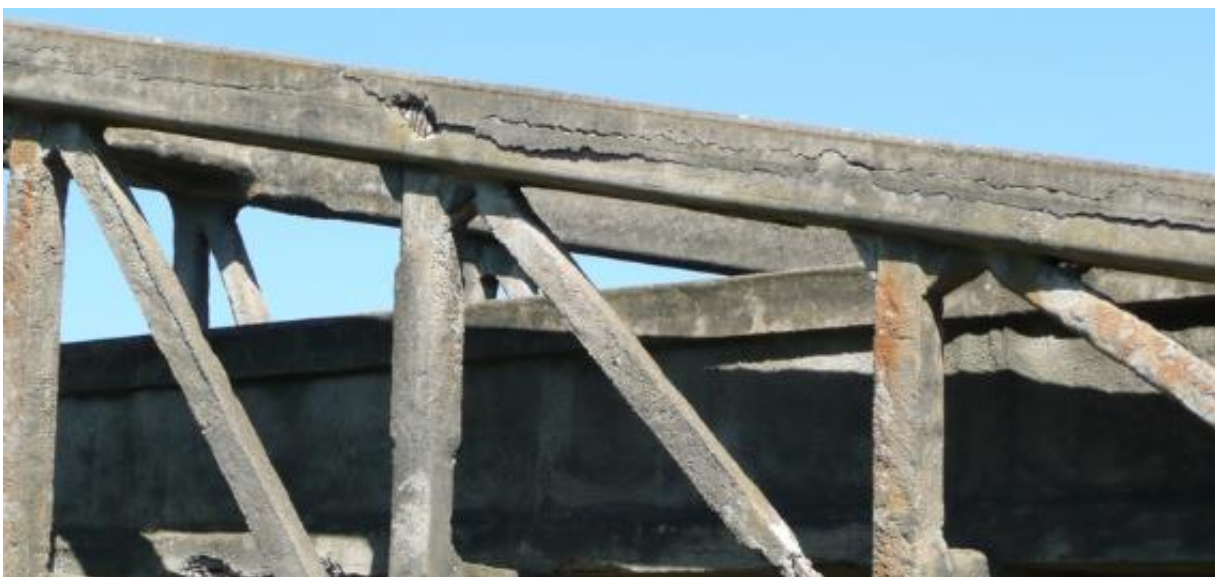
Figure 22. Detail of the bridge showing concrete deterioration. *Source:* Heritage Victoria, 2020.

After considerable deliberation and options analysis, a permit was granted by Heritage Victoria to allow the partial demolition of four spans of the aqueduct, particularly to enhance access to the waterway by the Traditional Owners as well as the general public. Other sections of the structure are proposed to be conserved to the fullest extent possible at an exorbitant cost to place managers Barwon Water, with a public exclusion fence constructed to help manage the ongoing risk of the structure.

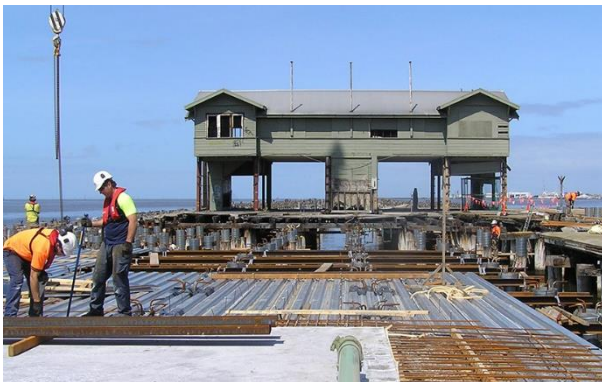
Figure 23. View of Princes Pier in c2008 showing the dilapidation of the structure prior to reconstruction works. *Source:* Major Projects Victoria (Peter Glenane).

Following significant deterioration and cessation of shipping traffic to the pier, the pier was substantially demolished in c.2009-2010 with reconstruction and restoration works undertaken to the first 196 metres of the pier (including the gatehouse) with the remainder of the pier structure left uncovered. This resulted in a 'sea of piles' outcome that demonstrates the original length of the pier while managing the cost considerations of full reconstruction of a redundant structure. However, the ongoing conservation issue is that without the structural decking or girders, the remaining piles have no support and continuously fall into the water. This becomes a concern for boats and other watercrafts with submerged floating piles posing a serious risk to health and safety.

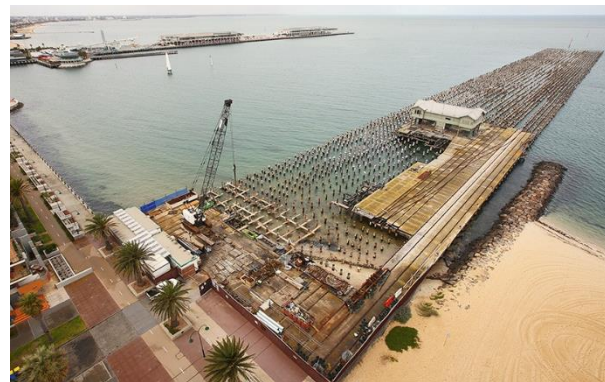
Figure 24. View of the 'sea of piles' at Princes Pier where the deck of the pier was not reconstructed following conservation works. *Source:* Major Projects Victoria (Peter Glenane).

On this basis, similar with the above analysis regarding the Ovoid Sewer Aqueduct, land-based sections of the structure could be conserved to the greatest extent possible, with a public exclusion fence constructed to help manage the ongoing risk of the structure. Additionally, some fabric could be retained to allow for the interpretation and understanding of the site, however the structural risk would be minimised.

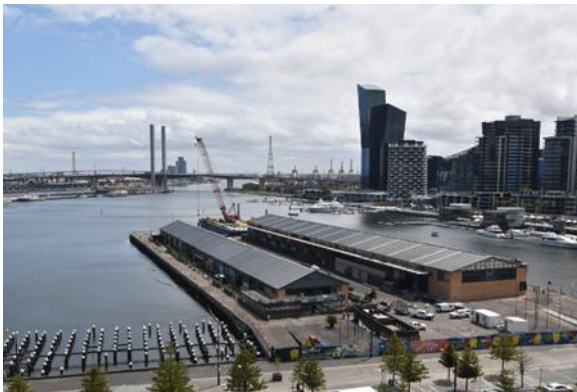
Figure 25. November 2023 view of Central Pier showing the commencement of demolition. *Source:* Development Victoria, November 2023.

Central Pier was permanently closed in early 2020 due to fears of major structural failure. Following its closure in 2020, the bridge continued to deteriorate to the point where collapse was deemed imminent. In 2020, Heritage Victoria issued a heritage permit (P37012) allowing the demolition of the structure on public safety grounds.
