Structural Engineering Advice

Chinamans Bridge

Nagambie

27th May 2024

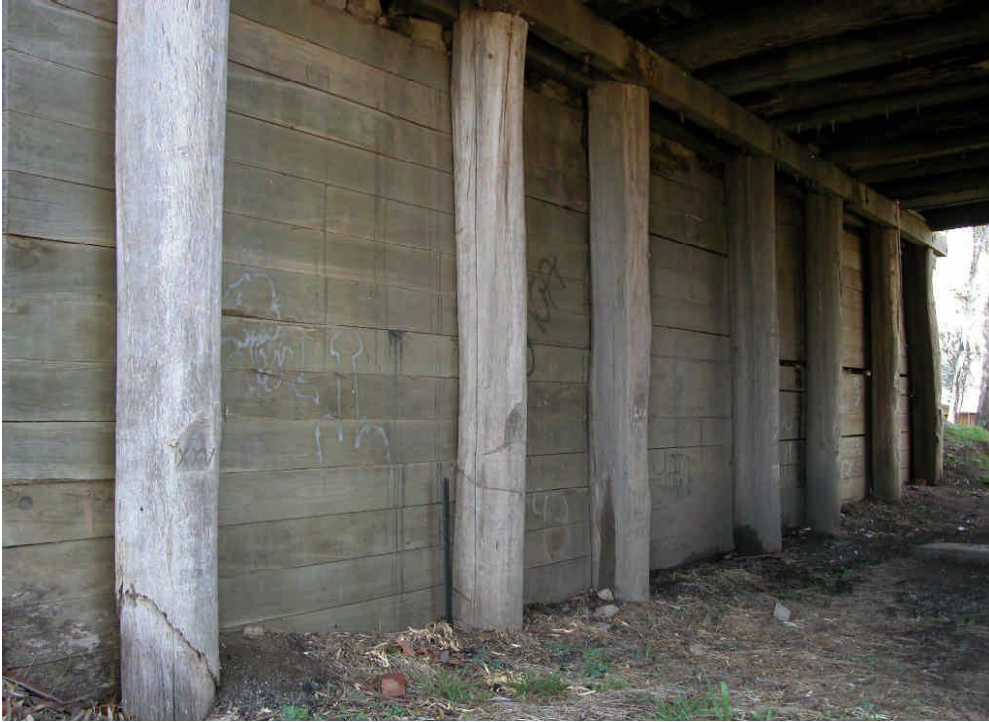
Condition State 1

Timber piles in good condition.

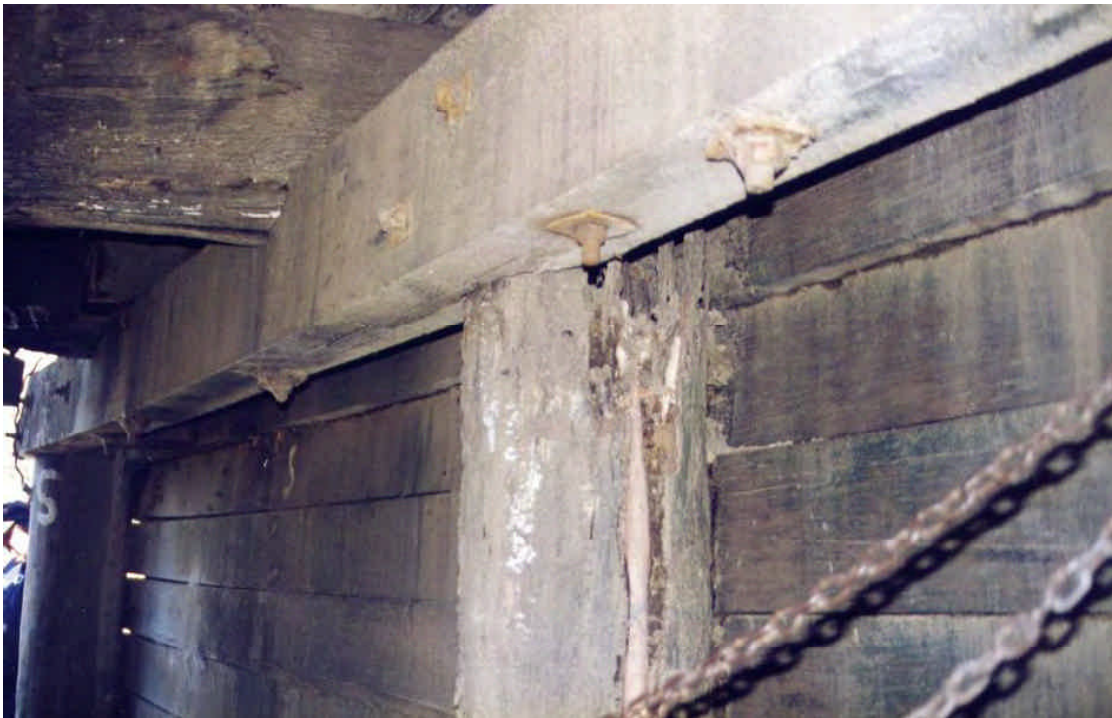
Badly rotten pile.
