Structural Engineering Advice

Chinamans Bridge

Nagambie

27th May 2024

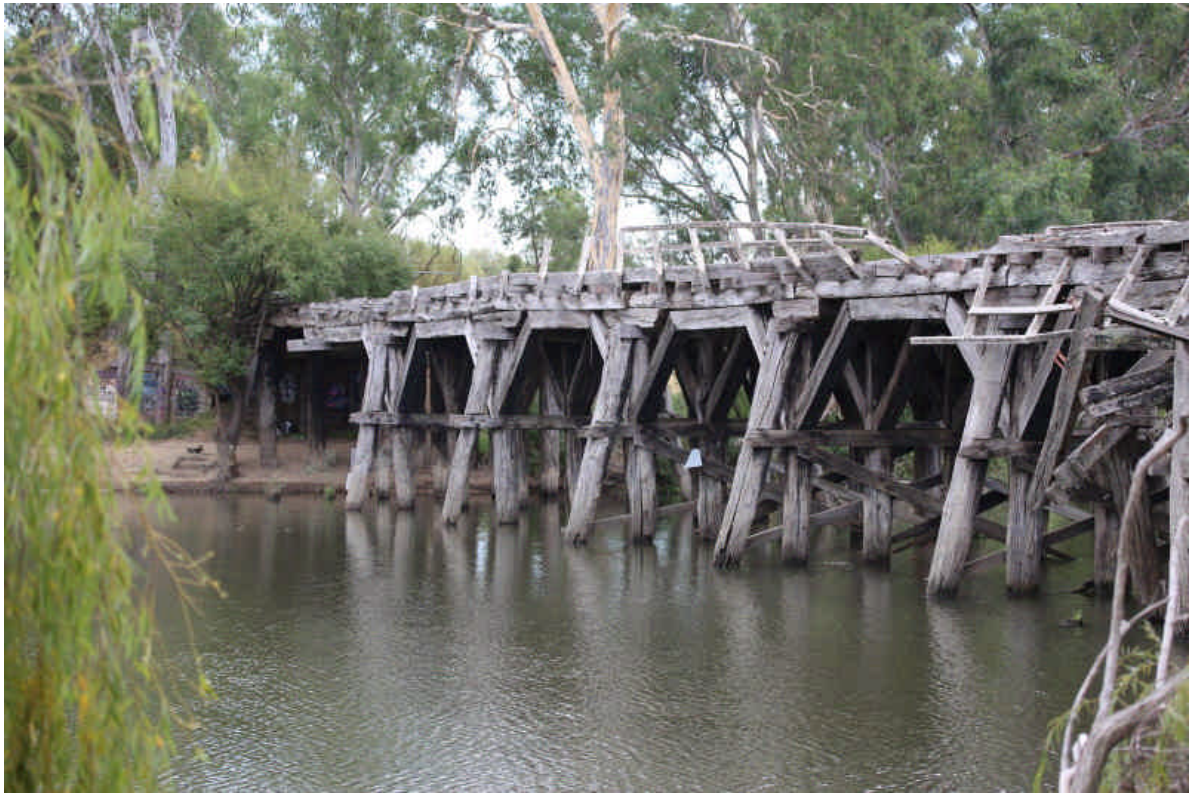
Photograph 1

A view of the northern end of the western elevation.

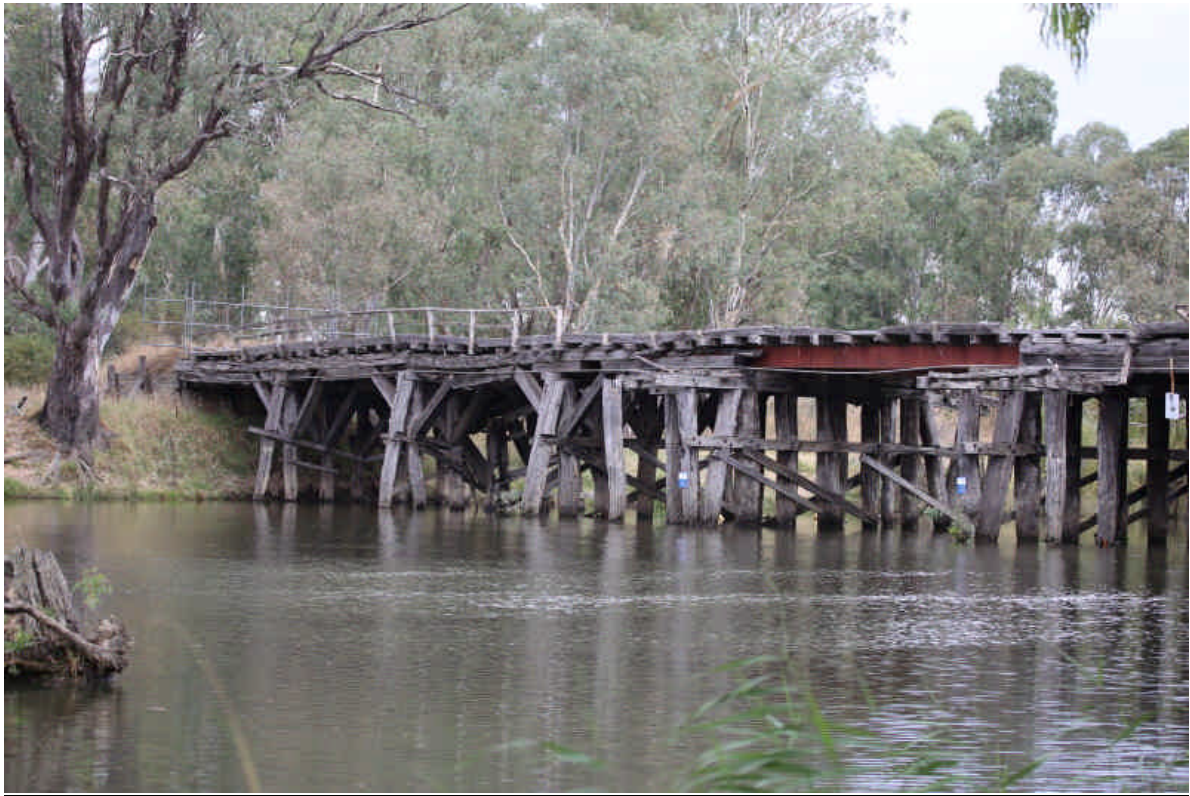
Photograph 2

A part view of the eastern elevation showing the RSJ girders.

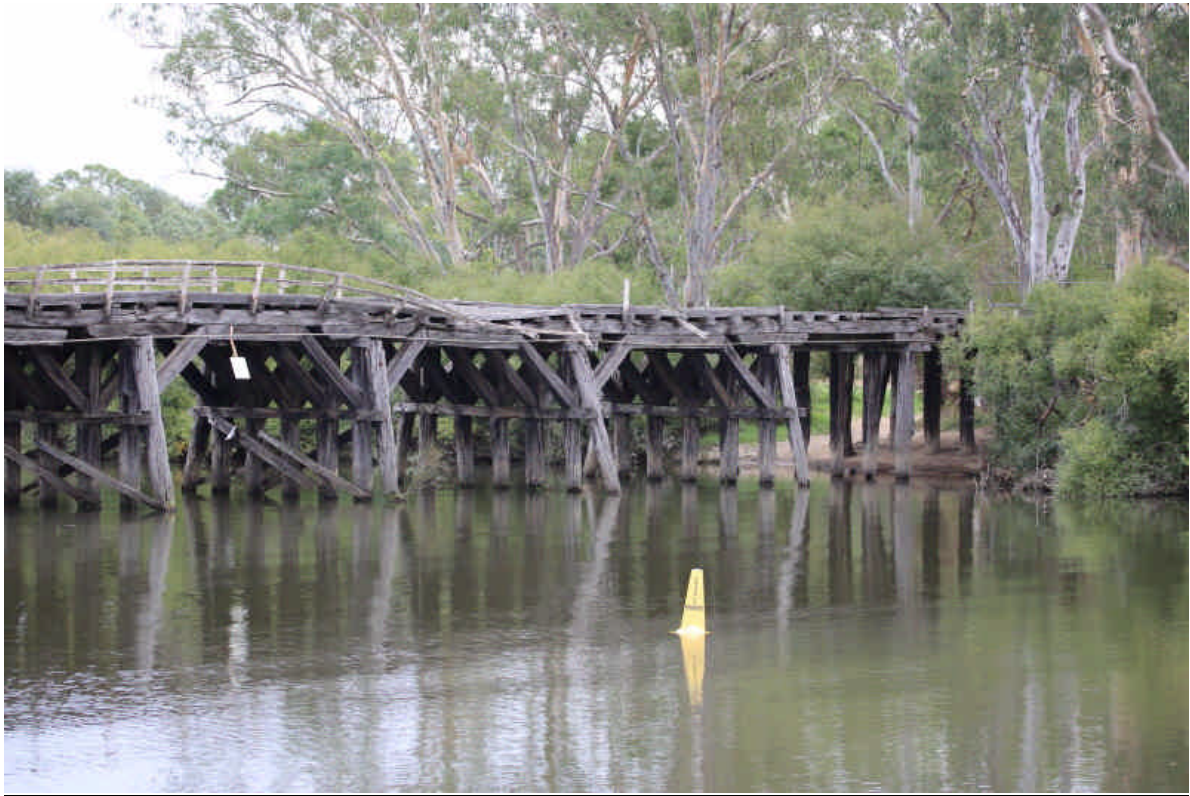
Photograph 3

A view of the northern end of the eastern elevation.

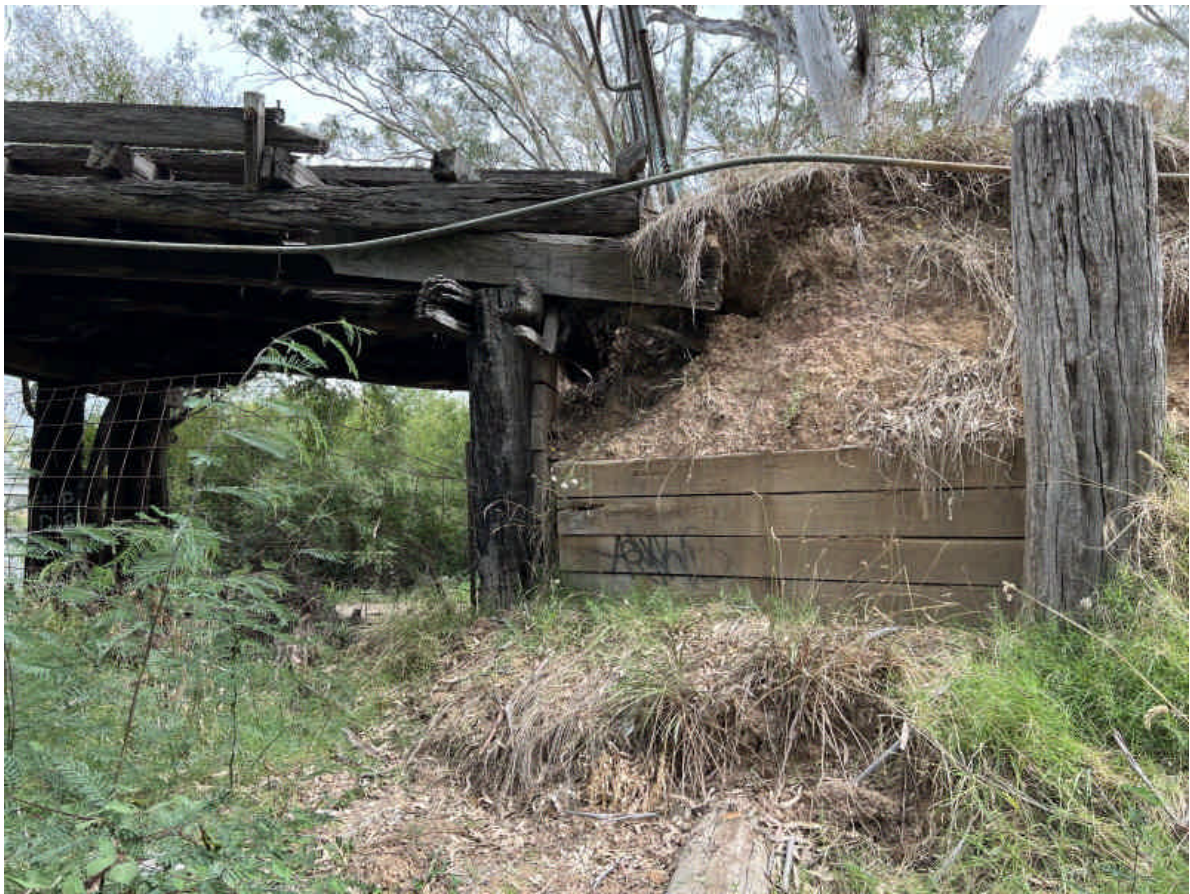
Photograph 5

In general the central section of the southern abutment appears to be in serviceable condition, albeit the piles are in variable condition.

A view of the southern abutment.

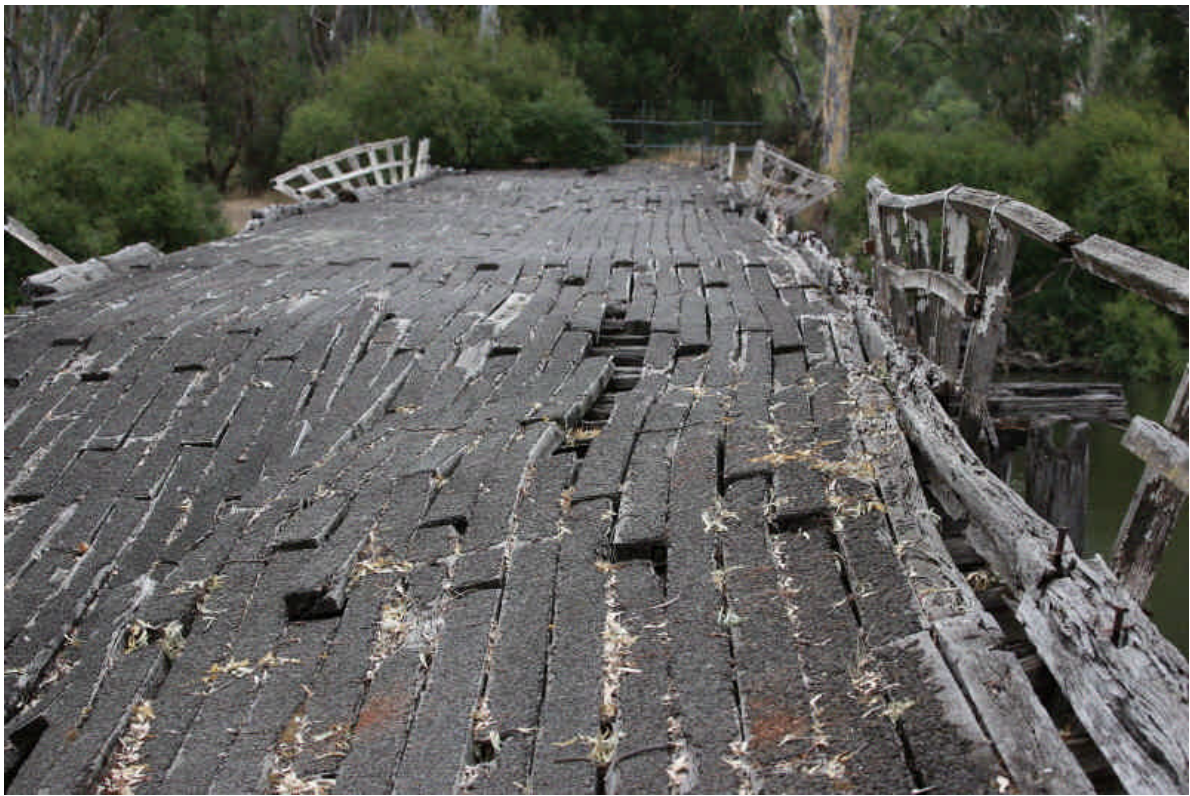
Photograph 6

A view of the southern end of the deck.

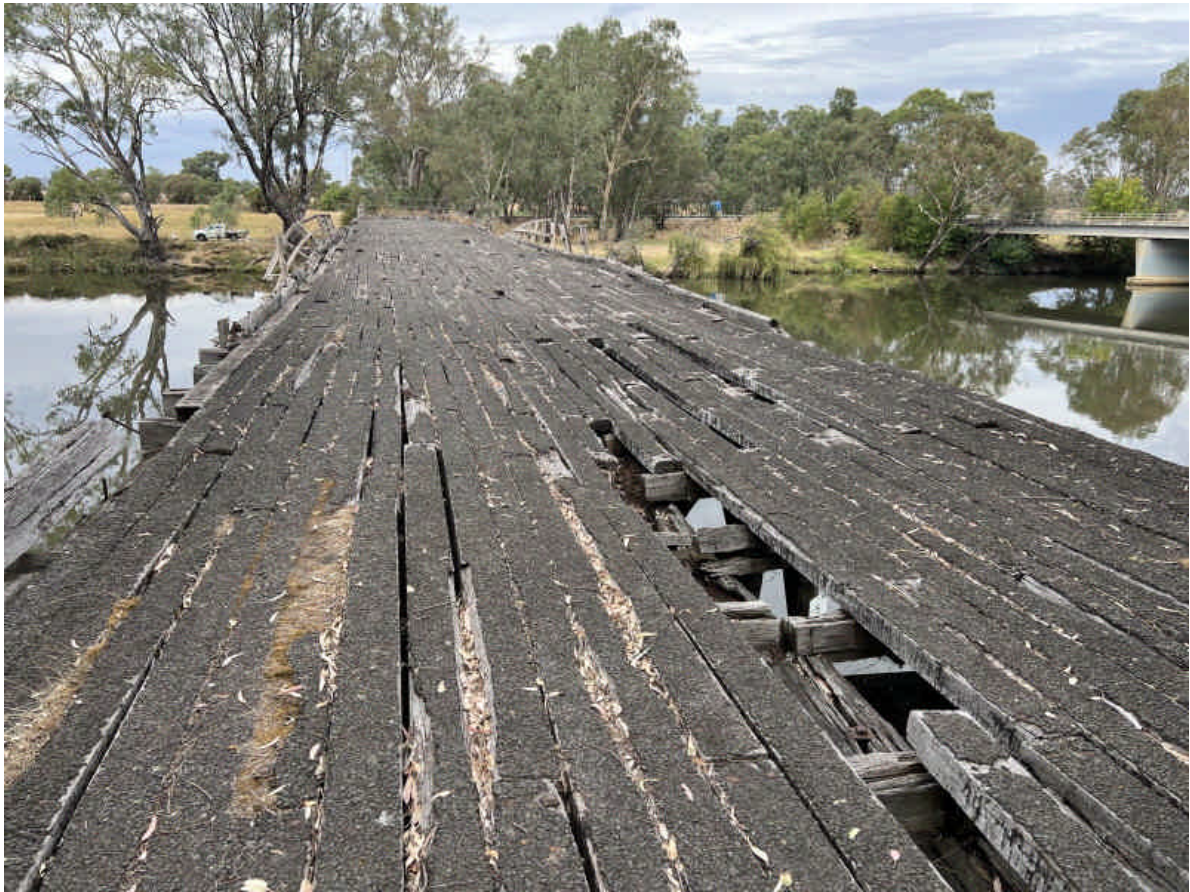
Photograph 8

A view of the northern end of the deck.

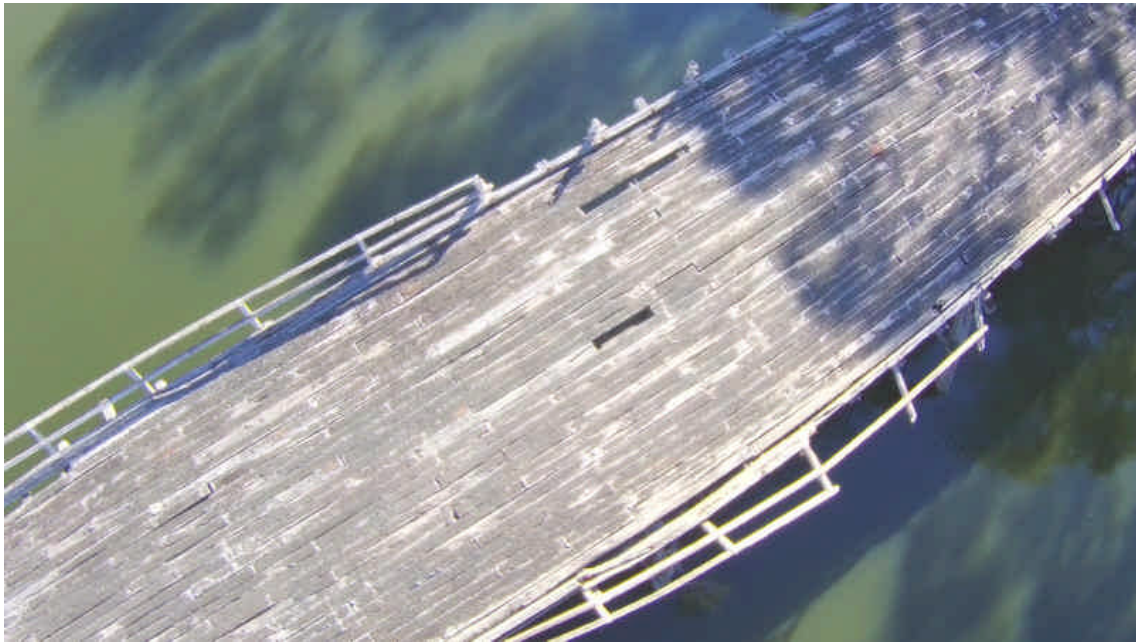
Photograph 9

An aerial view of the deck.

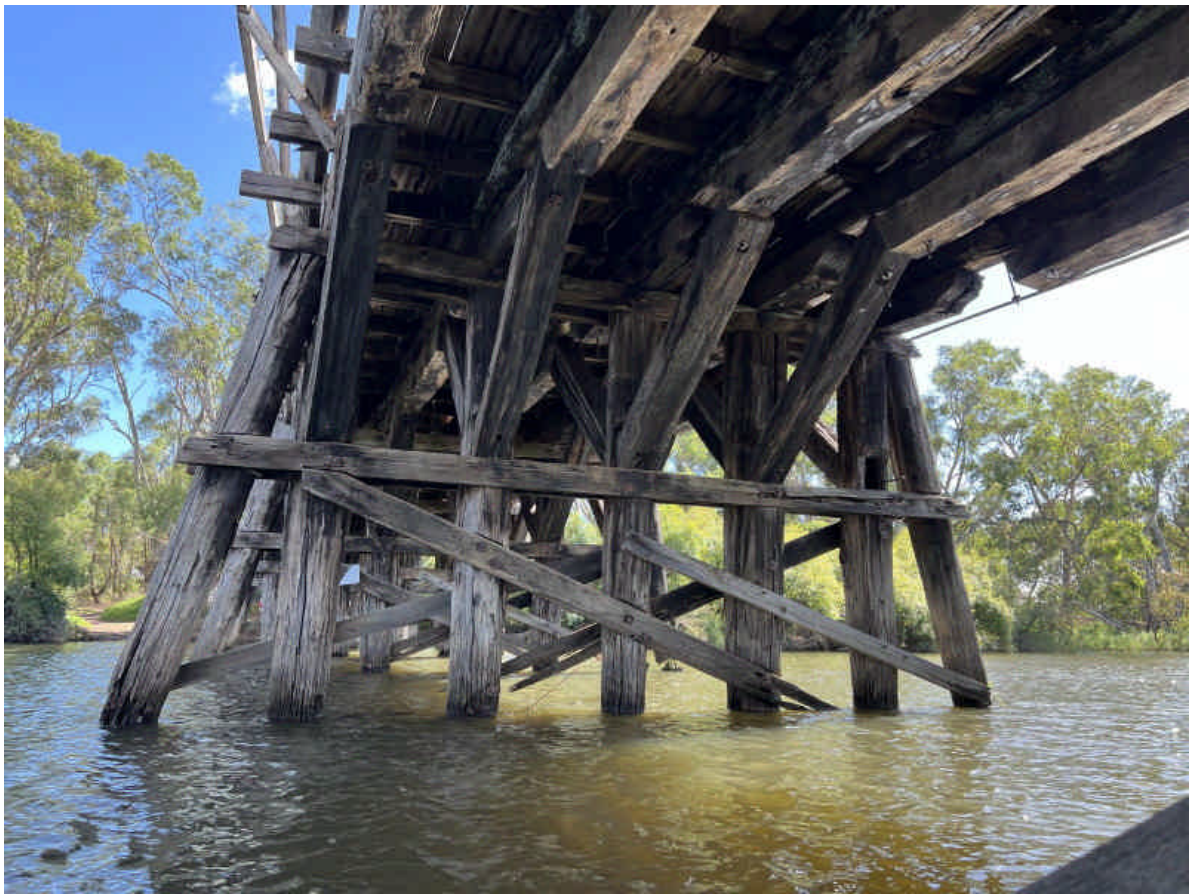
Photograph 10

A view of a typical trestle.

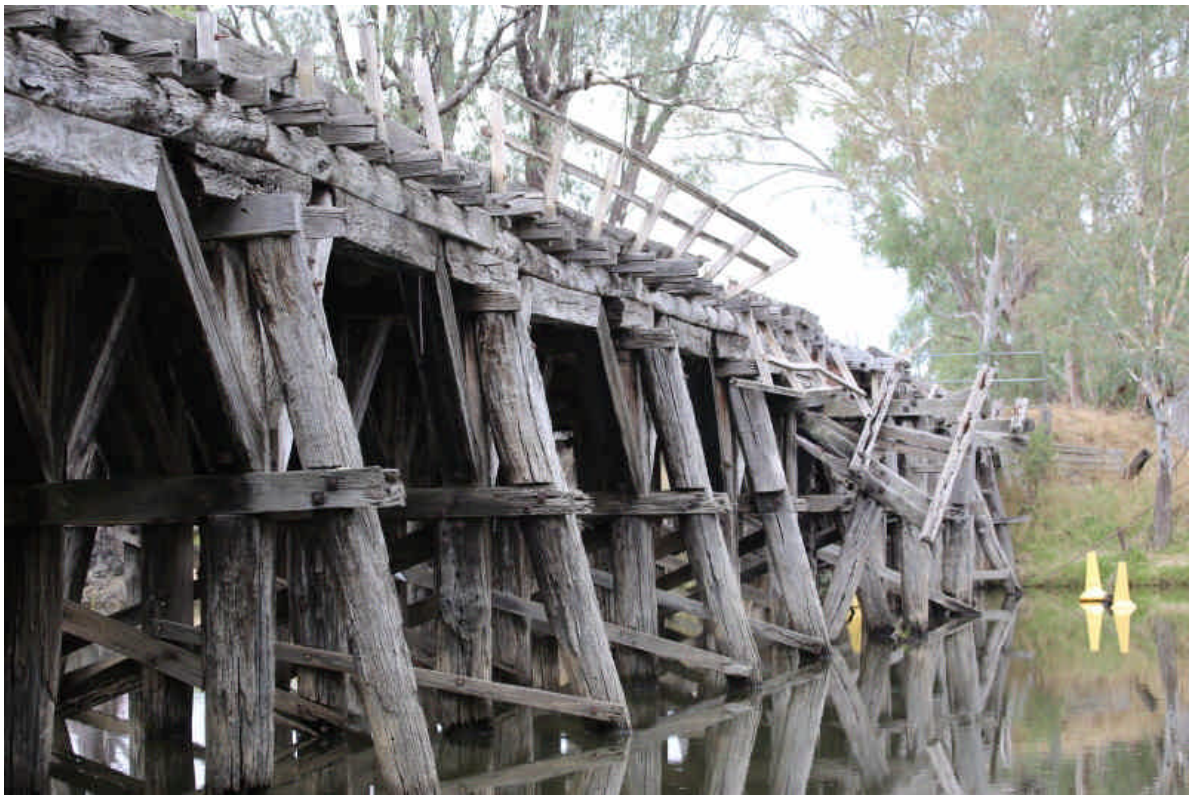
Photograph 11

A view of the western side of the trestles.

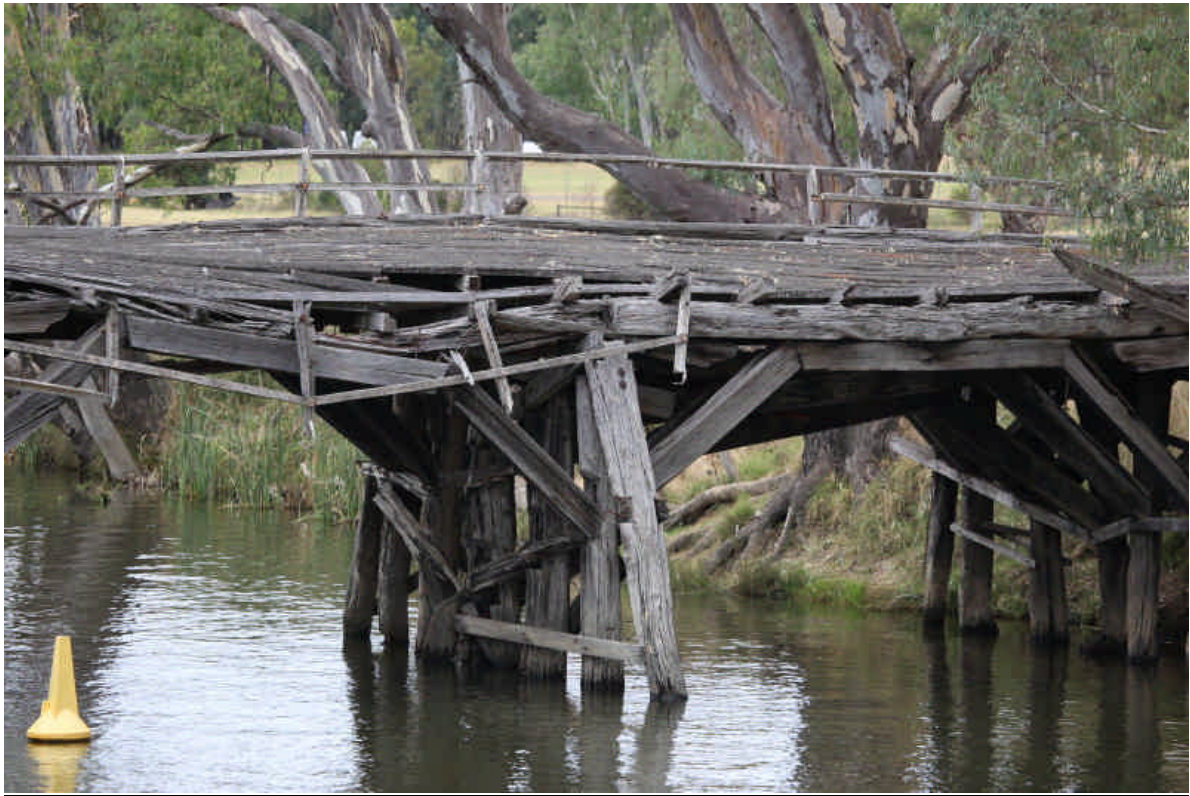
Photograph 12

A view of the collapse at the southern end.

A discussion of the remedial and strengthening works that would be required to achieve a live load capacity of 4.0 KPa or 4.5 kN follows. It should be noted that where the collapses have occurred the super-structure will need to be dismantled and then reconstructed.

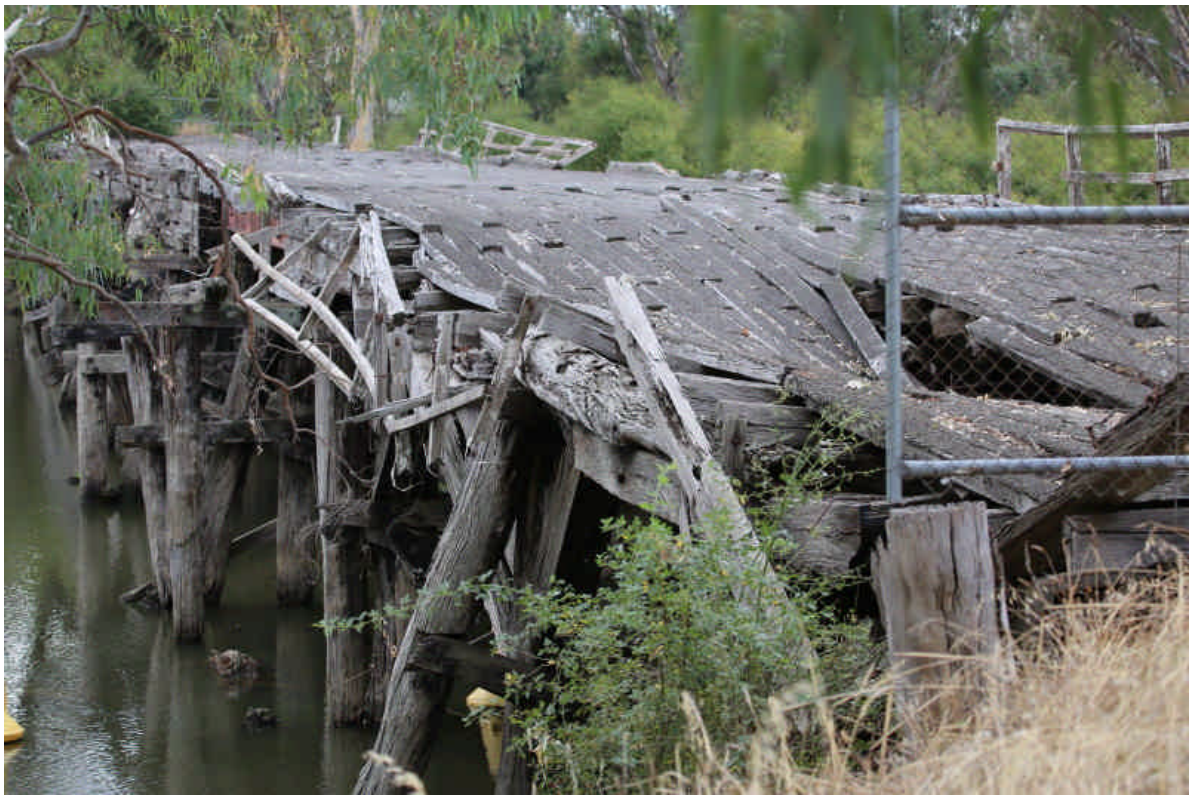
Photograph 13

A view of the collapse at the southern end.

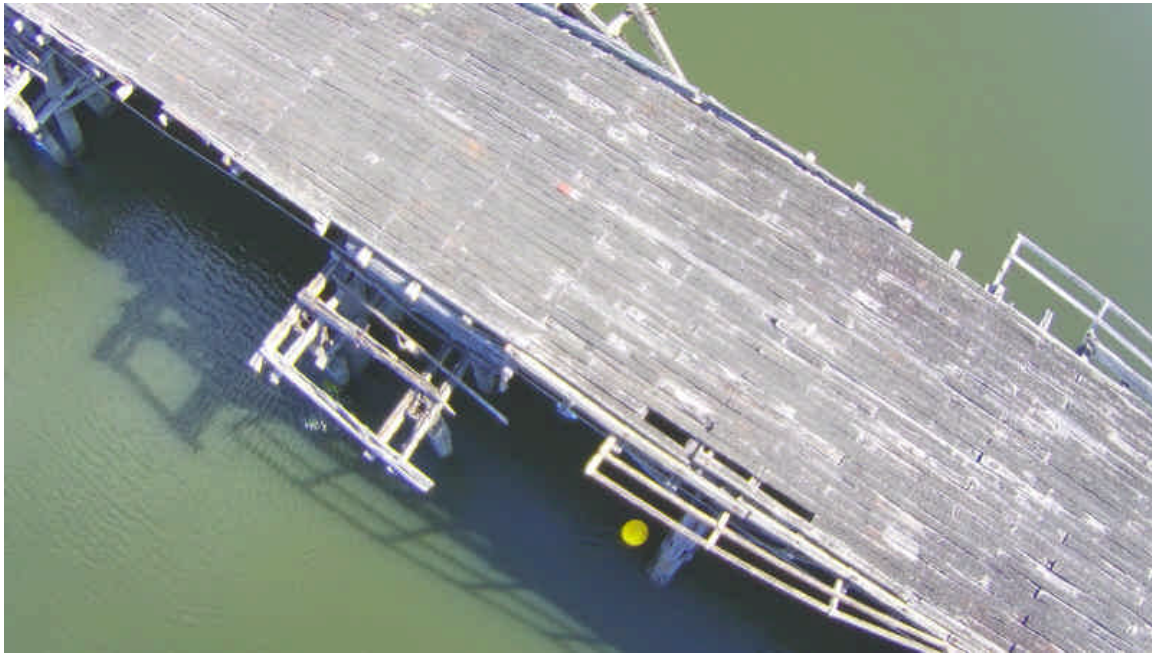
Photograph 1

In general the HW decking appears to be in reasonable condition albeit the ends of the planks have dry-rot, and the asphalt coating may have been applied to 'patch' and even the tops of the planking. Refer to photographs 1 to 4, Appendix C.

An aerial part view of the deck.

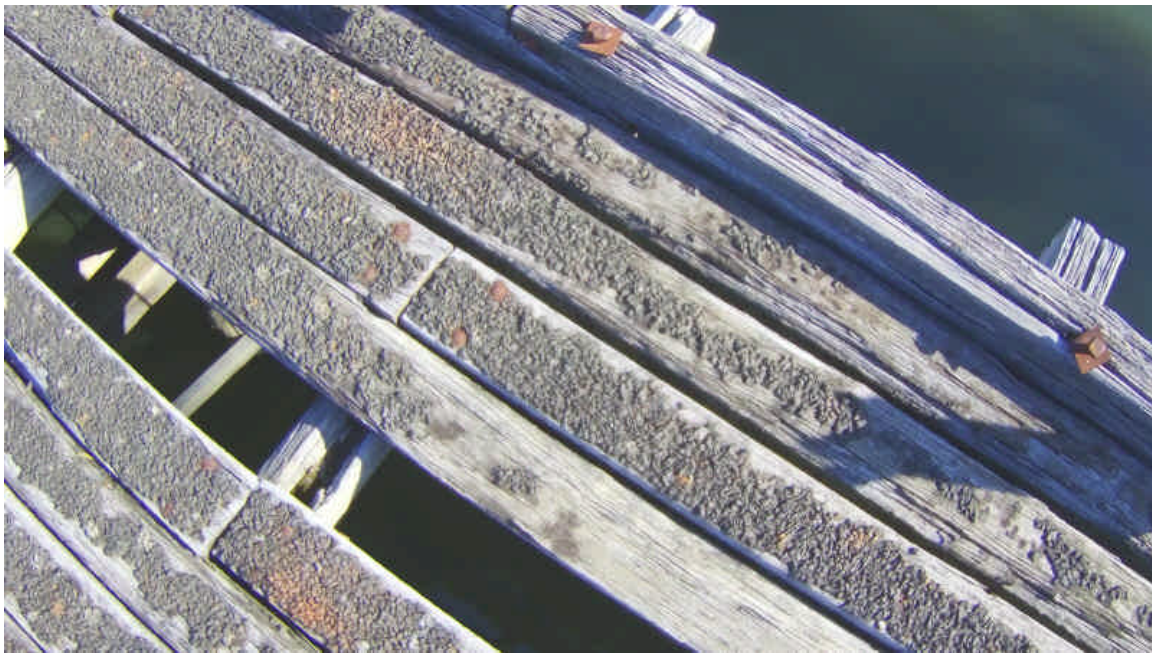
Photograph 2

A close up aerial part view of the decking.

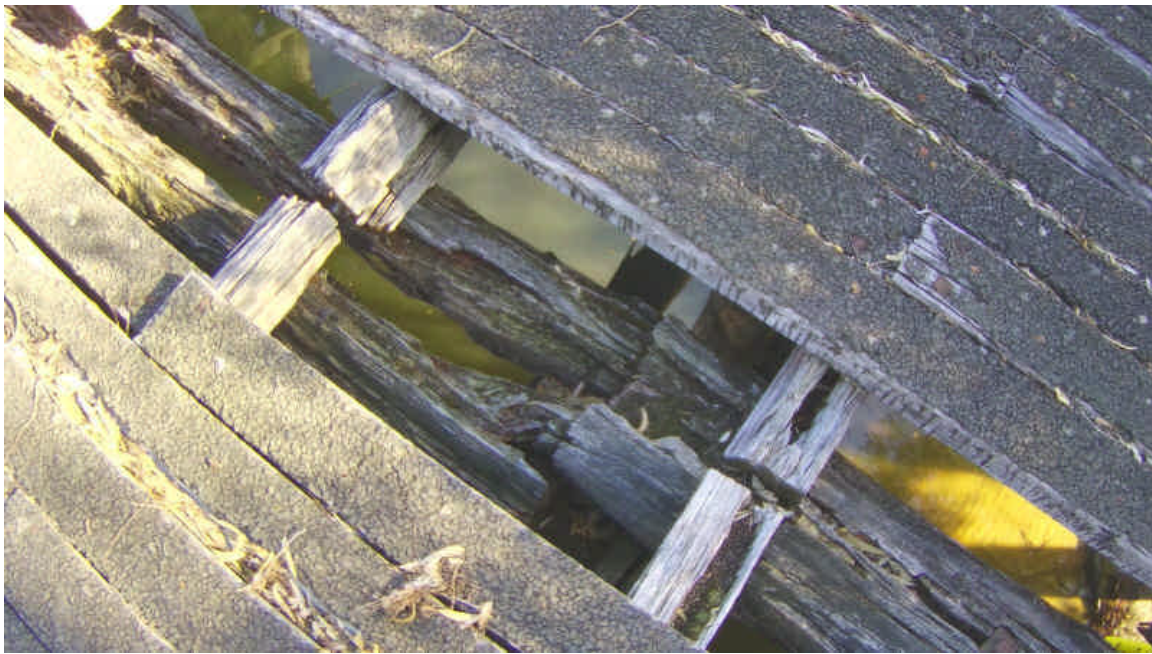
Photograph 5

The HW cross-beams are in generally poor condition and many of them have failed. Further, the numerous bolts and plates that have been retrofitted along the sides and below the cross-beams to secure the planks in position, indicates that the tops of the cross-beams have deteriorated and no longer hold the dog spikes that were originally used to fix the planks. Refer to photographs 5 to 7, Appendix C.

An aerial view of the cross-beams.

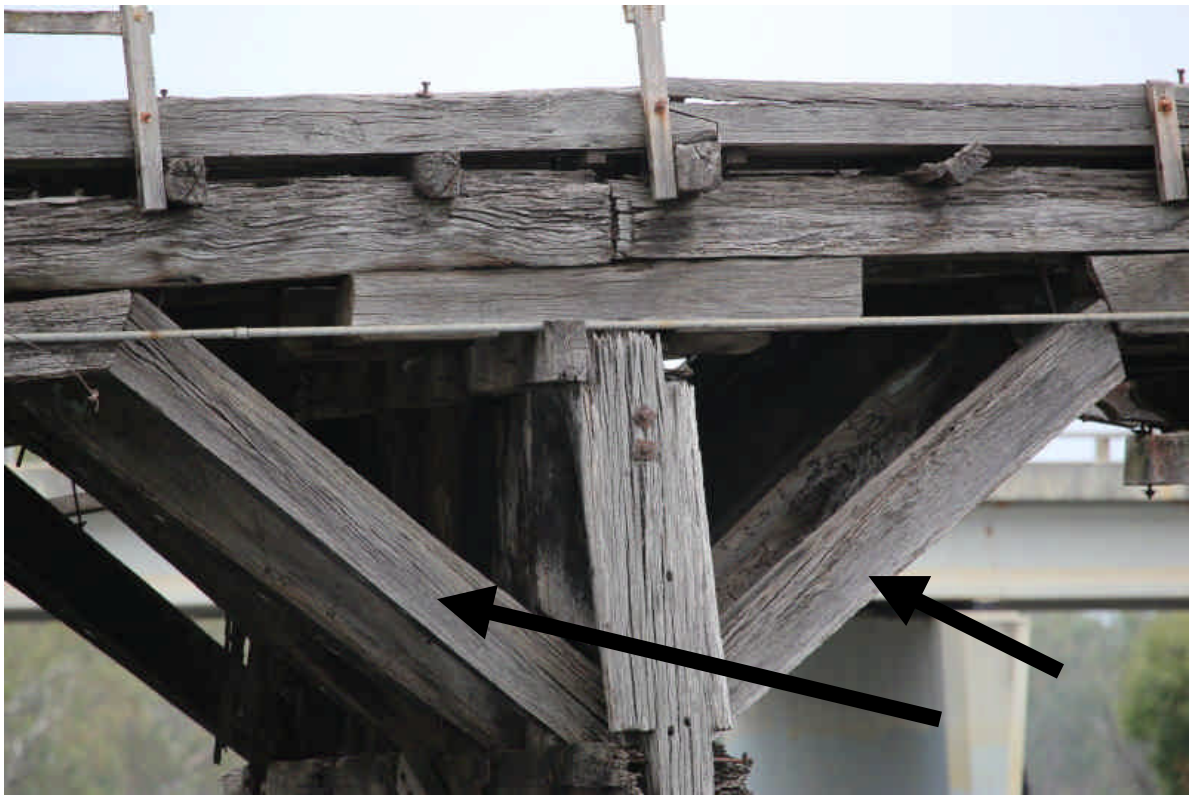
Photograph 18

In general the knee braces appear to be in serviceable condition. Refer to photographs 18 to 20, Appendix C.

A view of the knee braces – see arrows.

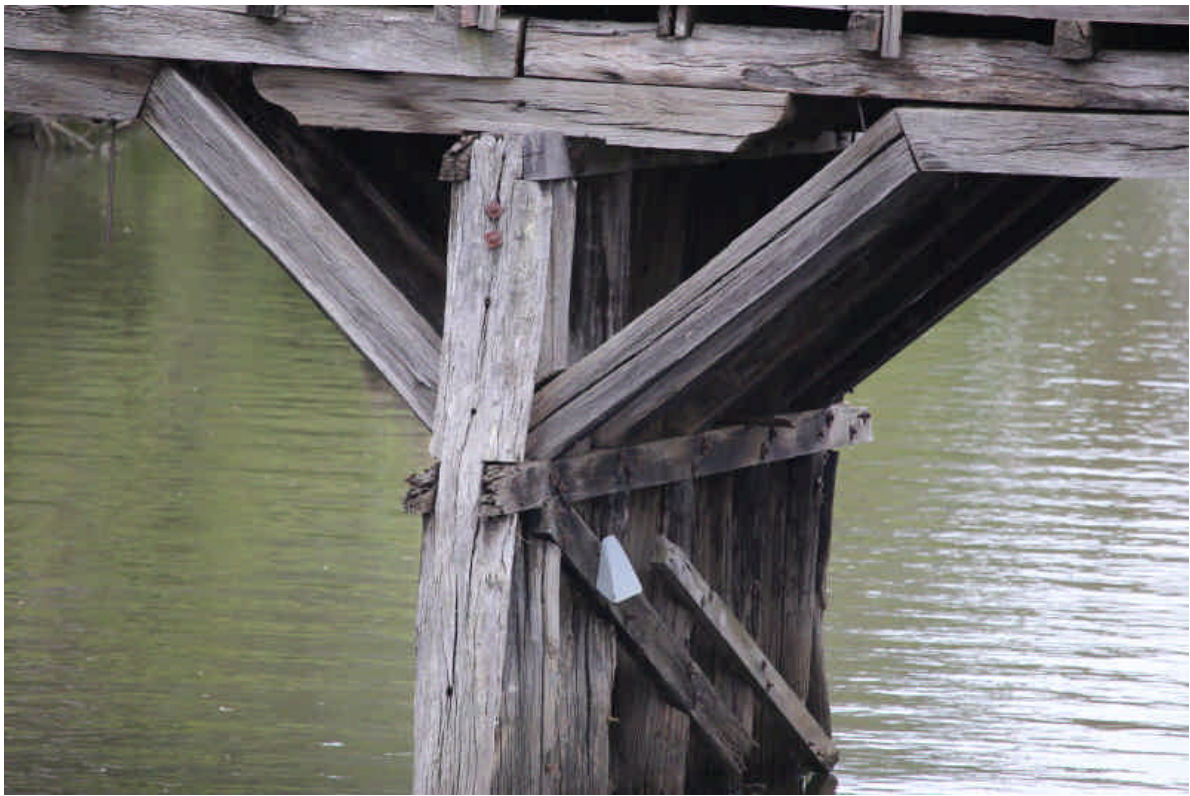
Photograph 19

A view of the knee braces.

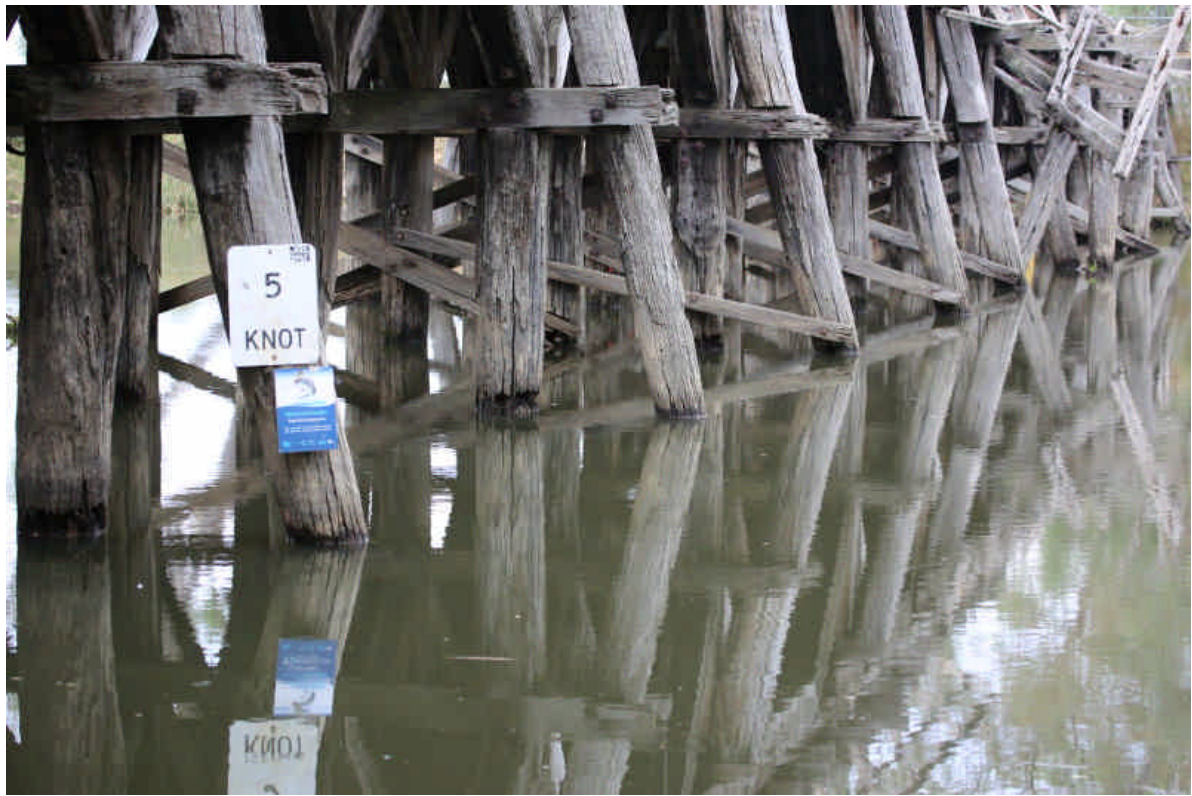
Photograph 23

Condition State 4 is defined as "*Advanced deterioration, heavy decay, insect infestation, splits, cracks or crushing has produced loss of strength that affects serviceability of the bridge*". Condition State 3 is defined as "*Medium decay, insect infestation, splitting, cracking or crushing has produced loss of strength of the element but not of a sufficient magnitude to affect the serviceability of the bridge.*" Condition State 2 is defined as "*Minor decay, insect infestation, splitting, cracking, checking or crushing may exist but none is sufficiently advance to affect serviceability.*" We have adopted the RTA Manual in lieu of the VicRoads Bridge Maintenance and Repair Manual as the RTA Manual is more explanatory, noting that both Manuals use a similar 1, 2, 3 and 4 rating system. Refer to photographs 23

A view of the vertical and inclined piles.

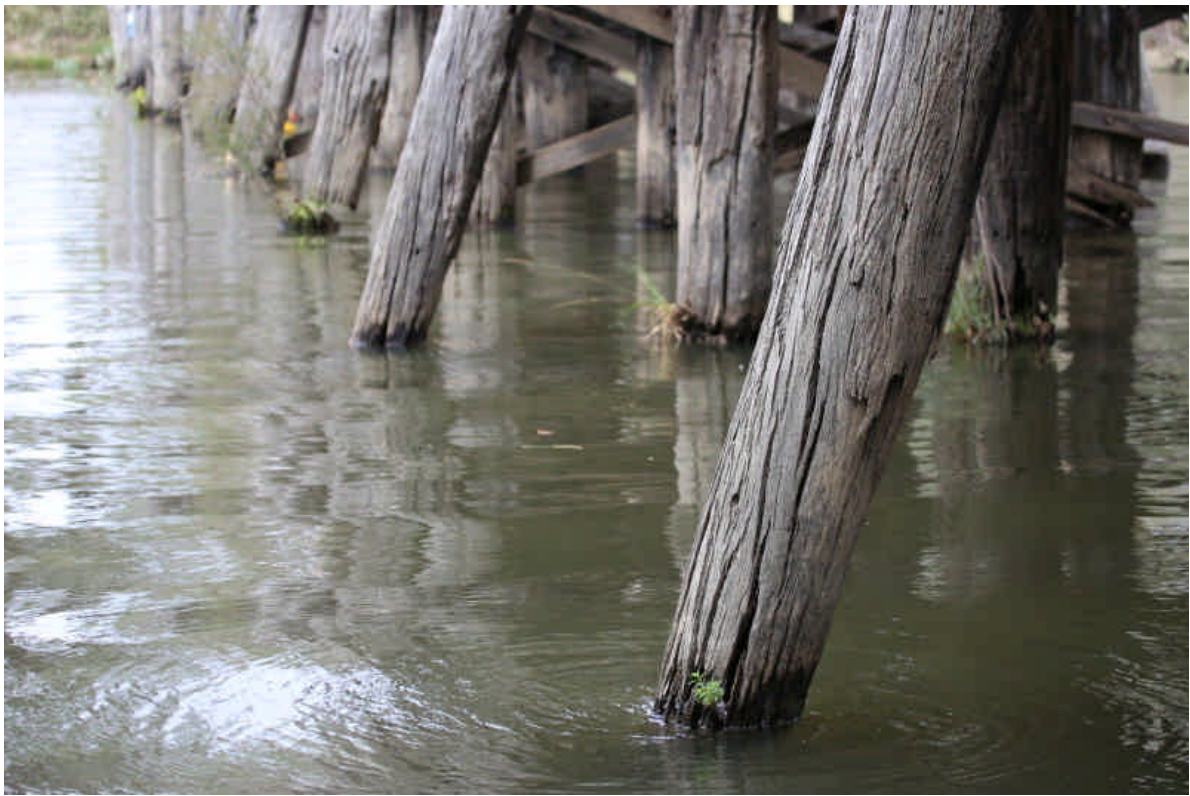
Photograph 24

A view of the vertical and inclined piles.
